EMERGENCY ALERT SERVICE BULLETIN

Tail Gear Box (TGB) P/Nos. 365A33-6005-09 and 365A33-6005-10

HELICOPTER(S) CONCERNED	NUMBER	Version(s)	
		Civil	Military
AS365	01.00.71	N1, N2, N3	F, Fi, K, K2
AS565	01.00.24		MA, MB, MBe, SA, SB, UB
EC155	04A016	B, B1	
SA366	01.31		GA

Airbus Helicopters has recently been informed of a case of chip detection on a control rod double bearing of a TGB P/N 365A33-6005-09.

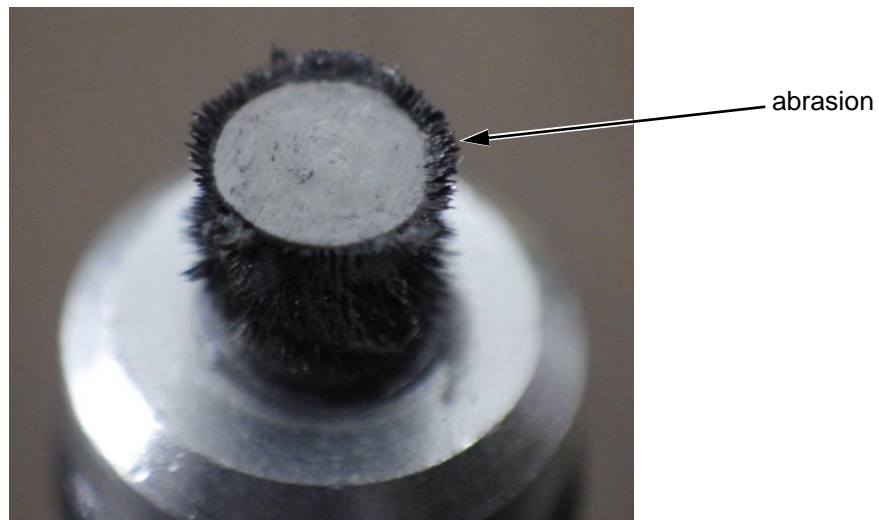
Figure 1: Example of abrasion on the chip detector

IN THE FLOW CHART, THE ABRASION PARTICLES (CLASS g AS PER MTC) MUST BE TAKEN INTO ACCOUNT IN ADDITION TO THE PARTICLE TYPES USUALLY TAKEN INTO ACCOUNT.

Are there **abrasion** (as per example in Figure 1)/scale/chip/splinter type particles or particles different from cotter pins, lockwire, swarf, various non-metallic debris ?**

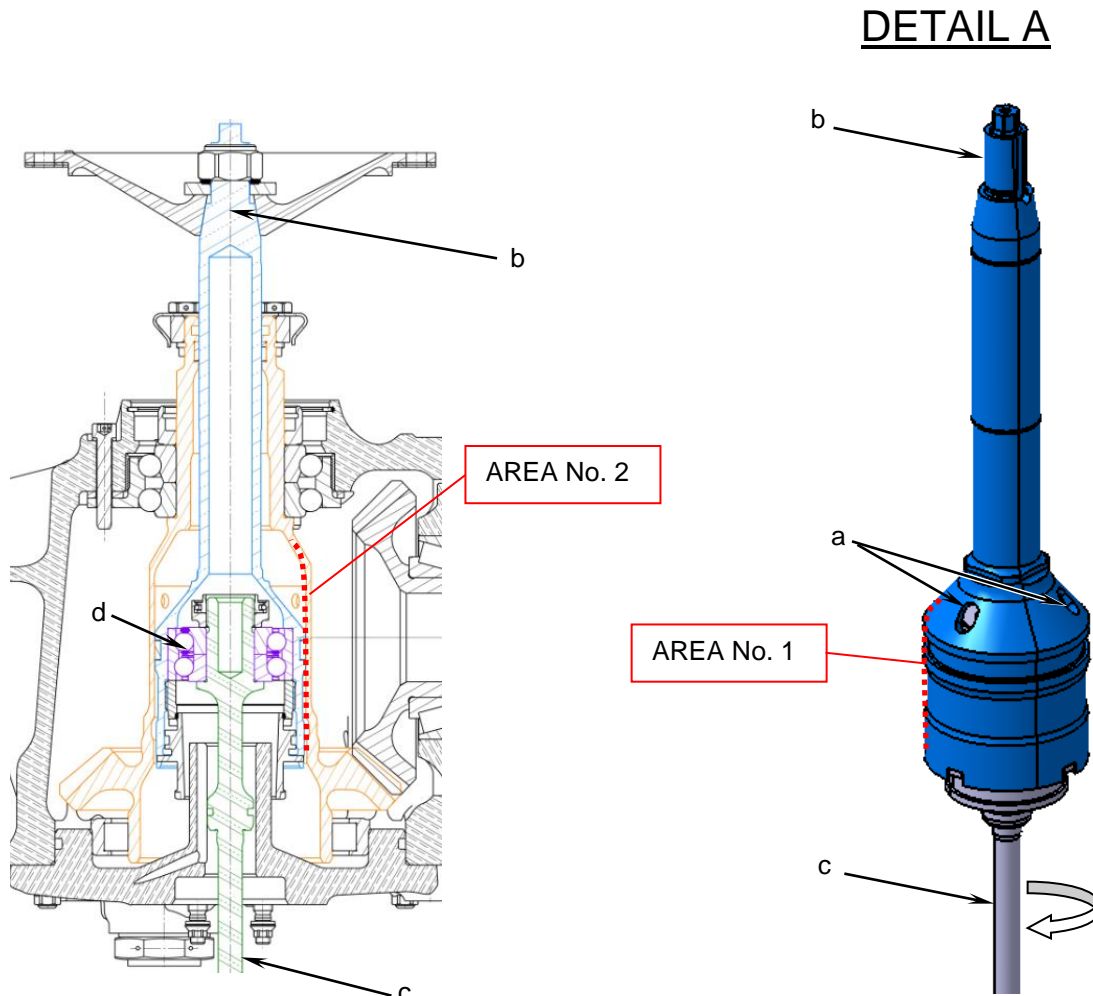
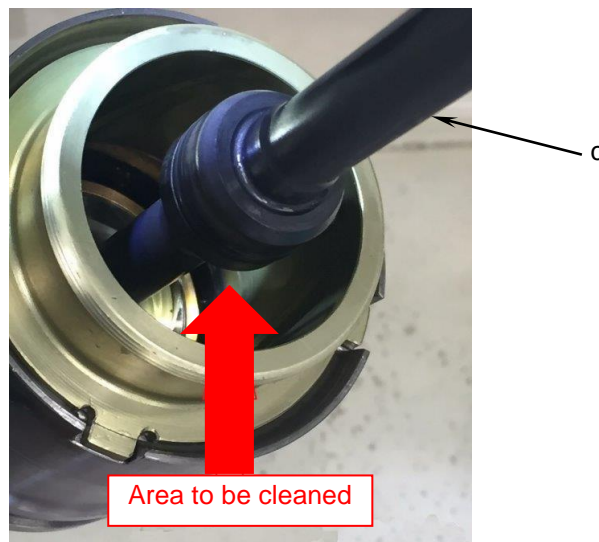
Figure 2 (Washing of the double bearing)

- Remove the control shaft/rod assembly as per paragraph [3.B.4.a.](#)
 - Be very careful when performing the particle detection and collection in the two areas defined as per Figure 2.

Make sure that the area pointed out in [DETAIL B Figure 2](#) is clean.

- Clean the control shaft/rod assembly using WHITE SPIRIT (2) as per Work Card 20-04-01-102 (MTC):
 - . Hold the shaft (b) in the vertical position pointing upward.

- 1) Insert WHITE SPIRIT (2) under pressure (for example using a can) in the hole (a) of the control shaft (b). **(See [DETAIL A Figure 2](#)).**
 - . Manually turn the control rod (c) several times to wash the double bearing (d) by draining the WHITE SPIRIT (2) through the bearing. **(See [Detail A Figure 2](#)).**

- 2) Insert WHITE SPIRIT (2) (for example using a can) in the area of the control shaft (b) that must be cleaned. **(See [DETAIL B Figure 2](#)).**
 - . Manually turn the control rod (c) several times to wash the double bearing (d) by draining the WHITE SPIRIT (2).

- Lubricate the double bearing (d) with service oil.
- Install the control shaft/rod assembly as per paragraph [3.B.4.b.](#)

- . Complete [APPENDIX 4.A.](#) and [4.B.](#)
- . Replace double bearing (d) with a double bearing (1) as per Work Card 65-21-00-702 (MRM) or as per Task 65-20-01-961 (AMM).
- . Install the control shaft/rod assembly as per paragraph 3.B.4.b.
- . **Inform the Technical Support Department of the Airbus Helicopters Customer Service as per paragraph [2.B.](#)**
- . **Comply with paragraph [2.D.](#)**
