# EMERGENCY ALERT SERVICE BULLETIN

DAUPHIN	NUMBER	VERSIONS	
<b>EC155</b>	<b>05A007</b>	Civil:	B, B1

**SUBJECT: TIME LIMITS - MAINTENANCE CHECKS**

Check of the MGB Planet Gear Carrier

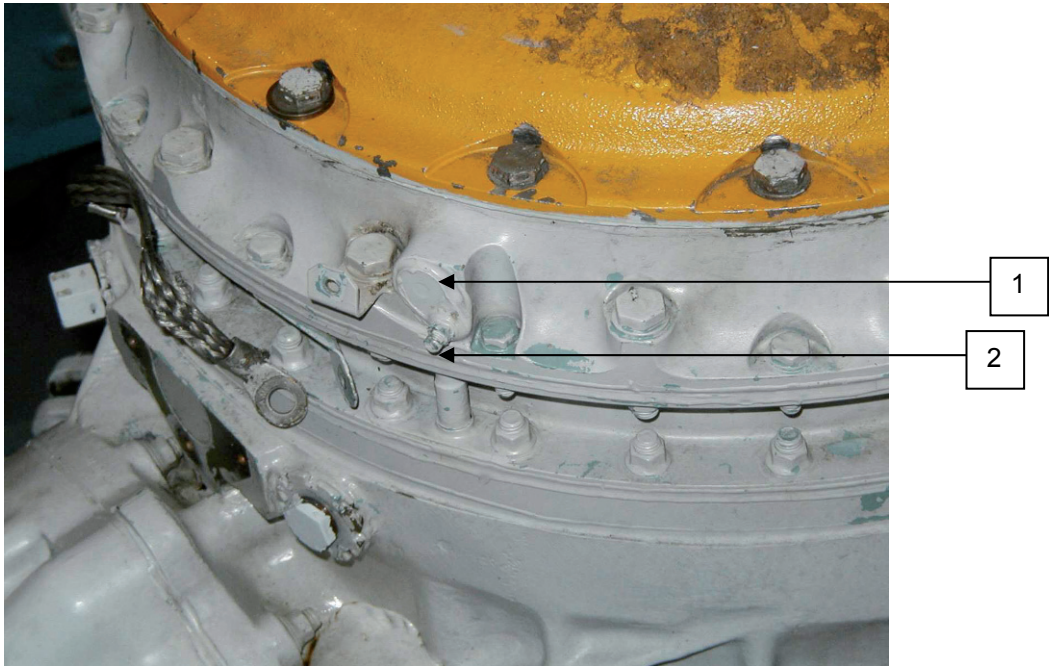
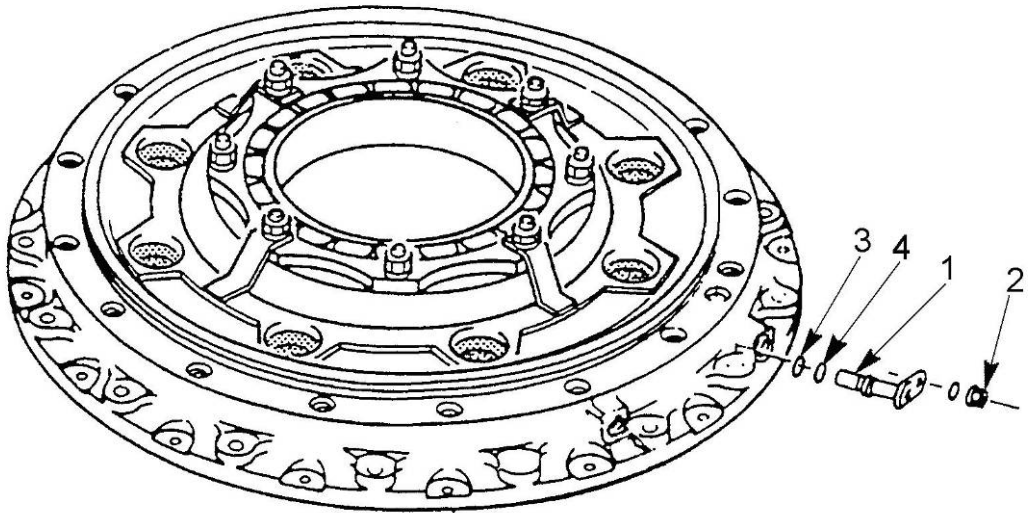
Figure 1

- Remove nut (2) and oil jet (1) from the LH side of the MGB (on the opposite side to the oil filter). Should the electrical harness impede access to oil jet (1), remove the clamp to move the electrical harness away.
- Insert borescope (9) into the port of oil jet (1) so as to position borescope (9) above the top face of the web of the planet gear carrier (5).
- Pivot the borescope through approximately 30° about its axis, in the counter-clockwise direction so as to position it the best you can, in order to inspect the web and the inside of each crankpin in turn.

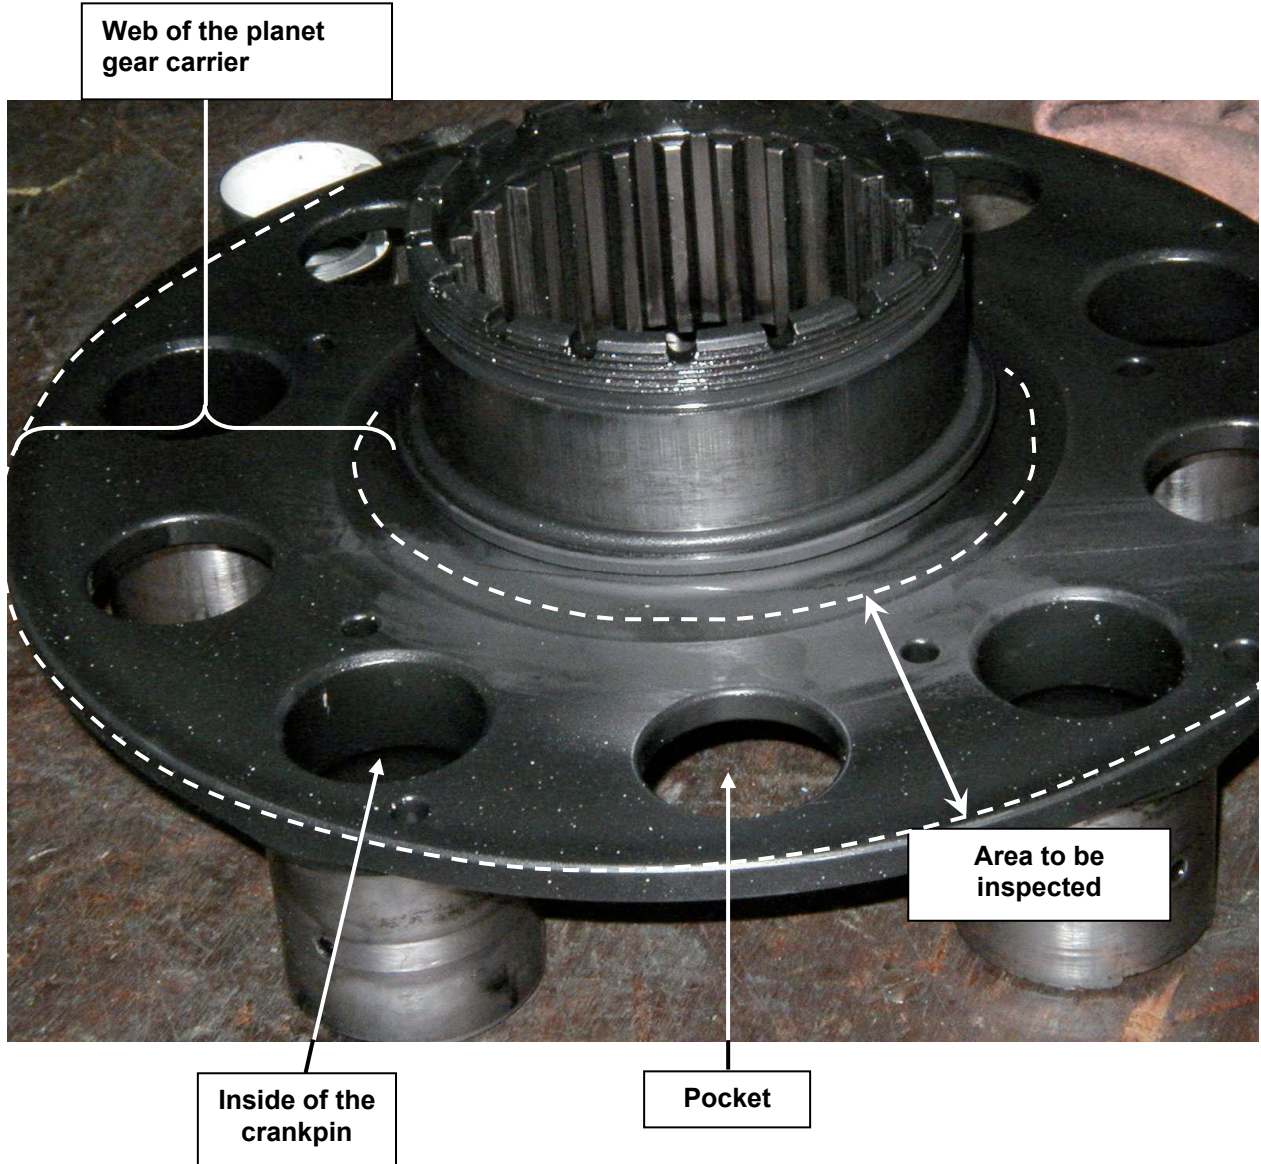
- Whilst rotating the planet gear carrier one full turn by acting on the tail rotor, make sure that there is no crack in the area, shown in Figure 3 by the strip located between the circles depicted in white dotted lines.

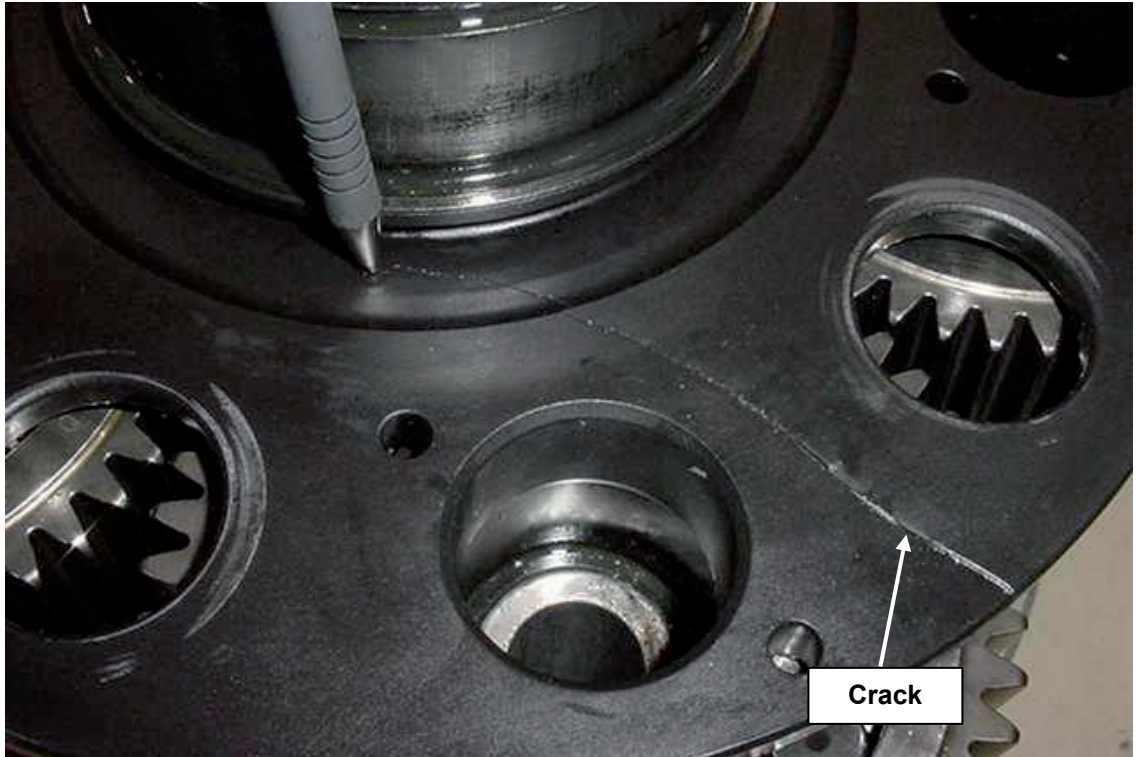
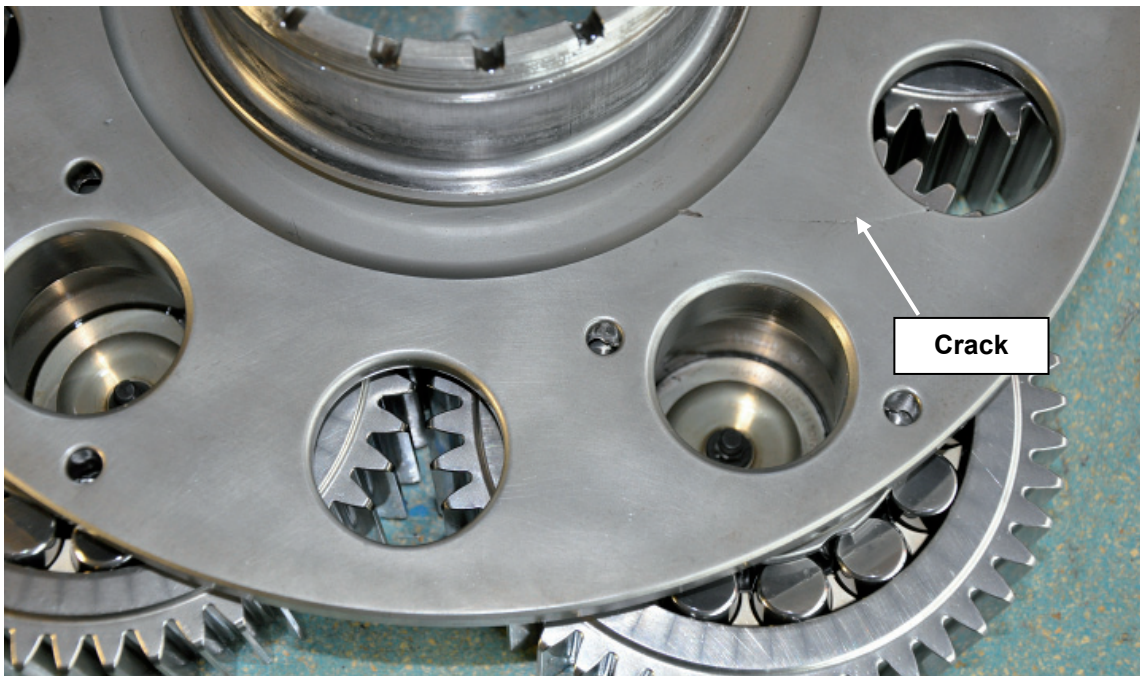
Figure 4

- the area to the right of each crankpin on the web of the planet gear carrier up to the pocket (cases of cracks of the No. 1 and the No. 2-type, Figures 4 and 5).
- the inside of each crankpin, on the RH side, when looking onto the top face of the planet gear carrier (case of a crack of the No. 3-type, Figure 6).

*The crack starts from the bottom face of the web of the planet gear carrier and then runs across the material section of the web. When the crack opens on the top face, i.e. the face which is visible during the borescope inspection, it measures at least 60 mm.*

2.B.2.a.2. If one or more cracks are found:

- Fit oil jet (1) and nut (2).
- Before the next flight, remove the MGB as per AMM Task 63-20-00-061.
- Contact the EUROCOPTER Customer Service Technical Support Operations Department (STVM) at:
  - . Tel: 33 (0)4.42.85.99.67
  - . Fax: 33 (0)4.42.85.99.66
  - . Email: [DynComp.Technical-Support@eurocopter.com](mailto:DynComp.Technical-Support@eurocopter.com)

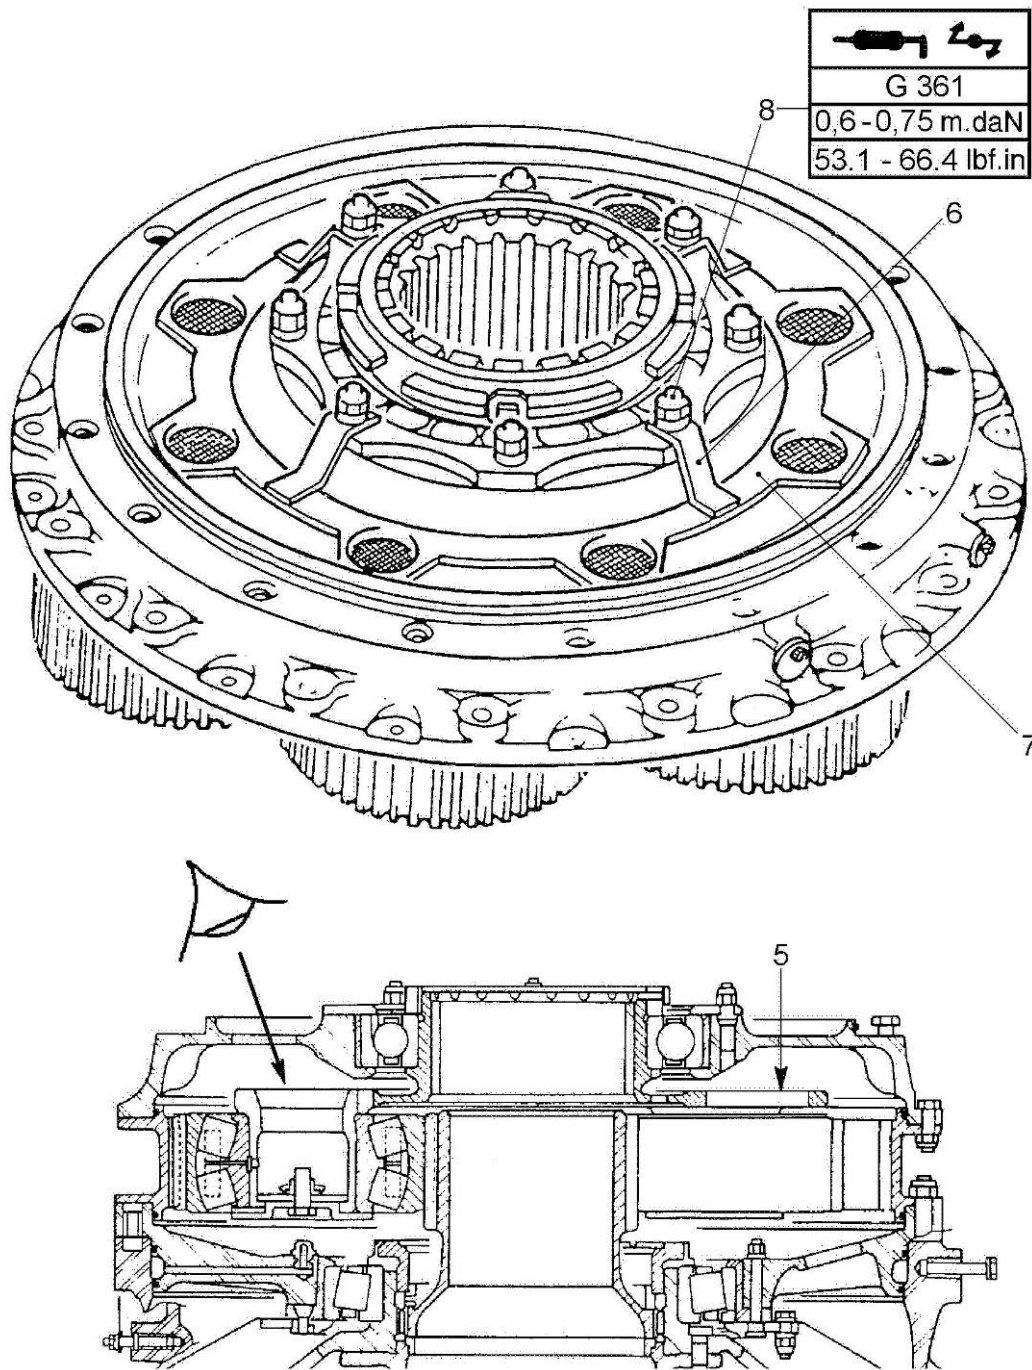
Figure 7

- Remove the rotor mast as per AMM Task 62-21-00-061.
- Remove the four nuts (8), the four spring tabs (6) and strainer (7).
- Using a light source, through the ports in the cover, inspect the area around each pocket of the crankpins of planet gear carrier (5) for absence of cracks whilst rotating the planet gear carrier using the tail rotor (release the rotor brake).

##### 2.B.3.a.2. If any crack(s) are found:

- Remove the MGB before the next flight as per AMM Task 63-20-00-062.
- Contact the EUROCOPTER Customer Service Technical Support Operations Department (STVM) at:
  - . Tel: 33 (0)4.42.85.99.67
  - . Fax: 33 (0)4.42.85.99.66
  - . Email: [DynComp.Technical-Support@eurocopter.com](mailto:DynComp.Technical-Support@eurocopter.com)
