CT7-2E1 ALERT SERVICE BULLETIN - 72- A0034 R01

Revised: 04  
/05/2024

**SB 72-A0034 R01 ENGINE - POWER TURBINE MODULE (72-50-00) - POWER TURBINE SHAFT /TORQUE REFERENCE TUBE MAGNETIC INSERT BRAZE INSPECTION**

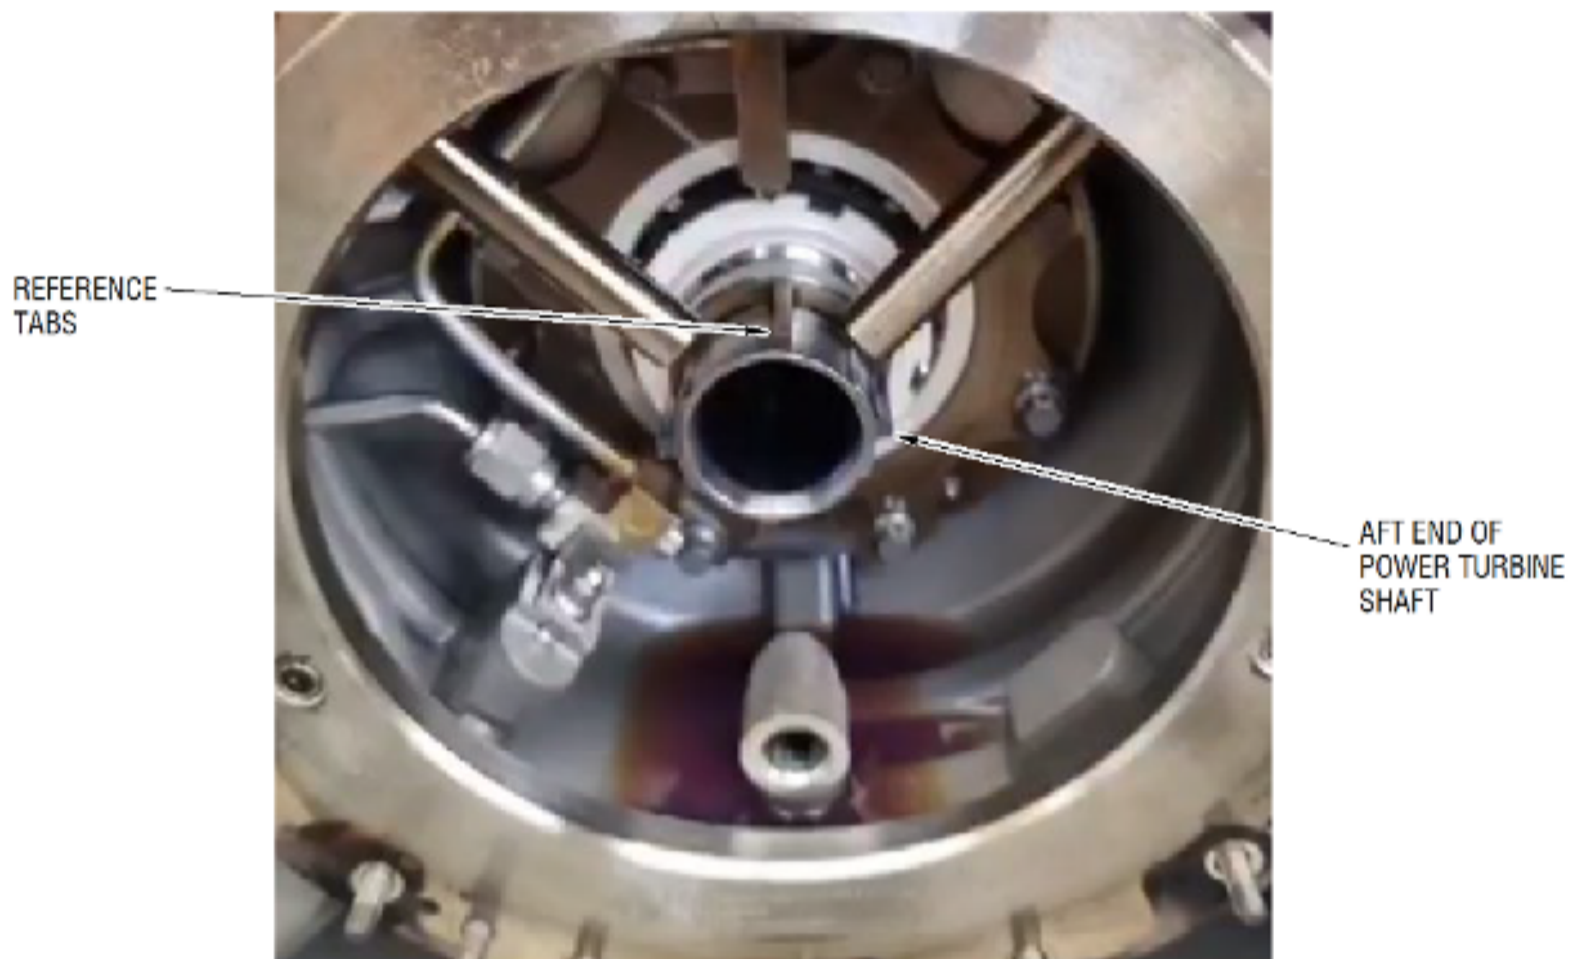
C-Sump and Aft End of Power Turbine Shaft  
Figure 2

Multiple PT drive shaft assemblies were shipped with inadequate braze coverage on the end of the PT shaft reference tube magnetic insert joint.

Inadequate braze coverage within the torque reference tube magnetic insert joint can become compromised leading to improper torque and speed indications.

NOTE: Review the engine log book for the installation time of the installed PT drive shaft assembly P/N [5125T92G01](#). If the current operational time on the part since installation is over 100 hours, compliance with this Alert Service Bulletin is satisfied. Go to paragraph 3.B.(3) and record compliance with this Alert Service Bulletin. If the PT drive shaft assembly is less than 100 hours, proceed with the remainder of this Alert Service Bulletin.NOTE: This procedure gives instructions to remove the C-sump heat shield (01-020, [Figure 1](#)) and C-sump cover (01-040) to inspect the magnetic insert braze joint on the PT drive shaft assembly (01-070, [Figure 2](#) and [Figure 3](#)).
