MANDATORY**MTL-53-03****TITLE**

FUSELAGE - CROSS TIE FASTENER INSPECTION AT FUSELAGE STATION 158.00

B300

SERIAL NUMBERSFL-1161 thru FL-1200, FL-1202 thru FL-1241,
FL-1243**REASON**

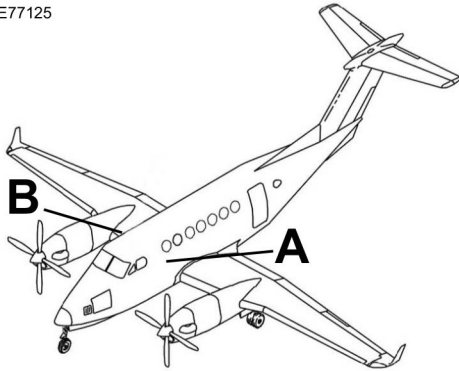
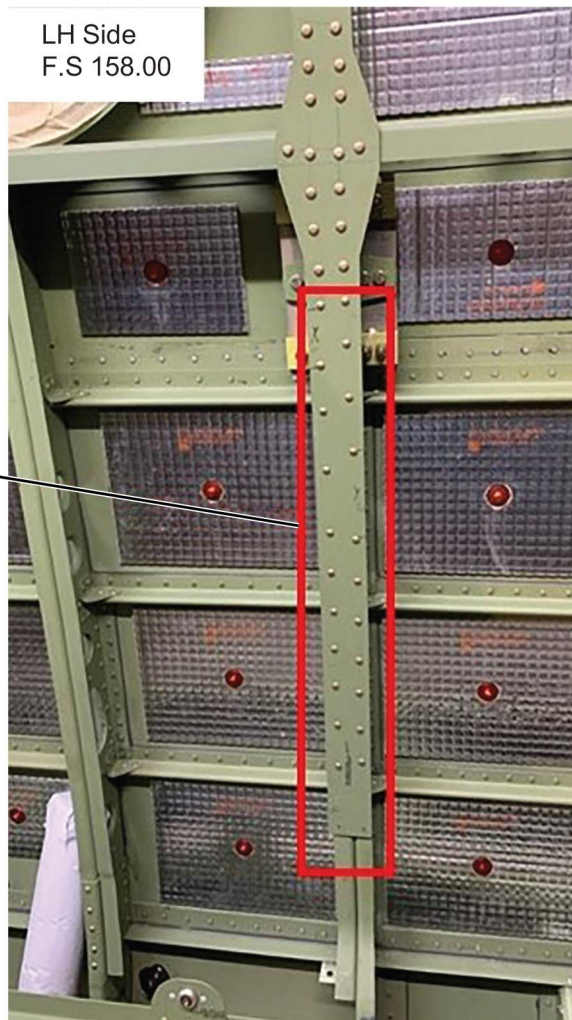
Figure 1. Cross Tie at Fuselage Station 158.00 (Sheet 1)

3. (Refer to Figure 1, Sheets 1, and 2.) Inspect FS 158.00 for correct rivet installation.
 - A. Compare the left and right side of the aircraft to the illustration and identify locations that are missing rivets.

Area to Inspect
132369AD4-5
Rivets
(16 Each row,
32 total)

View Looking Outboard at Left Side FS 158.00

NOTE: This example is showing 8 missing rivets, 4 for each row.

NOTE: Maximum spacing between two rivets is 8D from one rivet center to next rivet center (8-times rivet diameter, 1/8" diameter x 8 = 1").
Minimum spacing between two rivets is 4D from one rivet center to next rivet center (4-times rivet diameter, 1/8" diameter x 4 = 1/2").
Edge distance for rivets being installed is standard 2D from edge to center of rivet hole (2-times rivet diameter, 1/8" diameter x 2 = 1/4").
 - B. Drill a Number 30 (0.1285 inch diameter) hole at the identified locations.
 - C. Debur all drilled holes.
 - D. Make sure all rivet shavings are removed.
 - E. Apply Color Chemical Film Treatment to all bare metal.

- F. Install a 132369AD4-5 Rivet into all drilled holes. (Refer to the Beechcraft Structural Inspection and Repair Manual, Chapter 20, Fastener Installation and Removal.)
5. Install and complete an operational check of all passenger compartment upholstery and equipment that was disconnected or removed to gain access to FS 158.00.
6. Remove the maintenance warning tags and connect the airplane battery.
7. Make an entry in the airplane logbook that states compliance and method of compliance with this service document.

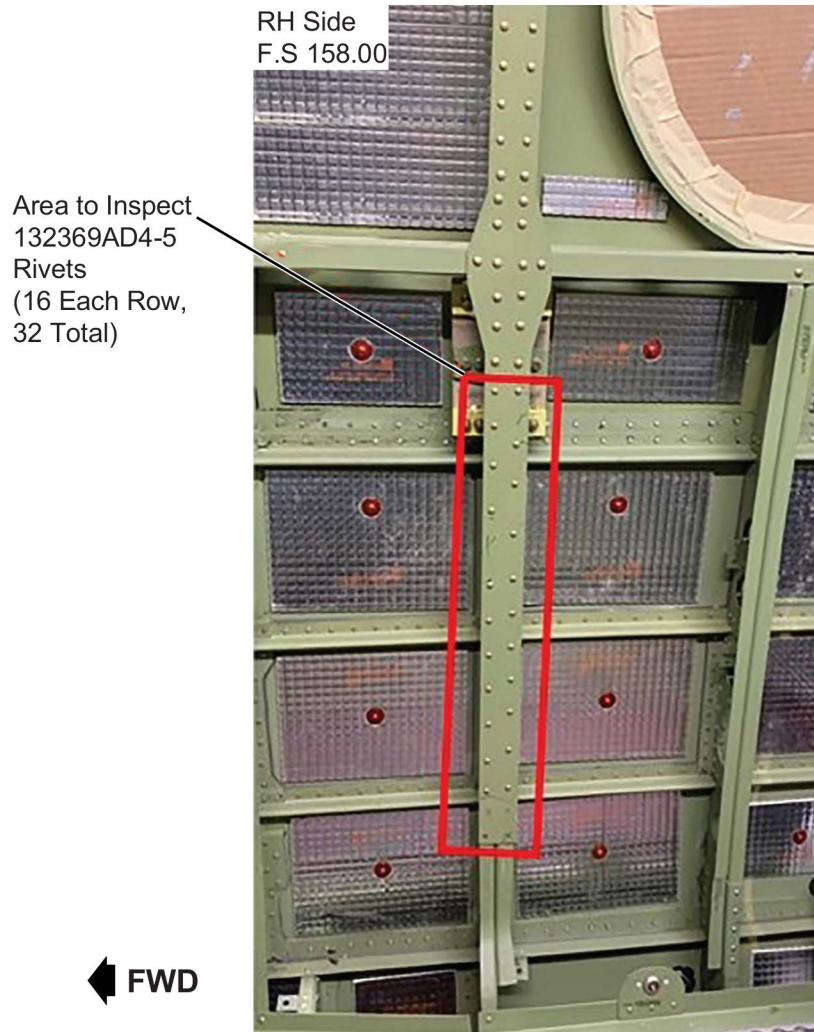
Figure 1. Cross Tie at Fuselage Station 158.00 (Sheet 2)

View Looking Outboard at Right Side FS 158.00

NOTE: This example is showing 8 missing rivets, 4 for each row.
