MANDATORY**MTL-53-04****TITLE**

FUSELAGE - FORWARD FUSELAGE FASTENER INSPECTION

MTL-53-04
Page 1 of 11

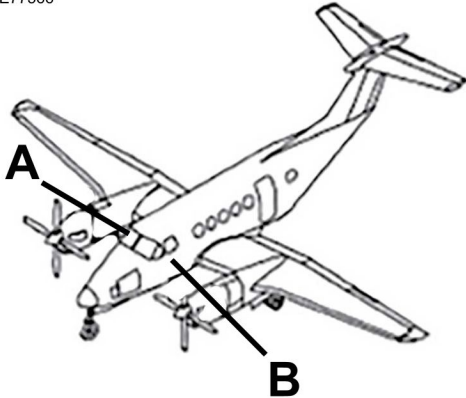
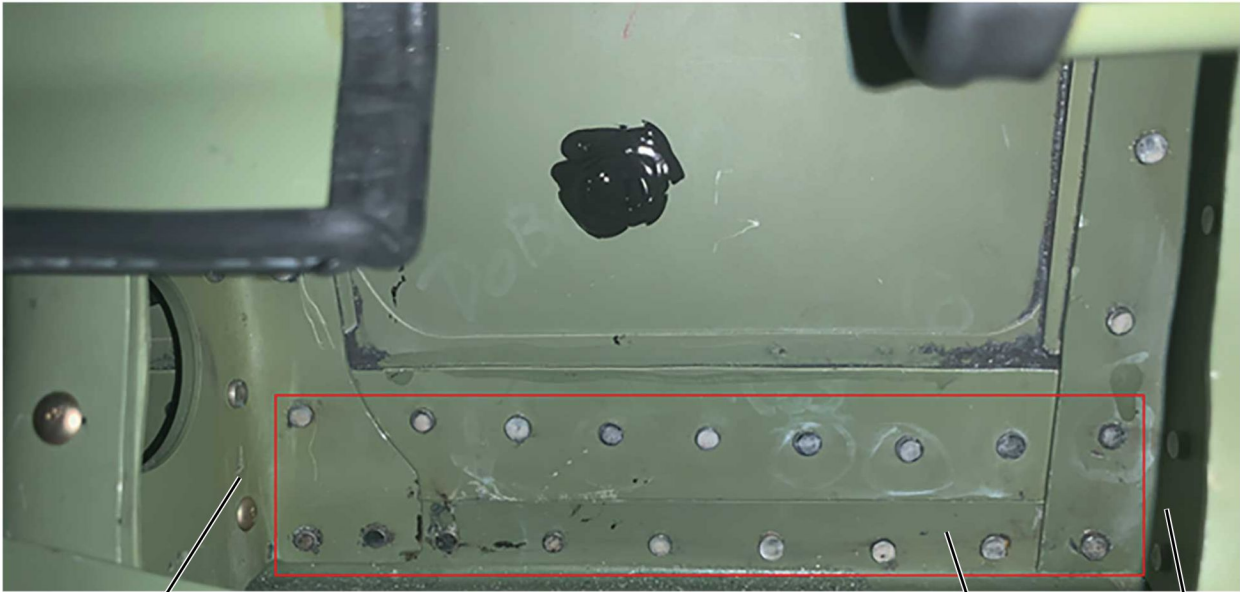
Figure 1. Rivet Inspection Area (Sheet 1)

During inspection it was found that there might be an insufficient amount of rivets between Fuselage Station (FS) 100.50 to FS 107.00 on the left and right sides of the fuselage.

NOTE: The rivets inside the red box show the area where the rivets need to be counted on the left and right sides of the fuselage.

2. (Refer to Figure 1, Sheet 1.) Count the number of rivets installed between FS 100.50 and FS 107.00 on the left and right sides as follows:
 - NOTE:** FS 100.50 to FS 107.00 and Stringer 11 is located at the forward fuselage below the windscreen approximately halfway down the fuselage. The seam lines for the fuselage skin panels can be used for locating the location of FS 107.00 while FS 100.50 will be the next forward vertical row of rivets. (Refer to the applicable Model Maintenance Manual, Chapter 6, Dimensions and Areas, Airplane Stations - Description and Operations.)

- (1) If there are 16 rivets or more on the left side and 16 rivets or more on the right side, go to Step 17.
 - (2) If there are 15 rivets or less on the left side or 15 rivets or less on the right side, go to Step 3.

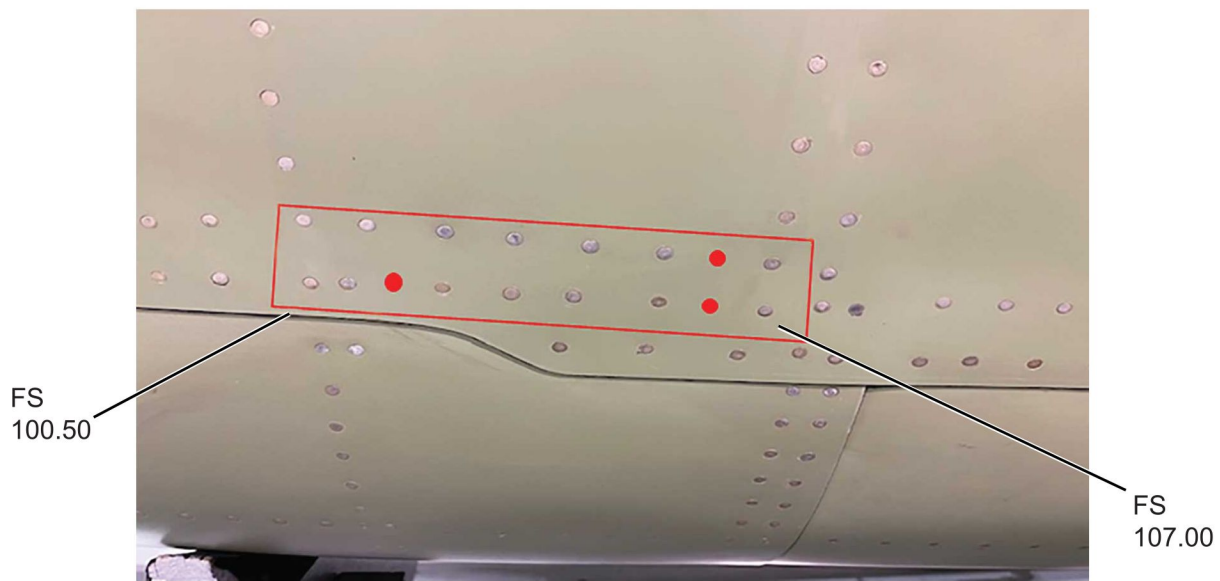
Figure 1. Rivet Inspection Area (Sheet 2)

NOTE: The rivets and red circle marks inside the red box show a possible configuration that would have a total amount of 16 or more rivets and marks.

5. (Refer to Figure 1, Sheet 2.) Install the CM3827AD4-4 Rivets into the marked areas on the left side of all B200 and B300 models as follows:

- A. From the inboard side of the lap joint, drill a Number 30 (0.1285 inch diameter) hole as required for each of the marked locations on the left side.
- B. Debur all drilled holes.
- C. From the outboard side, counter sink all drilled holes to 100 degrees x 0.222 to 0.228 inch diameter.
- D. Apply Color Chemical Film Treatment to all bare metal.
- E. Install a CM3827AD4-4 Rivet, as required, wet with U470637 Sealant into all drilled holes. (Refer to the Beechcraft Structural Inspection and Repair Manual, Chapter 20, Fastener Installation and Removal.)
- F. If the rivet installation is needed on the right side, go to the steps that follow:
 - (1) If the rivets needs to be installed on the right side, go to Step 8.
 - (2) If only the left side needed rivets to be installed, go to Step 13.

11. (Refer to Figure 1, Sheet 2.) Install the CM3827AD4-4 Rivets into the marked areas on the right side of all B200 and B300 models without a FOD shield as follows:

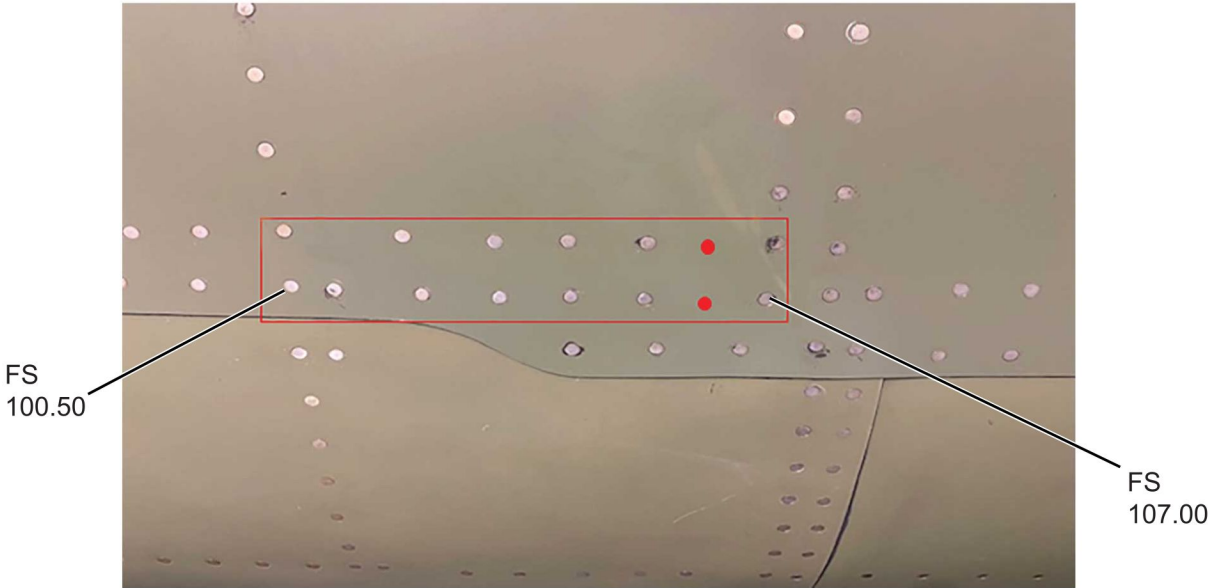
Figure 1. Rivet Inspection Area (Sheet 3)

NOTE: The rivets and red circle marks inside the red box show a possible configuration that would have a total amount of 15 or less rivets and marks.

6. (Refer to Figure 1, Sheet 3.) Remove the previously installed rivets on the left side on all B200 and B300 airplanes as follows:

- A. Remove all the rivets, on the left side, that were installed between FS 100.50 and FS 107.00. (Refer to the Beechcraft Structural Inspection and Repair Manual, Chapter 20, Fastener Installation and Removal.)

- B. From the inboard side of the lap joint, drill a Number 30 (0.1285 inch diameter) hole as required for each of the marked locations.
 - C. Debur all drilled holes.

- D. From the outboard side, counter sink all drilled holes to 100 degrees x 0.222 to 0.228 inch diameter.
 - E. Apply Color Chemical Film Treatment to all bare metal.

- F. Install a MS20427F4-4 Rivet, as required, wet with U470637 Sealant into all drilled holes. (Refer to the Beechcraft Structural Inspection and Repair Manual, Chapter 20, Fastener Installation and Removal.)

12. (Refer to Figure 1, Sheet 3.) Remove the previously installed rivets on the right side on all B200 and B300 airplanes without a FOD shield as follows:
