July 07, 2021

HARTZELL PROPELLER INC.
SERVICE BULLETIN
HC-SB-61-392

108298 Cylinder Bushing and 108346 Hub Bushing

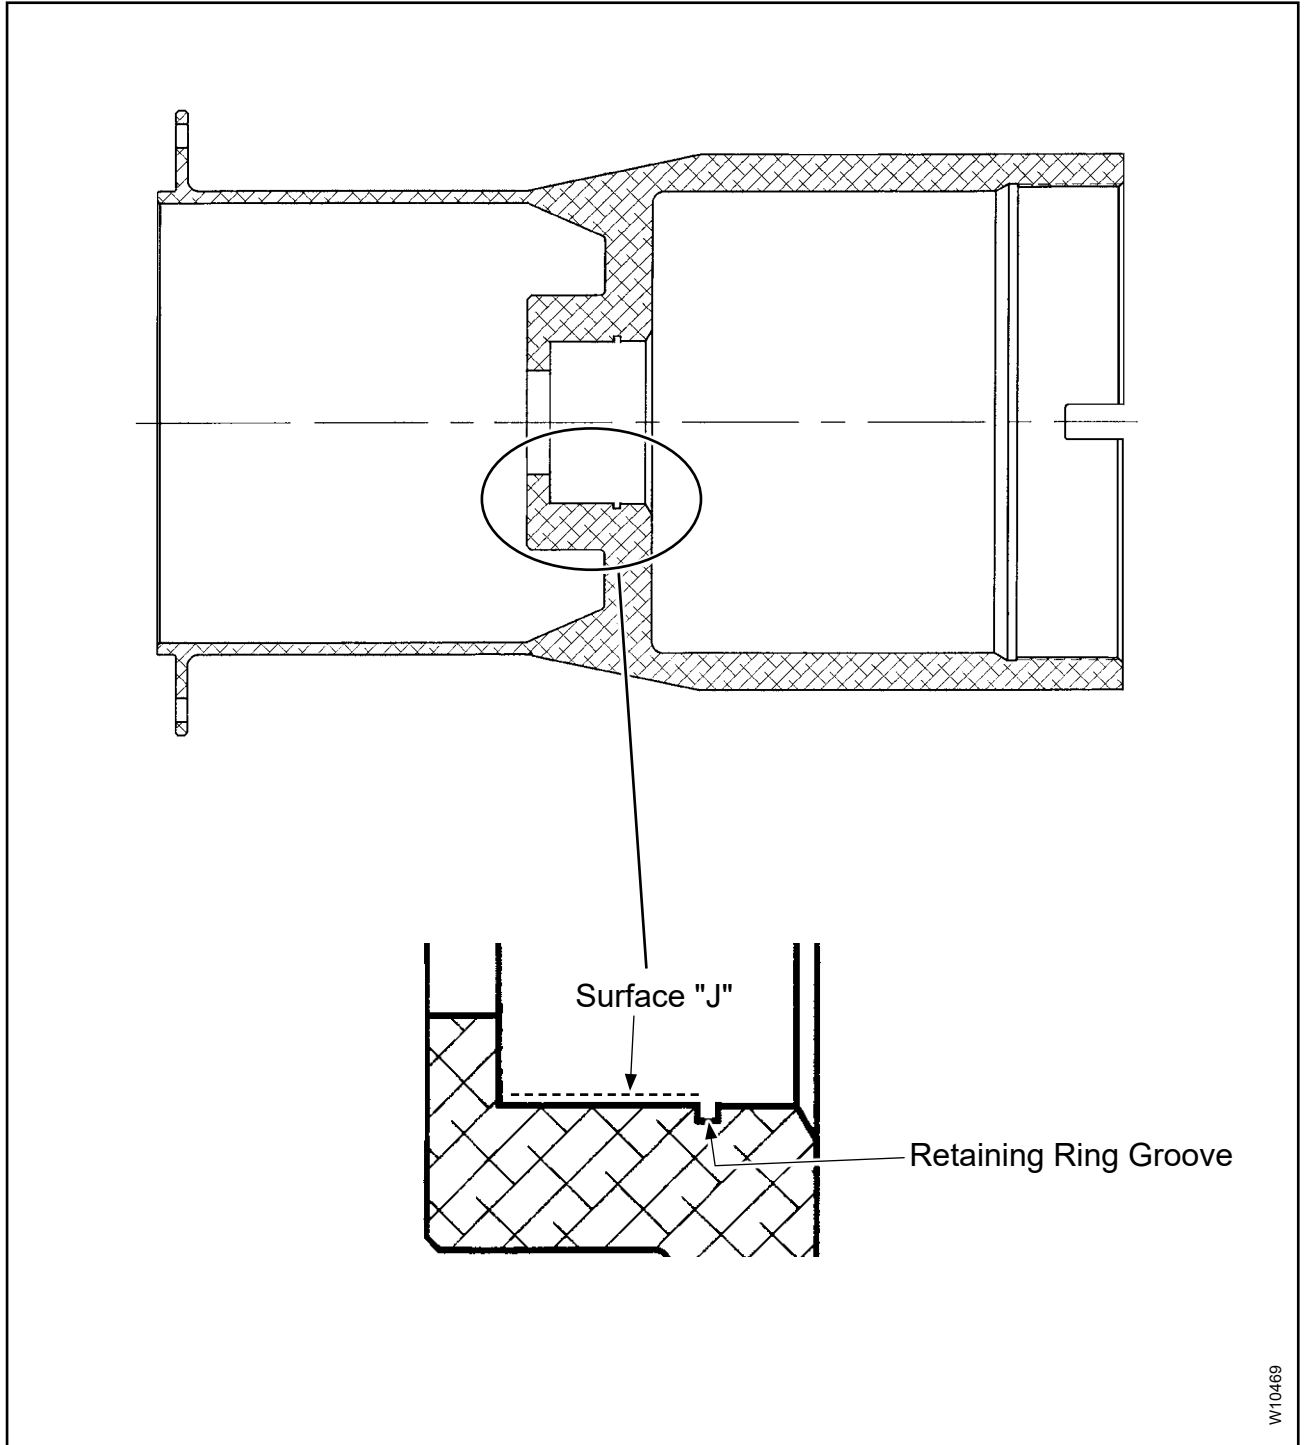
Cylinder Inspection: Surface "J"
Figure 3

- (1) Inspect the cylinder in the affected propeller in accordance with the Check chapter of the applicable Hartzell Propeller Inc. overhaul manual, **except:**
 - (a) Inspect Surface "J" of the cylinder in accordance with Table 1 and Figure 3 in this Service Bulletin.

Inspect	Serviceable Limits	Corrective Action
<u>CYLINDER (Surface "J")</u> (Refer to Figure 3)		
(1) Using a Profilometer TE436-2 or equivalent, examine the finish on Surface "J".	The maximum permitted surface finish is 32Ra.	If the surface finish is greater than the permitted serviceable limits, polish Surface "J" using 3M microfinishing film (373L), or equivalent. The maximum permitted diameter of Surface "J" after repair is 1.7560 inch (44.602 mm).

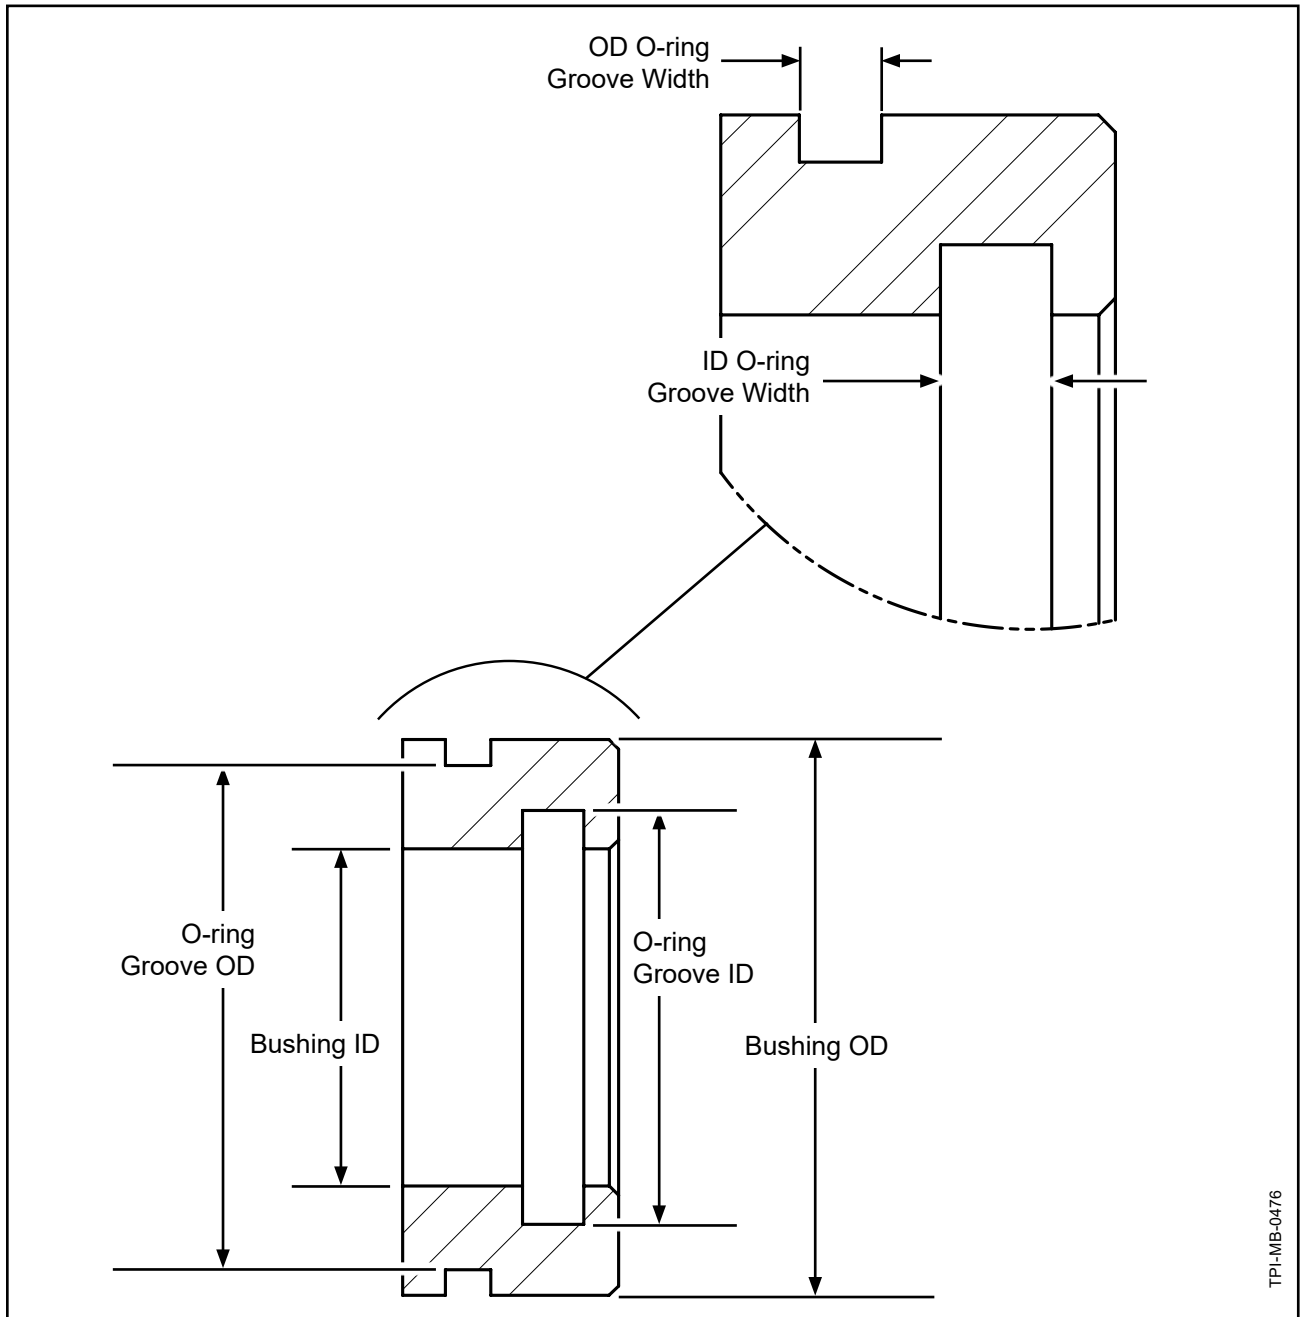
**108298 Cylinder Bushing Inspection
Figure 4**

- (1) Inspect the 108298 cylinder bushing in accordance with Table 2 and Figure 4 in this Service Bulletin.

Inspect	Serviceable Limits	Corrective Action
<u>108298 CYLINDER BUSHING</u>		
(Refer to Figure 4)		
(1) Visually examine both sides of the cylinder bushing for wear, damage, and distortion.	Wear, damage, or distortion is not permitted.	If there is wear, damage, or distortion, replace the cylinder bushing.

(2) Measure the cylinder bushing OD.	The minimum permitted bushing OD is 1.750 inches (44.45 mm).	If the bushing OD is less than the permitted serviceable limit, replace the cylinder bushing.

(3) Measure the cylinder bushing ID and examine the surface finish.	The maximum permitted ID is 1.064 inches (27.02 mm). A smooth surface is required.	If the bushing ID is greater than the permitted serviceable limit, or if the surface finish is not smooth, replace the cylinder bushing.

(4) Measure the cylinder bushing O-ring groove ID and examine the surface finish.	The maximum permitted O-ring groove ID is 1.306 inches (33.17 mm). A smooth surface is required.	If the O-ring groove ID is greater than the permitted serviceable limit, or if the surface finish is not smooth, replace the cylinder bushing.

(5) Measure the cylinder bushing O-ring groove OD and examine the surface finish.	The minimum permitted O-ring groove OD is 1.586 inches (40.29 mm). A smooth surface is required.	If the O-ring groove OD is less than the permitted serviceable limit, or if the surface finish is not smooth, replace the cylinder bushing.

(6) Measure the width of the ID O-ring groove and examine the groove for wear, damage, and distortion.	The maximum permitted width of the ID O-ring groove is 0.170 inch (4.31 mm). Wear, damage, or distortion is not permitted.	If the width of the ID O-ring groove is greater than the permitted serviceable limit, or if there is wear, damage, or distortion, replace the the cylinder bushing.

(7) Measure the width of the OD O-ring groove and examine the groove for wear, damage, and distortion.	The maximum permitted width of the OD O-ring groove is 0.146 inch (3.70 mm). Wear, damage, or distortion is not permitted.	If the width of the OD O-ring groove is greater than the permitted serviceable limit, or if there is wear, damage, or distortion, replace the the cylinder bushing.

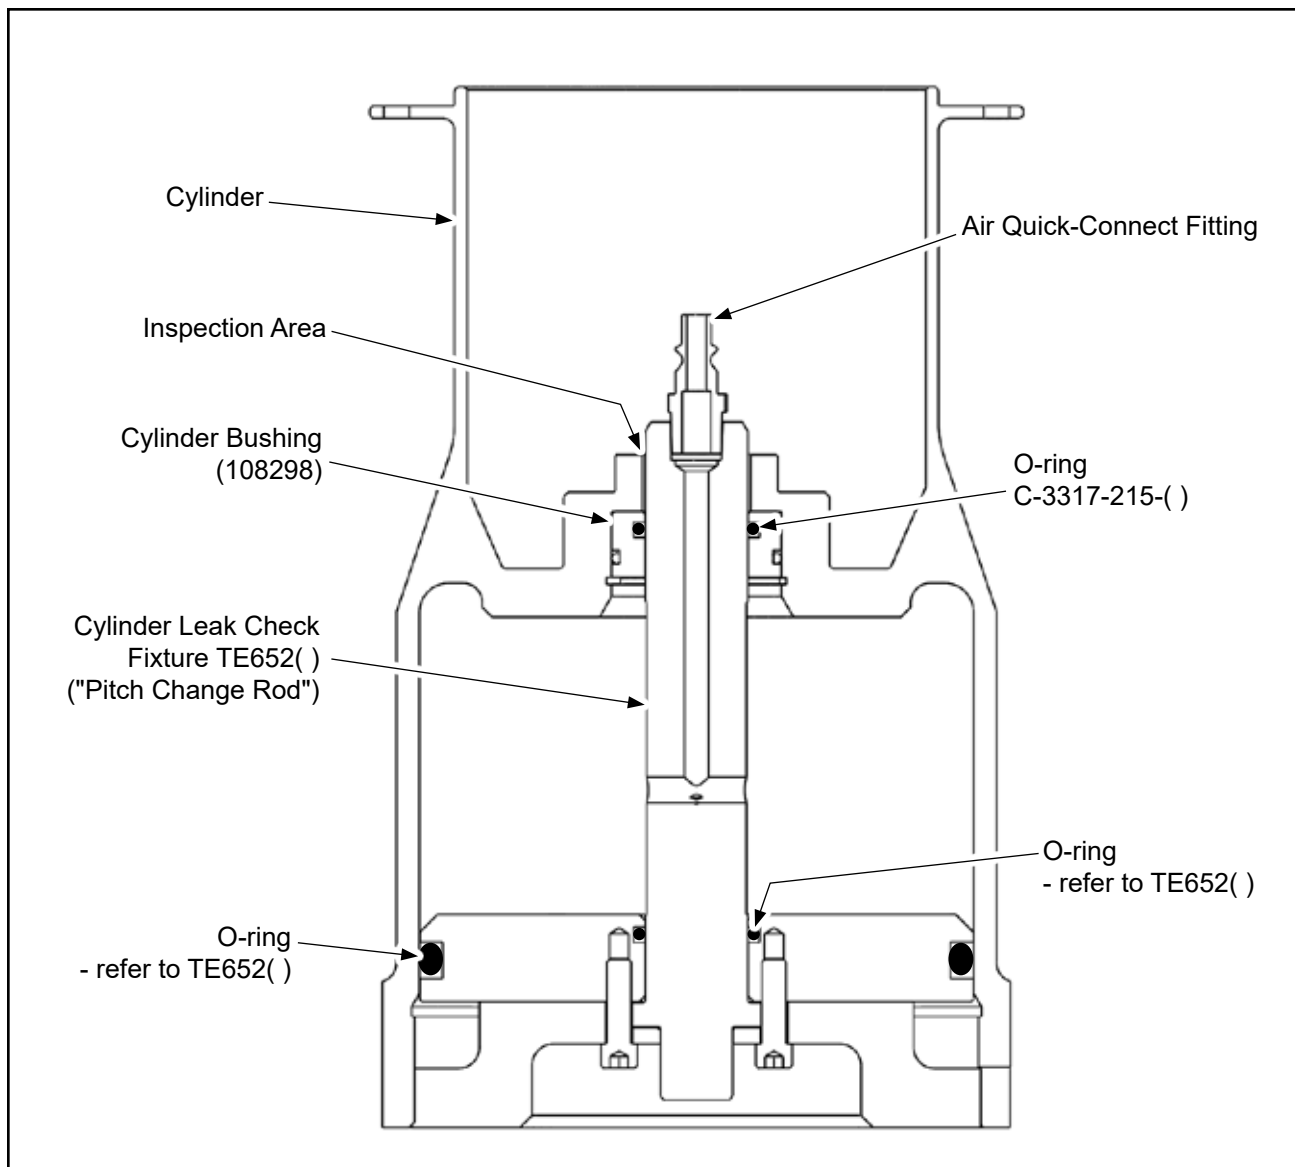
Cylinder Leak Check Procedure
Figure 6

- (6) Check for leaks in the inspection area identified in Figure 6.
- (a) Apply leak detector CM122 to the inside of the cylinder where the "pitch change rod" of the cylinder leak check fixture TE652() contacts the cylinder.

- 1 Observe for approximately 10 seconds.
 - 2 A leak is indicated by continuous bubbling at the inspection area.
 - 3 A leak is not permitted.
- (b) If a leak is detected:

- 1 Inspect the O-rings for damage and unwanted material.
 - a Remove unwanted material.
 - b Replace the O-ring(s).
 - 2 Repeat the leak inspection procedure.

- a If the leak cannot be stopped, replace the 108298 cylinder bushing, then repeat the leak inspection procedure.
- (7) After the test is complete, remove the cylinder from the cylinder leak check fixture TE652().

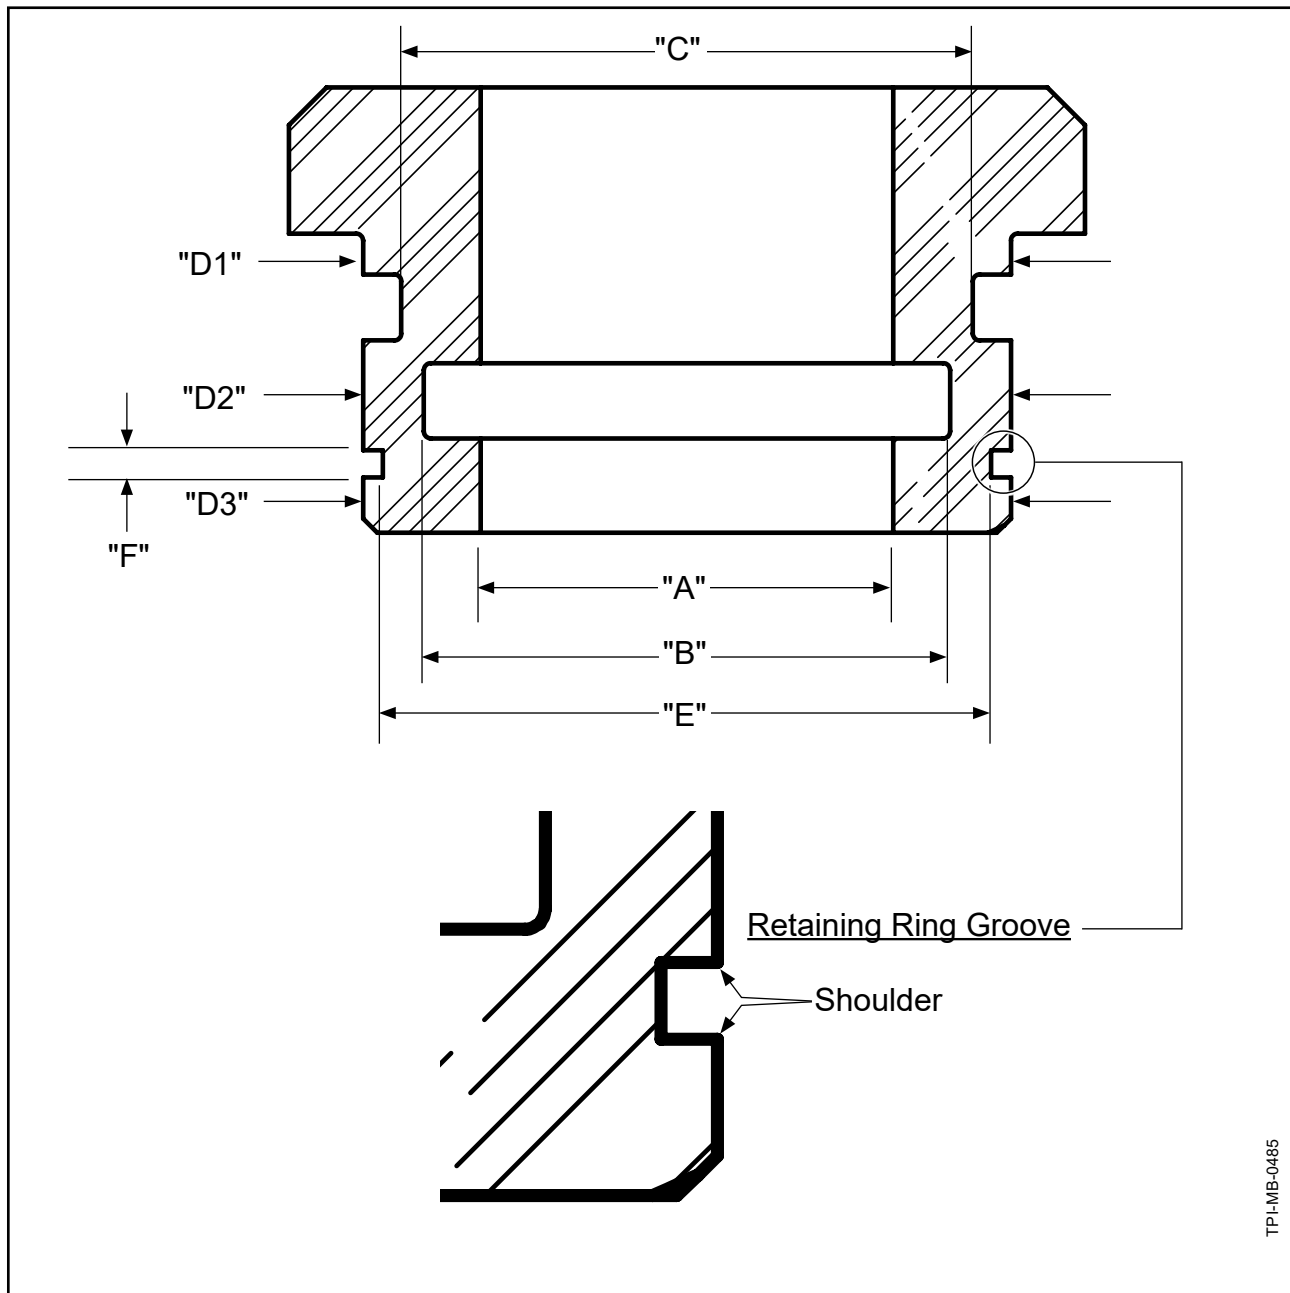
Inspection: 108346 Hub Bushing
Figure 7

- (1) Inspect the 108346 hub bushing in accordance with Table 3 and Figure 7 in this Service Bulletin.

Inspect	Serviceable Limits	Corrective Action
<u>108346 Hub Bushing</u> (Refer to Figure 7)		
(1) Measure the ID of the hub bushing ("A").	The maximum permitted ID is 0.878 inch (22.30 mm). A smooth surface finish is required.	If the ID is greater than the permitted serviceable limits or the surface finish is not smooth, replace the hub bushing.

(2) Measure the ID of the hub bushing O-ring groove ("B").	The maximum permitted ID is 1.121 inches (28.47 mm). A smooth surface finish is required.	If the ID is greater than the permitted serviceable limits or the surface finish is not smooth, replace the hub bushing.

(3) Measure the OD of the hub bushing O-ring groove ("C").	The minimum permitted OD is 1.211 inches (30.76 mm).	If the OD is less than the permitted serviceable limits, replace the hub bushing.

(4) Measure the OD of the hub bushing at two locations ("D1") and ("D2").	The minimum permitted OD at each location is 1.373 inches (34.88 mm).	If the OD is less than the permitted serviceable limits, replace the hub bushing.

(5) Measure the OD of the hub bushing at location ("D3").	The minimum permitted OD is 1.368 inches (34.75 mm).	If the OD is less than the permitted serviceable limits, replace the hub bushing.

(6) Measure the OD of the retaining ring groove ("E").	The minimum permitted OD is 1.284 inches (32.62 mm).	If the OD is less than the permitted serviceable limits, replace the hub bushing.

(7) Visually examine each shoulder of the retaining ring groove for damage.	The maximum permitted total accumulated damage for each shoulder is 25% of the circumference.	If the damage for either shoulder is greater than the permitted serviceable limits, replace the hub bushing.

(8) Measure the width of the retaining ring groove ("F").	The maximum permitted width is 0.062 inch (1.57 mm).	If the width is greater than the permitted serviceable limits, replace the hub bushing.

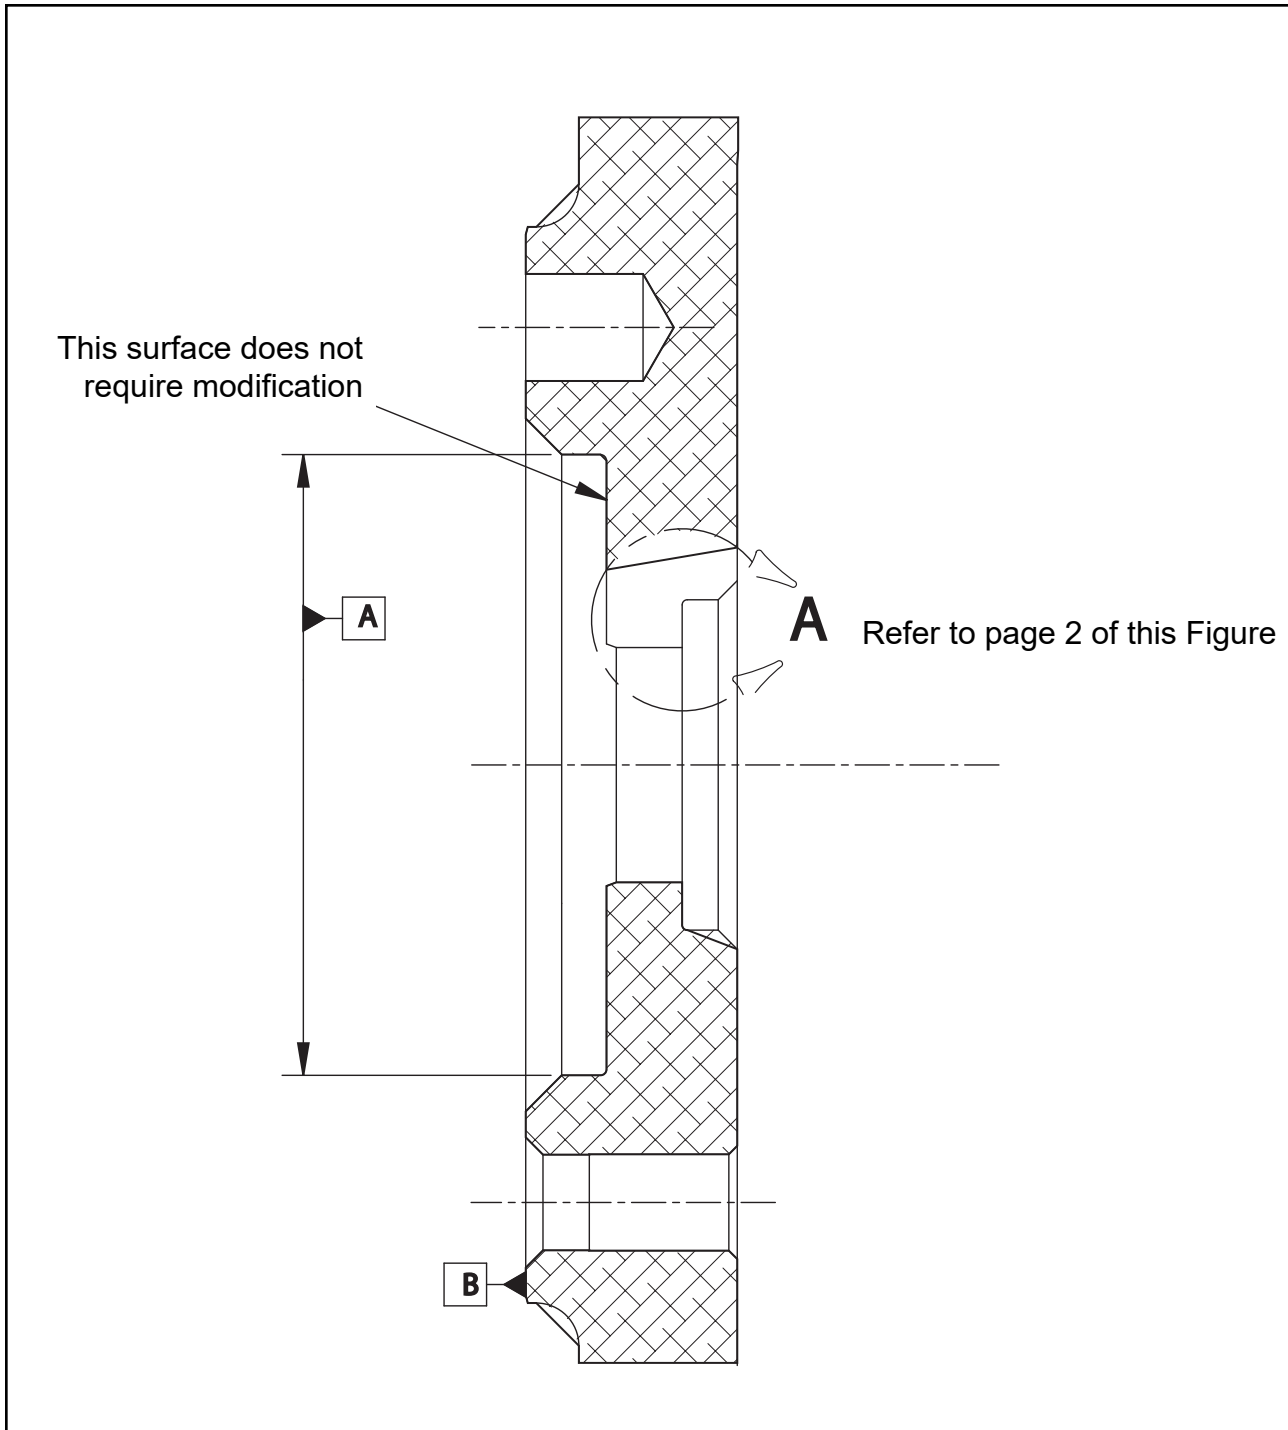
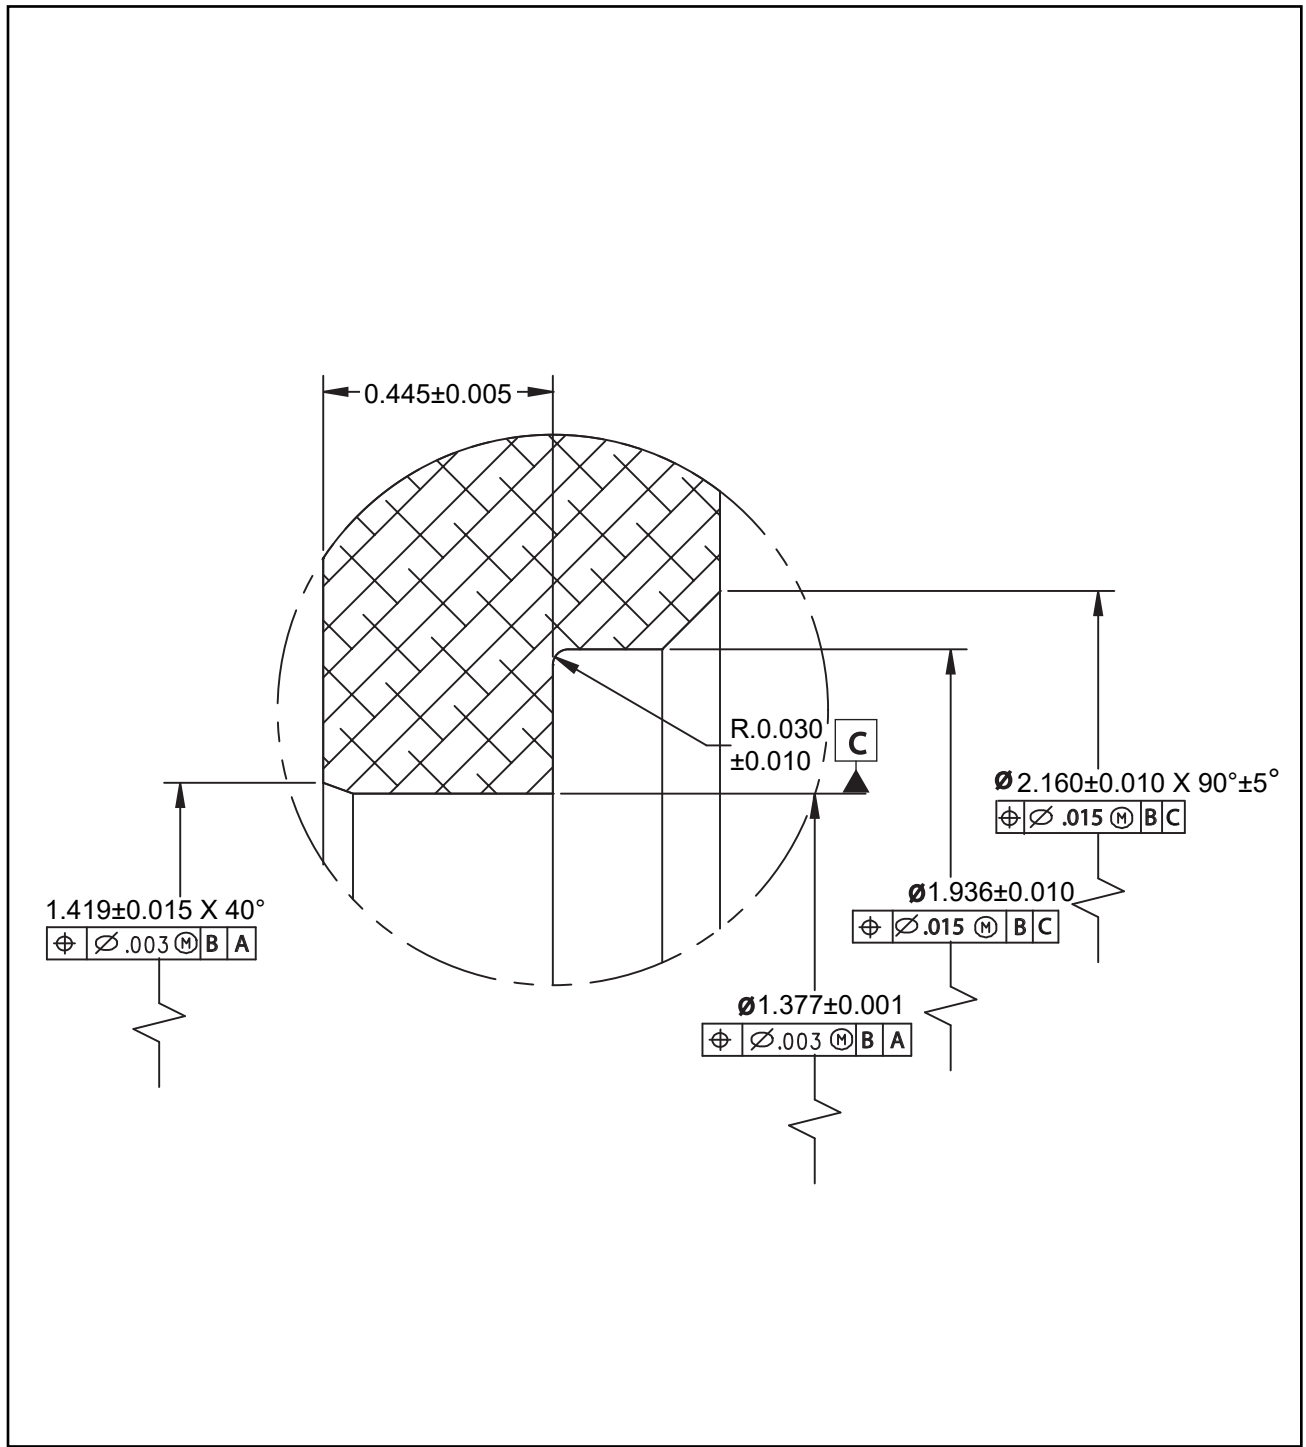
Hub Modification
Figure 9, page 1 of 2

NOTE: This procedure is required for D-7432 hub assemblies that have an A-3789() hub bushing bonded into the hub.

- (1) Remove the bonded A-3789() hub bushing in accordance with the applicable instructions in the Aluminum Hub Overhaul chapter of Hartzell Propeller Inc. Standard Practices Manual 202A (61-01-02).
- (2) Machine the propeller hub in accordance with Figure 9.
 - (a) Remove any burrs.
 - (b) Machined surfaces must have a surface finish of at least 63 micro inches (1.6 micro meters).
 - (c) Apply chemical conversion coating to the machined area in accordance with the Chromic Acid Anodizing chapter of Hartzell Propeller Inc. Standard Practices Manual 202A (61-01-02).
