HARTZELL PROPELLER INC.
SERVICE BULLETIN
TRANSMITTAL SHEET
HC-SB-61-392

108298 Cylinder Bushing and 108346 Hub Bushing

February 23, 2022

HARTZELL PROPELLER INC.
SERVICE BULLETIN
HC-SB-61-392

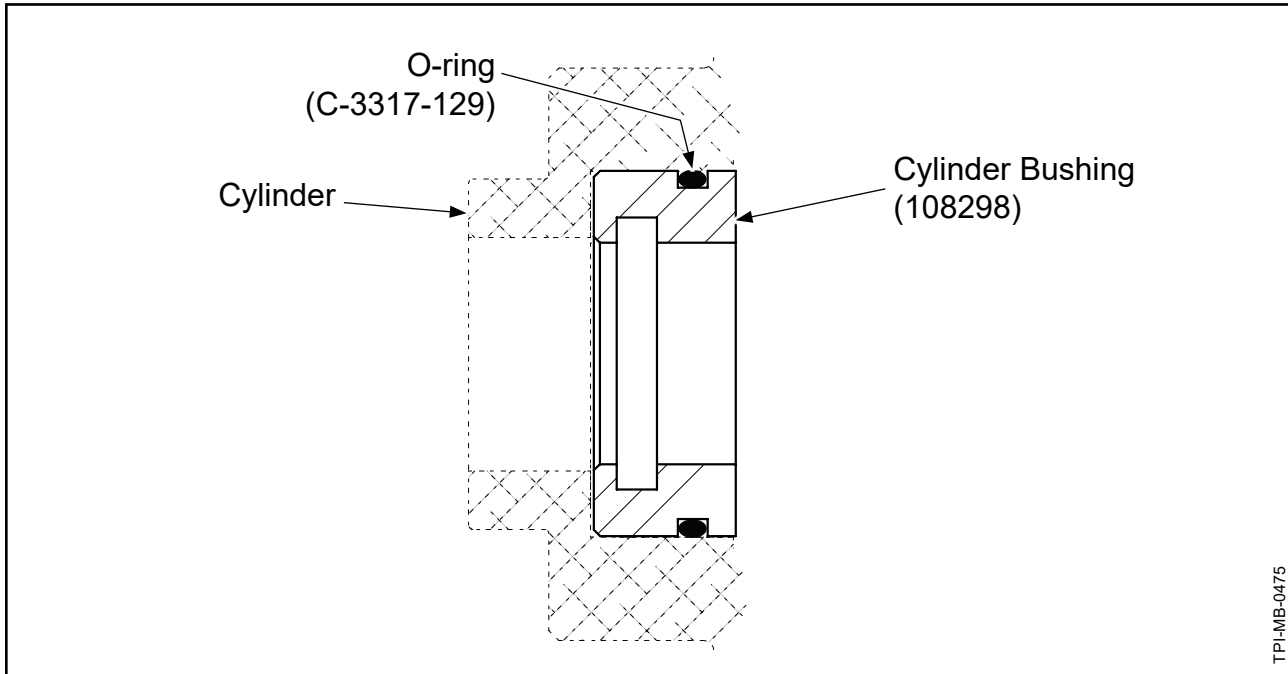
**108298 Cylinder Bushing
Figure 1**

- (1) Hartzell Propeller Inc. has received reports of oil leaking at the A-3784 cylinder bushing on affected propellers.
 - (a) Hartzell is introducing the 108298 cylinder bushing as a replacement for the A-3784 cylinder bushing on affected propellers.
 - 1 The 108298 cylinder bushing has a machined O-ring groove on the OD of the bushing. This provides a more consistent seal between the bushing and the cylinder to prevent oil leaks. Refer to Figure 1.

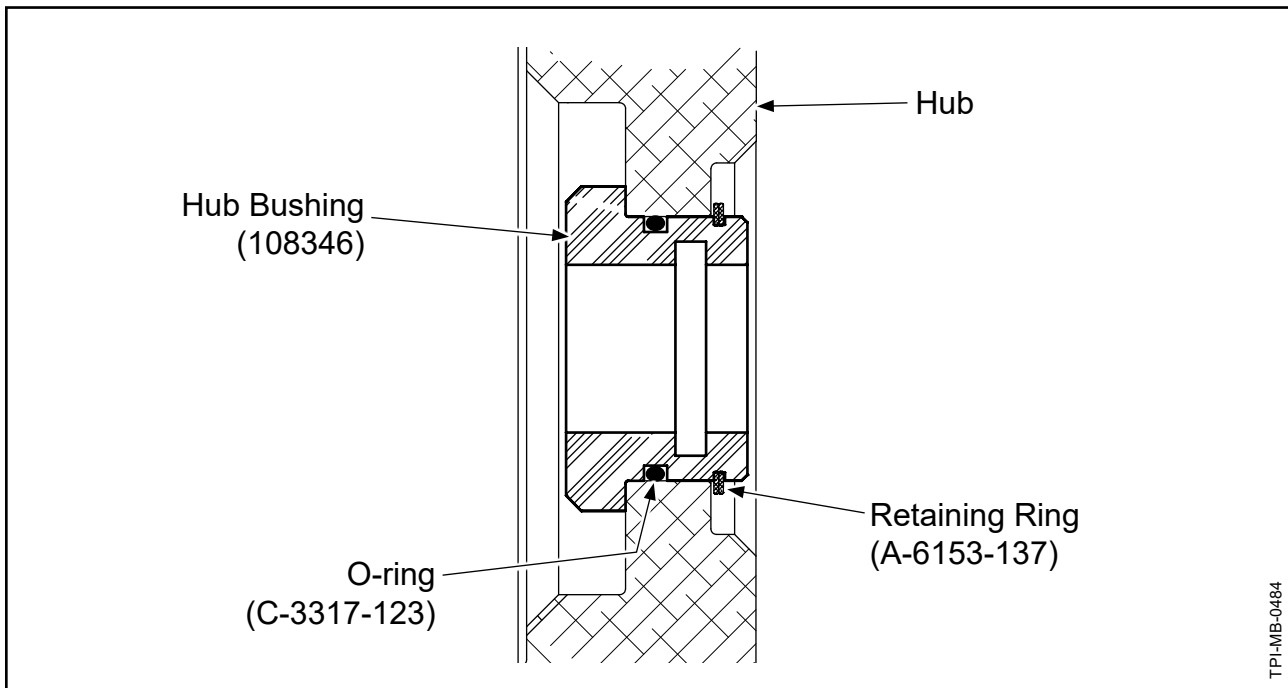
**108346 Hub Bushing
Figure 2**

- (2) Hartzell Propeller Inc. has received reports of oil leaking at the hub bushing [p/n 104903 or A-3789()] on affected propellers.
 - (a) Hartzell is introducing the 108346 hub bushing as a replacement for the 104903 and A-3789() hub bushings on affected propellers.
 - 1 The 108346 hub bushing has a larger O-ring groove on the OD of the bushing.
 - 2 The larger O-ring (p/n C-3317-123) used with the 108346 hub bushing provides a more consistent seal between the bushing and the hub to prevent oil leaks. Refer to Figure 2.
- (3) Affected Hartzell propeller overhaul kits that were shipped prior to the release date of Revision 2 of this Service Bulletin, contain the C-3317-026-2 O-ring - not the C-3317-123 O-ring required by this Service Bulletin.

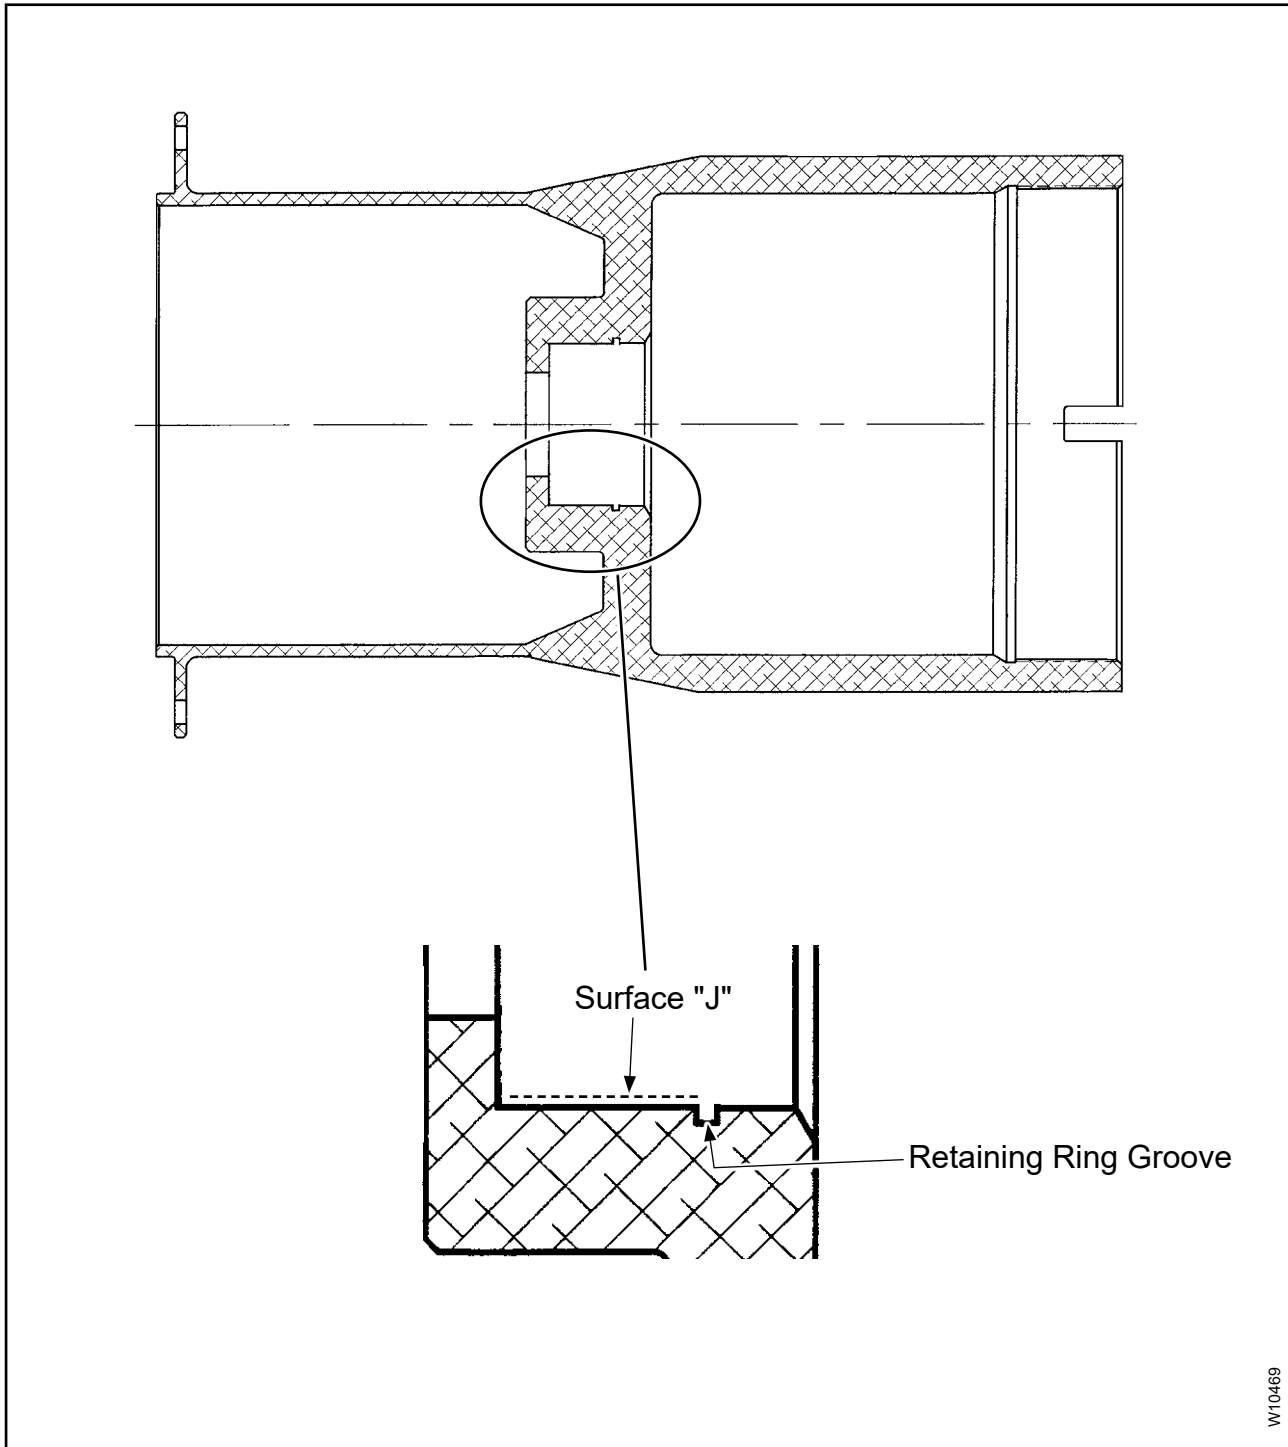
Cylinder Inspection: Surface "J"
Figure 3

- (1) Inspect the cylinder in the affected propeller in accordance with the Check chapter of the applicable Hartzell Propeller Inc. overhaul manual, **except:**
 - (a) Inspect Surface "J" of the cylinder in accordance with Table 1 and Figure 3 in this Service Bulletin.

Inspect	Serviceable Limits	Corrective Action
<u>CYLINDER (Surface "J")</u> (Refer to Figure 3)		
(1) Using a Profilometer TE436-2 or equivalent, examine the finish on Surface "J".	The maximum permitted surface finish is 32Ra.	If the surface finish is greater than the permitted serviceable limits, polish Surface "J" using 3M microfinishing film (373L), or equivalent. The maximum permitted diameter of Surface "J" after repair is 1.7560 inch (44.602 mm).

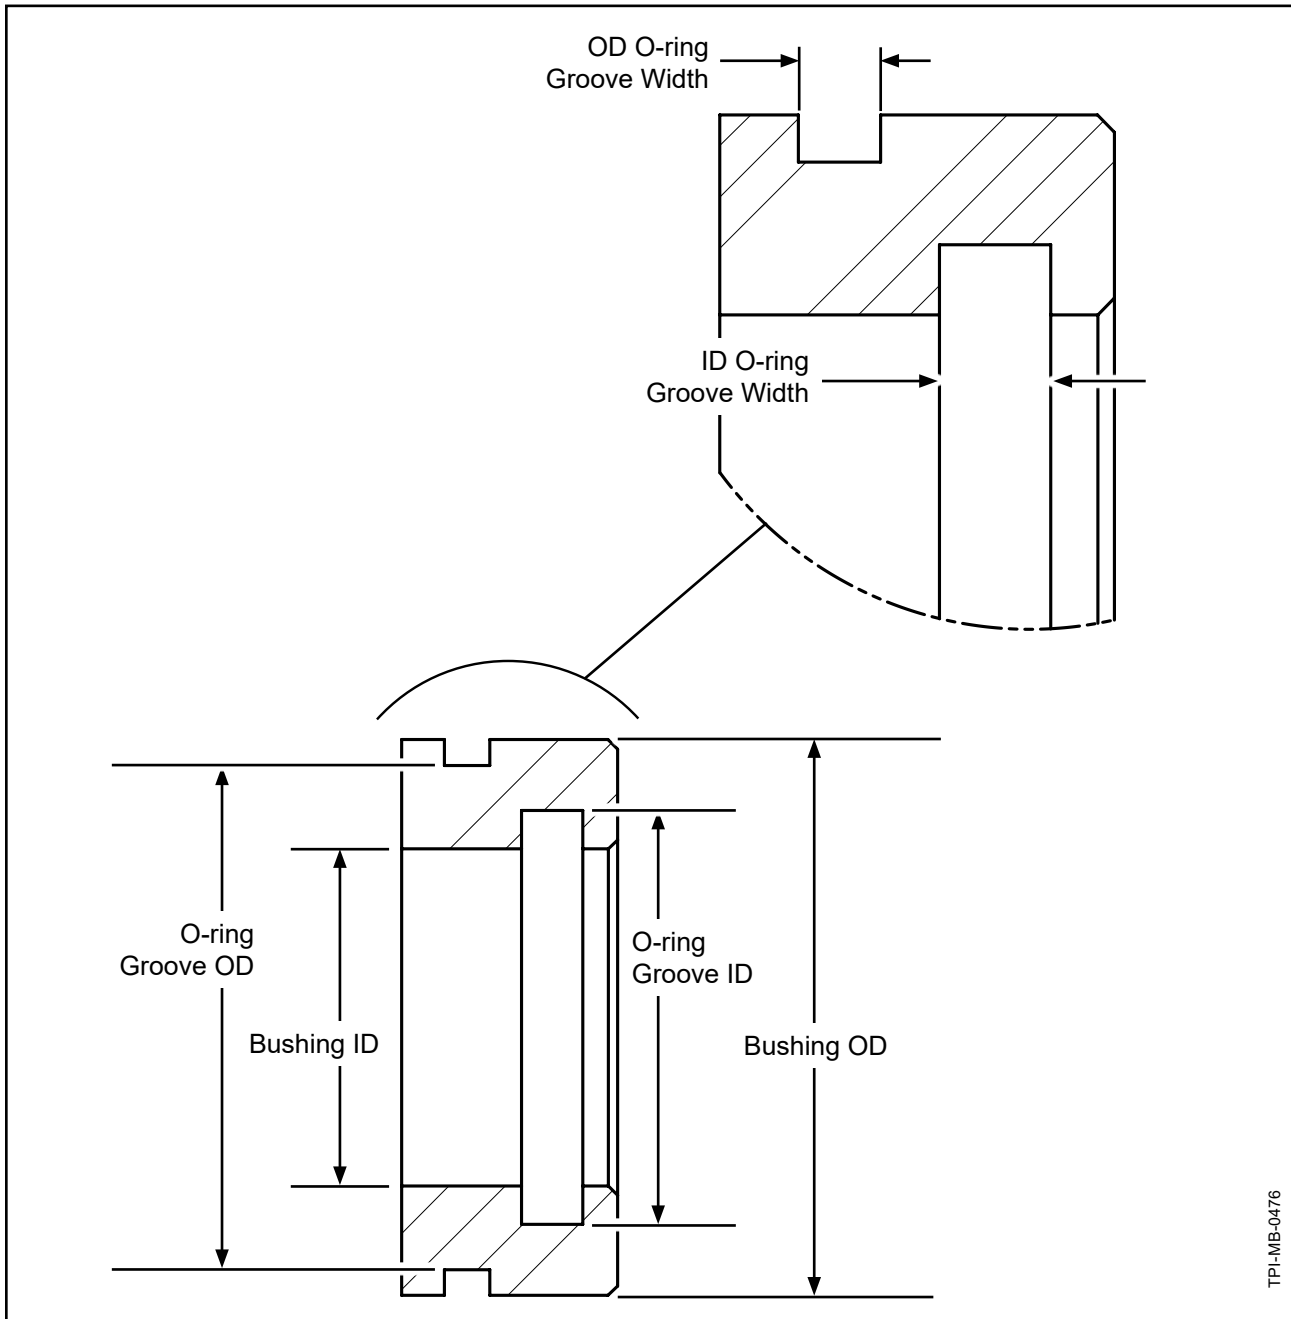
**108298 Cylinder Bushing Inspection
Figure 4**

- (1) Inspect the 108298 cylinder bushing in accordance with Table 2 and Figure 4 in this Service Bulletin.

Inspect	Serviceable Limits	Corrective Action
<u>108298 CYLINDER BUSHING</u>		
(Refer to Figure 4)		
(1) Visually examine both sides of the cylinder bushing for wear, damage, and distortion.	Wear, damage, or distortion is not permitted.	If there is wear, damage, or distortion, replace the cylinder bushing.

(2) Measure the cylinder bushing OD.	The minimum permitted bushing OD is 1.750 inches (44.45 mm).	If the bushing OD is less than the permitted serviceable limit, replace the cylinder bushing.

(3) Measure the cylinder bushing ID and examine the surface finish.	The maximum permitted ID is 1.064 inches (27.02 mm). A smooth surface is required.	If the bushing ID is greater than the permitted serviceable limit, or if the surface finish is not smooth, replace the cylinder bushing.

(4) Measure the cylinder bushing O-ring groove ID and examine the surface finish.	The maximum permitted O-ring groove ID is 1.306 inches (33.17 mm). A smooth surface is required.	If the O-ring groove ID is greater than the permitted serviceable limit, or if the surface finish is not smooth, replace the cylinder bushing.

(5) Measure the cylinder bushing O-ring groove OD and examine the surface finish.	The minimum permitted O-ring groove OD is 1.586 inches (40.29 mm). A smooth surface is required.	If the O-ring groove OD is less than the permitted serviceable limit, or if the surface finish is not smooth, replace the cylinder bushing.

(6) Measure the width of the ID O-ring groove and examine the groove for wear, damage, and distortion.	The maximum permitted width of the ID O-ring groove is 0.170 inch (4.31 mm). Wear, damage, or distortion is not permitted.	If the width of the ID O-ring groove is greater than the permitted serviceable limit, or if there is wear, damage, or distortion, replace the the cylinder bushing.

(7) Measure the width of the OD O-ring groove and examine the groove for wear, damage, and distortion.	The maximum permitted width of the OD O-ring groove is 0.146 inch (3.70 mm). Wear, damage, or distortion is not permitted.	If the width of the OD O-ring groove is greater than the permitted serviceable limit, or if there is wear, damage, or distortion, replace the the cylinder bushing.

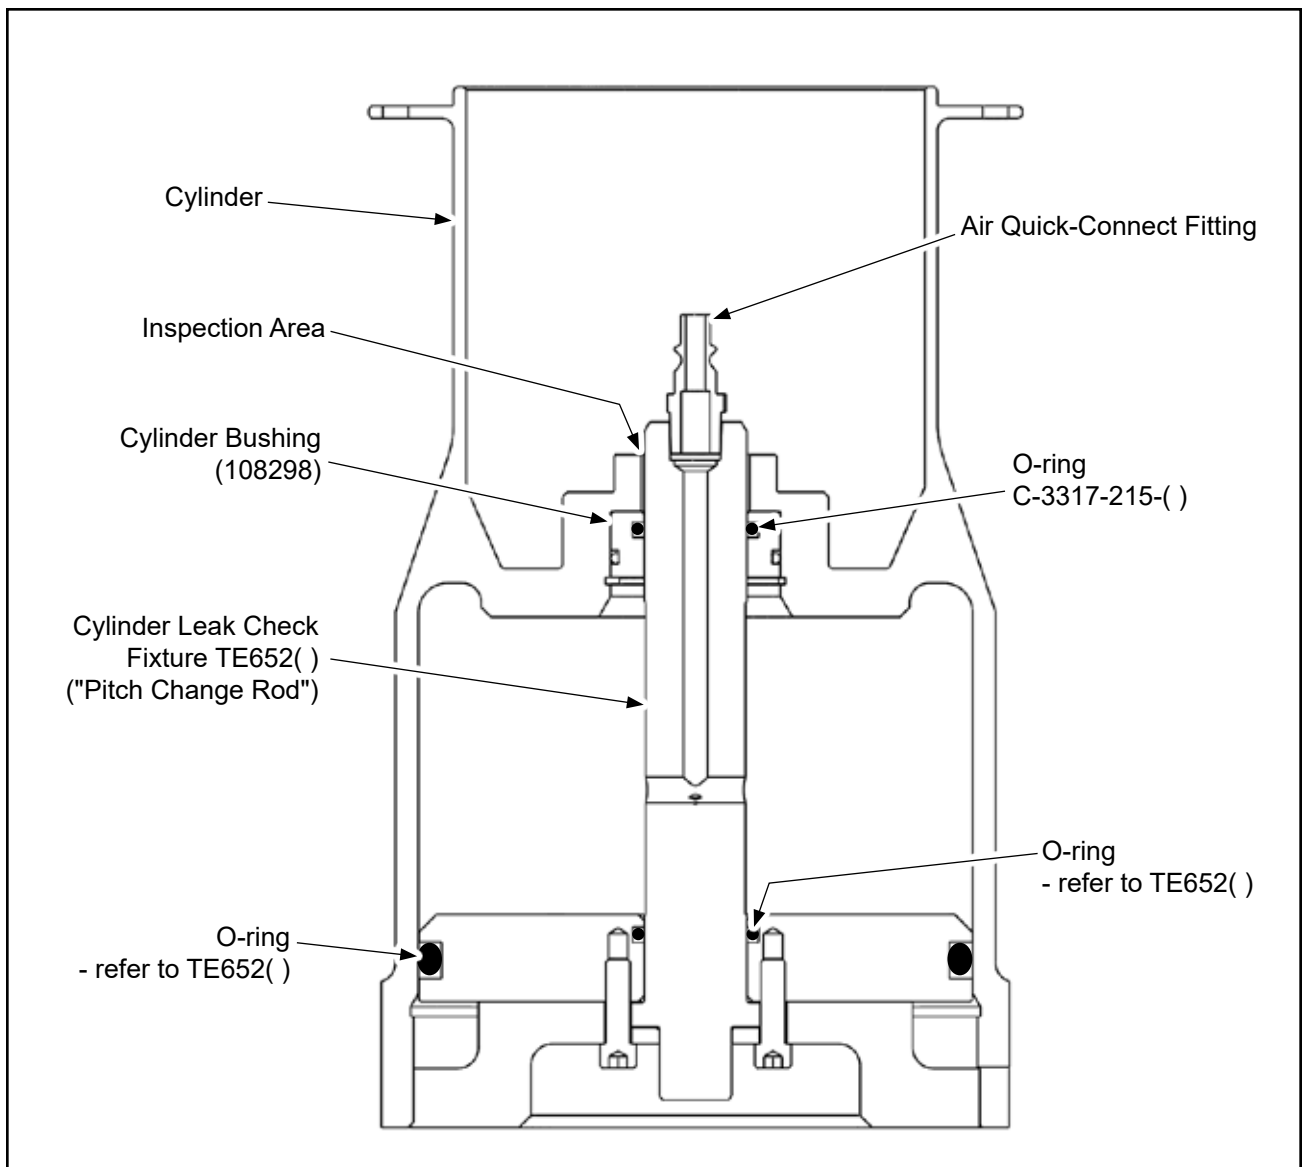
Cylinder Leak Check Procedure
Figure 6

- (6) Check for leaks in the inspection area identified in Figure 6.

2 A leak is indicated by continuous bubbling at the inspection area.

3 A leak is not permitted.

(b) If a leak is detected:

1 Inspect the O-rings for damage and unwanted material.

a If the leak cannot be stopped, replace the 108298 cylinder bushing, then repeat the leak inspection procedure.

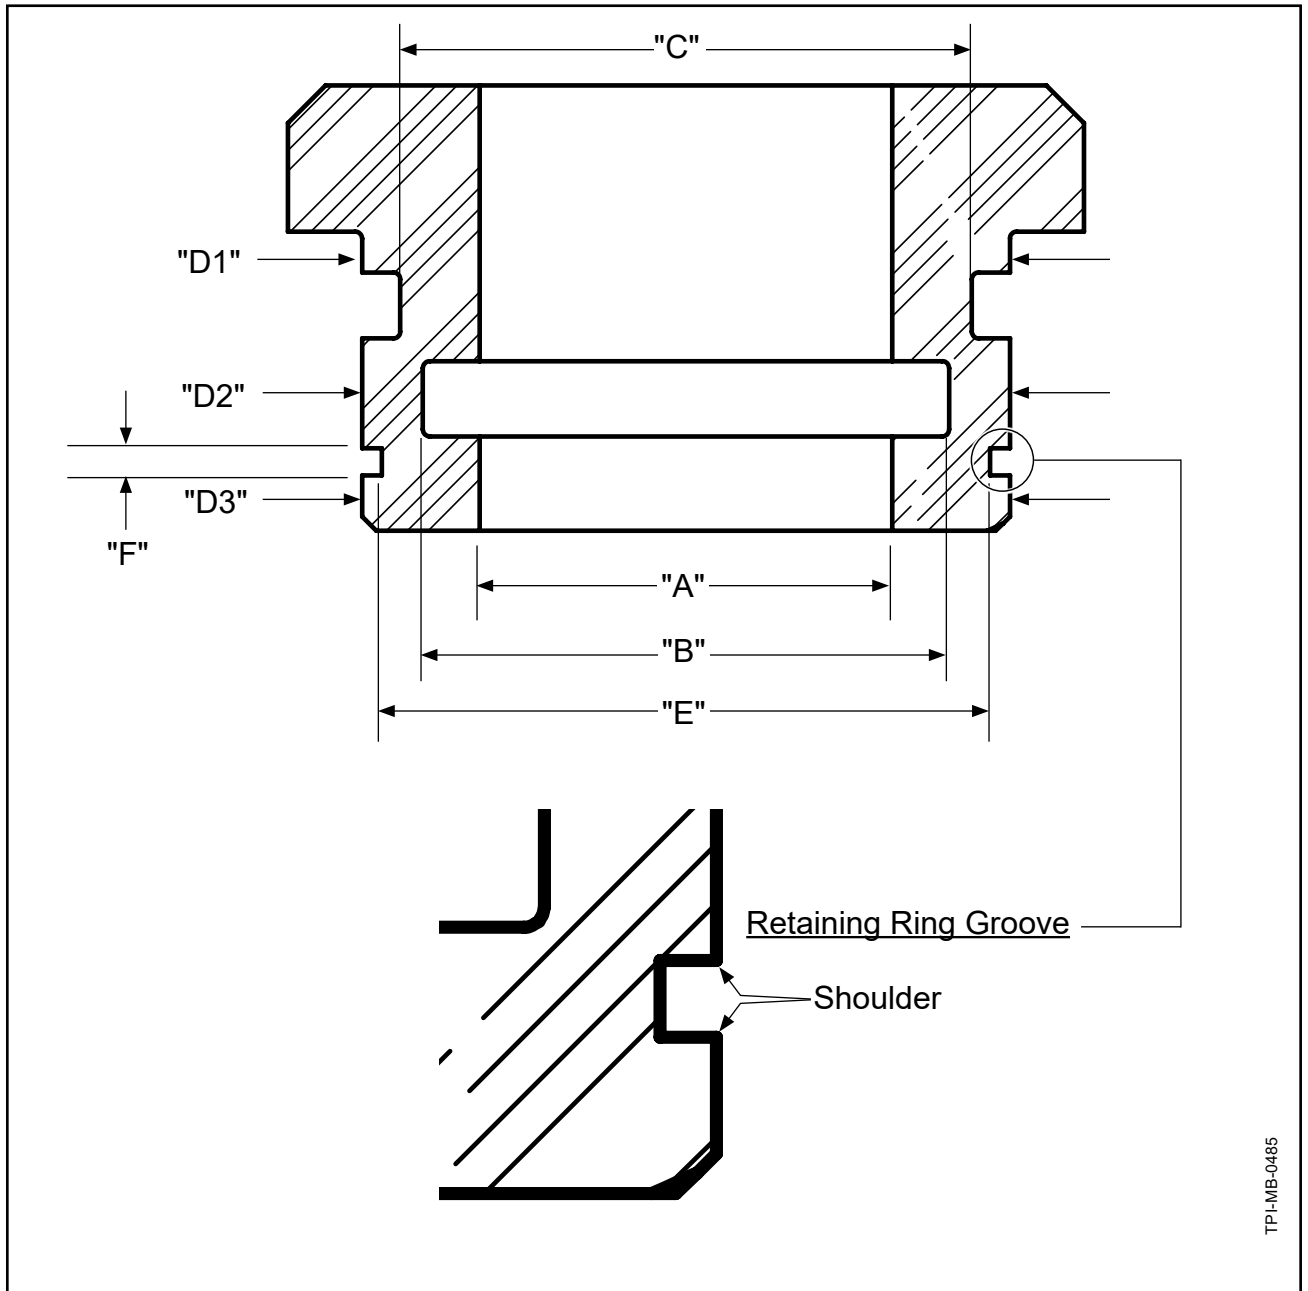
Inspection: 108346 Hub Bushing
Figure 7

- (1) Inspect the 108346 hub bushing in accordance with Table 3 and Figure 7 in this Service Bulletin.

Inspect	Serviceable Limits	Corrective Action
<u>108346 Hub Bushing</u> (Refer to Figure 7)		
(1) Measure the ID of the hub bushing ("A").	The maximum permitted ID is 0.878 inch (22.30 mm). A smooth surface finish is required.	If the ID is greater than the permitted serviceable limits or the surface finish is not smooth, replace the hub bushing.

(2) Measure the ID of the hub bushing O-ring groove ("B").	The maximum permitted ID is 1.121 inches (28.47 mm). A smooth surface finish is required.	If the ID is greater than the permitted serviceable limits or the surface finish is not smooth, replace the hub bushing.

(3) Measure the OD of the hub bushing O-ring groove ("C").	The minimum permitted OD is 1.211 inches (30.76 mm).	If the OD is less than the permitted serviceable limits, replace the hub bushing.

(4) Measure the OD of the hub bushing at two locations ("D1") and ("D2").	The minimum permitted OD at each location is 1.373 inches (34.88 mm).	If the OD is less than the permitted serviceable limits, replace the hub bushing.

(5) Measure the OD of the hub bushing at location ("D3").	The minimum permitted OD is 1.368 inches (34.75 mm).	If the OD is less than the permitted serviceable limits, replace the hub bushing.

(6) Measure the OD of the retaining ring groove ("E").	The minimum permitted OD is 1.284 inches (32.62 mm).	If the OD is less than the permitted serviceable limits, replace the hub bushing.

(7) Visually examine each shoulder of the retaining ring groove for damage.	The maximum permitted total accumulated damage for each shoulder is 25% of the circumference.	If the damage for either shoulder is greater than the permitted serviceable limits, replace the hub bushing.

(8) Measure the width of the retaining ring groove ("F").	The maximum permitted width is 0.062 inch (1.57 mm).	If the width is greater than the permitted serviceable limits, replace the hub bushing.

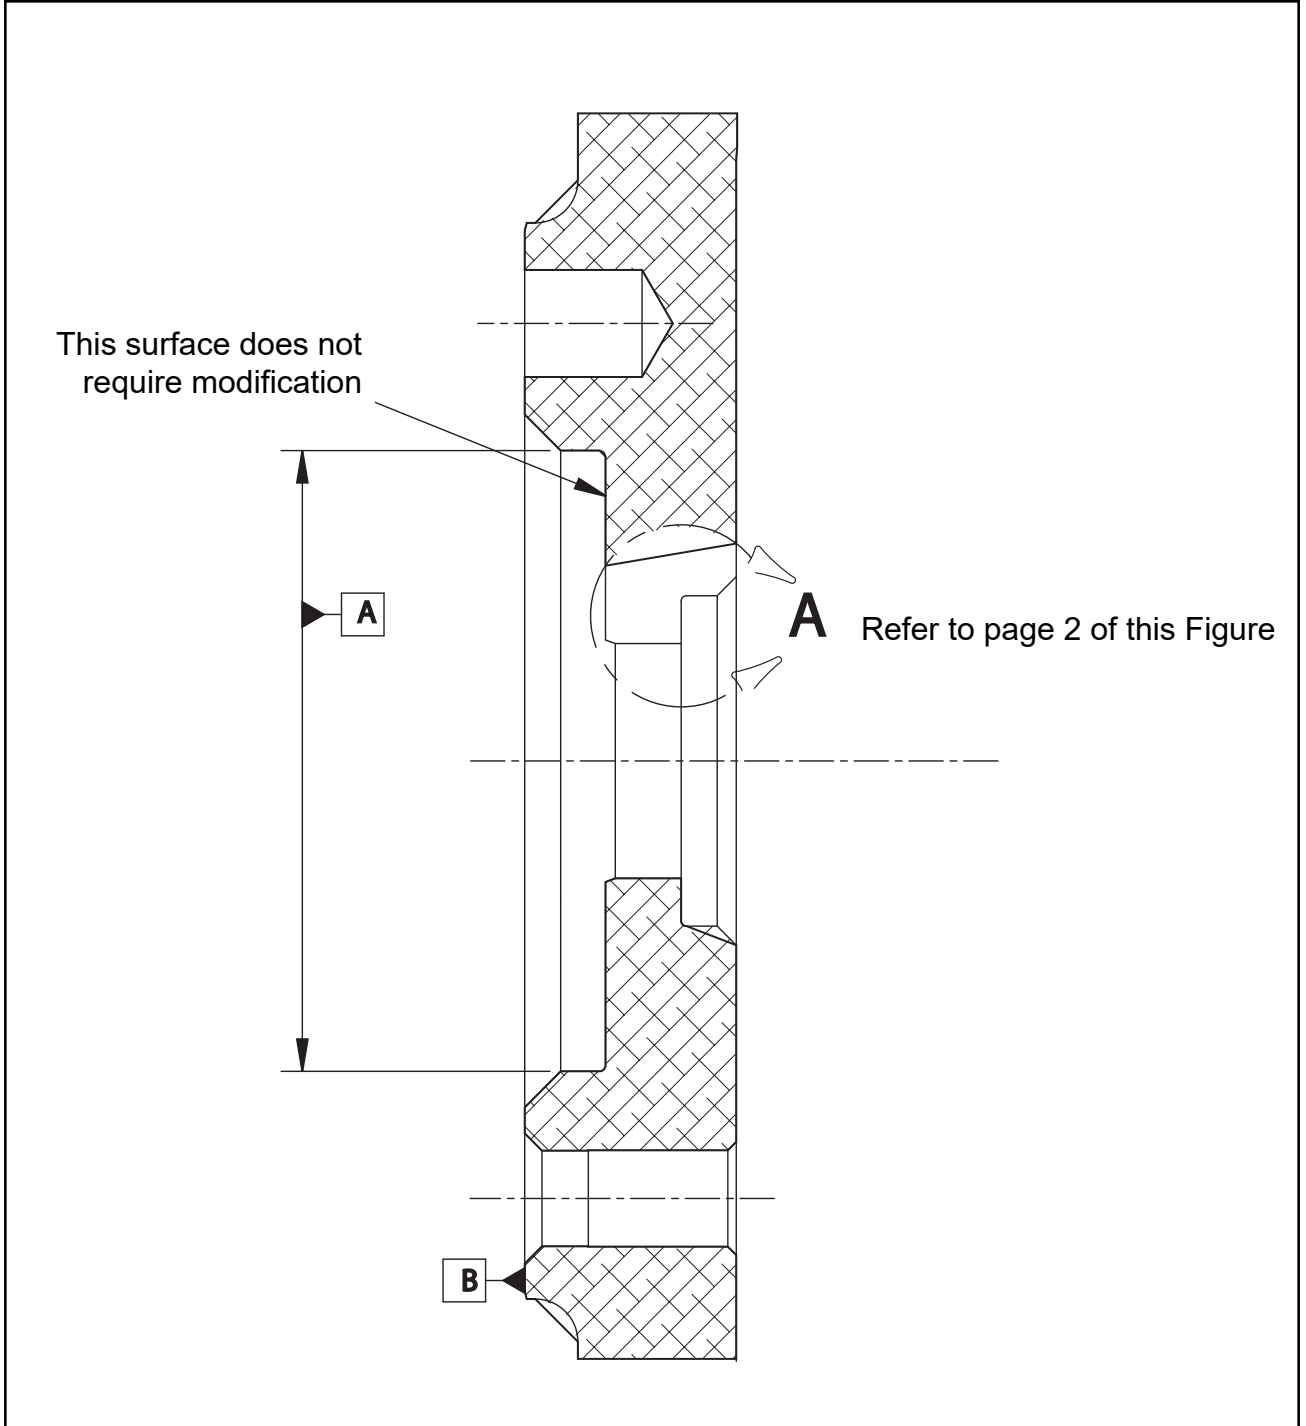
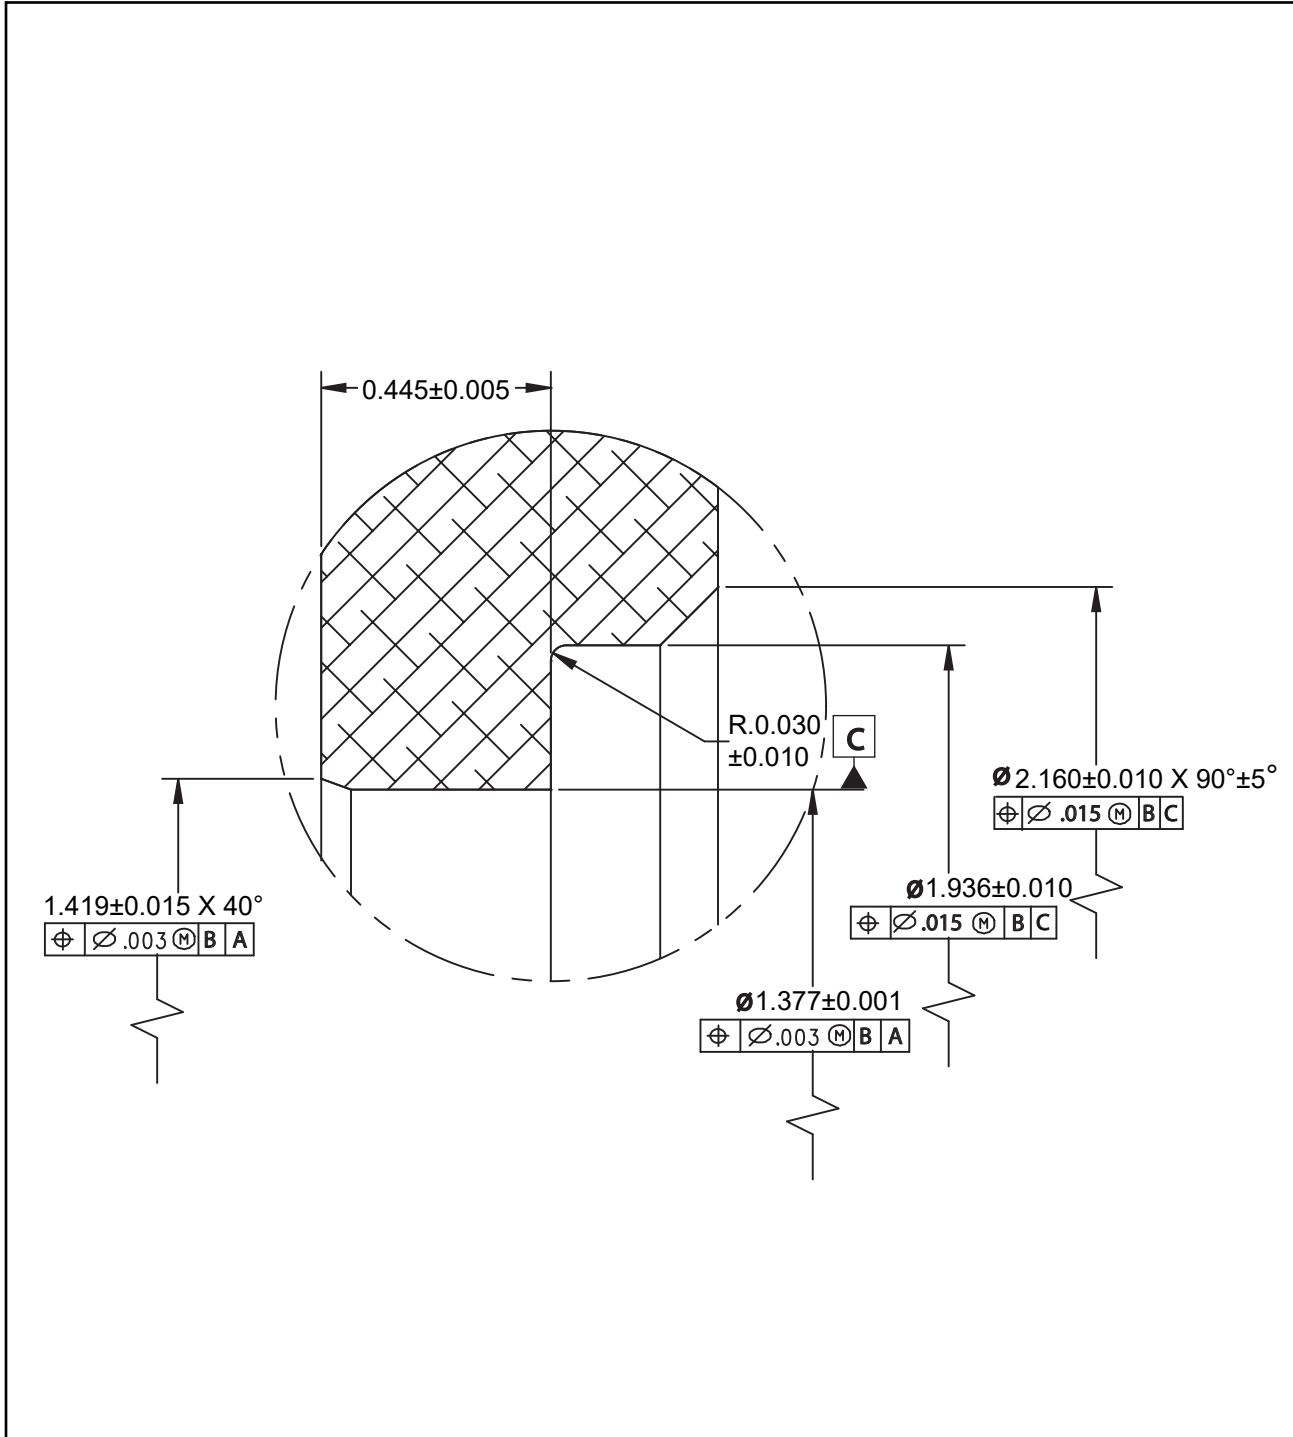
Hub Modification
Figure 9, page 1 of 2

NOTE: This procedure is required for D-7432 hub assemblies that have an A-3789() hub bushing bonded into the hub.

- (1) Remove the bonded A-3789() hub bushing in accordance with the applicable instructions in the Aluminum Hub Overhaul chapter of Hartzell Propeller Inc. Standard Practices Manual 202A (61-01-02).
- (2) Machine the propeller hub in accordance with Figure 9.
 - (a) Remove any burrs.
 - (b) Machined surfaces must have a surface finish of at least 63 micro inches (1.6 micro meters).
 - (c) Apply chemical conversion coating to the machined area in accordance with the Chromic Acid Anodizing chapter of Hartzell Propeller Inc. Standard Practices Manual 202A (61-01-02).
