- 1. Planning Information
 - A. Effectivity
 - (1) Hartzell Propeller Inc. Raptor-series turbine propeller models 5D3-NK366A1 with serial numbers listed in Table 1 are affected by this Service Bulletin.

HARTZELL PROPELLER INC. SERVICE BULLETIN <u>HC-SB-61-393</u>

Propeller Mounting Nut/Torque Inspection

Document No. HC-SB-61-393 Date of Issue: Mar 04/21 Revision: N/A Rev. Date: N/A

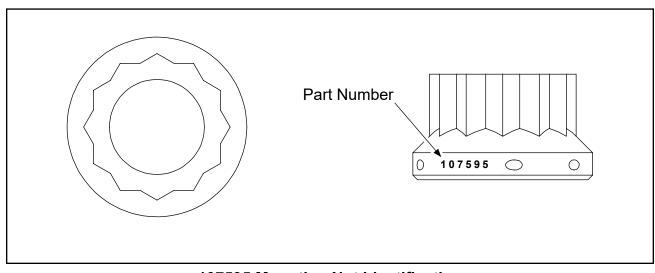
107595 Mounting Nut Identification Figure 1

- (a) In Manual 486 (Rev. 2), Table 3-1 ("Propeller Mounting Hardware") listed the propeller mounting nut as p/n C-6006.
 - <u>1</u> The mounting nut used on the affected propellers is p/n 107585.

- <u>NOTE</u>: All of the affected propellers were packaged and shipped from Hartzell with the 107585 mounting nuts. The part number is stamped on the 107585 mounting nuts as shown in Figure 1 of this Service Bulletin.

- <u>a</u> Check the part number of all eight mounting nuts. The affected propellers <u>must</u> use 107595 mounting nuts. Refer to Figure 1 in this Service Bulletin for part number location.

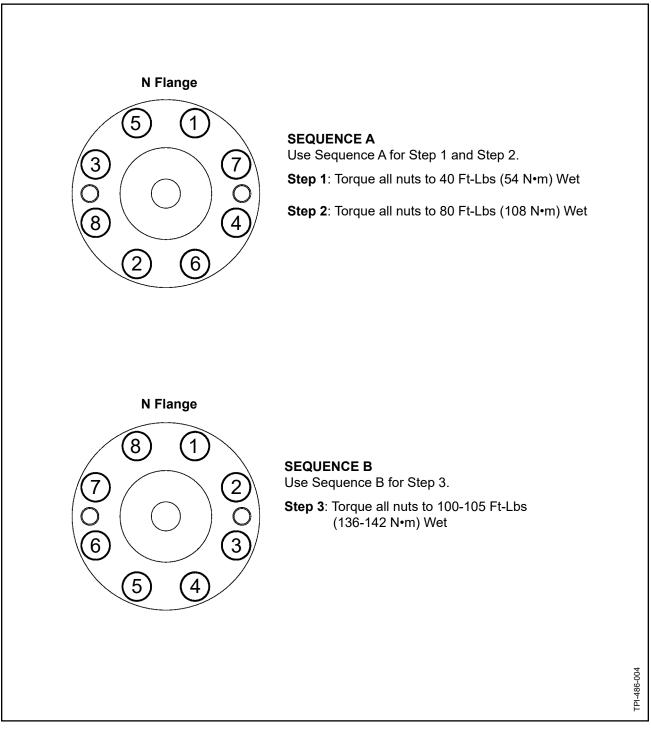
Torquing Sequence for Propeller Mounting Nuts Figure 3

- <u>1</u> The torque value for the 107585 mounting nut is 100-105 Ft-Lbs (136-142 N•m) wet.
- (2) To verify the condition of the mounting bolts/nuts on the affected propellers, a torque inspection of the mounting nuts is required.

Propeller Mounting Nut	Final Torque (Refer to Figure 3 for preliminary torque values and the correct torquing sequence)
107585	100-105 Ft-Lbs (136-142 N•m) Wet

- <u>2</u> Re-torque the mounting nuts in three steps. Use the torque specifications and sequence shown in Figure 3 of this Service Bulletin.
 - Safety all eight mounting nuts with 0.032 inch (0.81 mm) minimum diameter stainless steel wire or equivalent aircraft safety cable. (Two nuts per safety).
