HARTZELL PROPELLER INC.
SERVICE BULLETIN
HC-SB-61-394

Propellers - Inspection and Modification of Guide Lugs

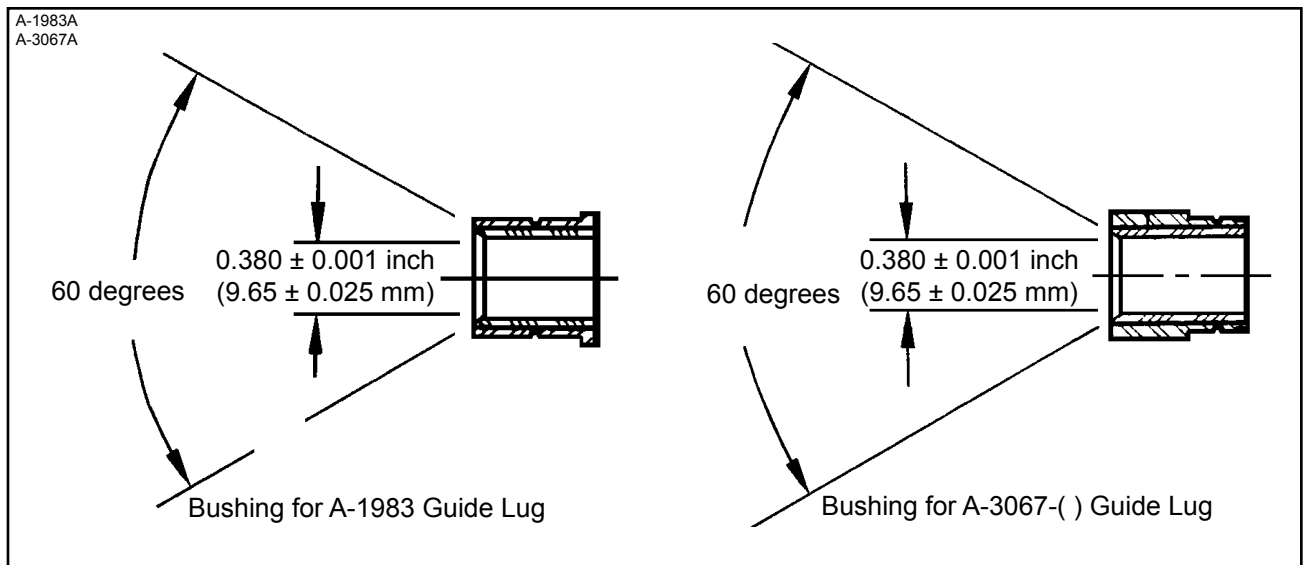
Guide Lug Bushing Dimensions
Figure 1

- (1) In September 2020, the inner diameter of A-3067-() and A-1983 guide lug bushings was changed. Guide lugs shipped from Hartzell, or overhauled, or inspected before September 2020 will have a smaller inner diameter.
- (2) The inner diameter of the guide lug bushing was enlarged to reduce possible interference between the guide lug and beta rod during propeller operation.
- (3) Regulatory action is not expected.

- A. Measure the ID of the guide lug bushing in accordance with Figure 1.
- (1) If the ID of the guide lug bushing is 0.380 ± 0.001 inch (9.65 ± 0.025 mm):

- (a) Return the part(s) to stock. Bag the returned part(s) and indicate on the bag compliance with this Service Bulletin.
 - (2) If the ID of the guide lug bushing is less than 0.380 ± 0.001 inch (9.65 ± 0.025 mm):

- (a) Ream the ID of the guide lug bushing using a self-centering reamer with at least four-flutes in accordance with Figure 1.
 - (b) Examine the ID of the bushing for burring.

- 1 Deburr the bushing if necessary.
 - (c) Test the bushing in the guide lug with a press out force.
 - 1 Apply 225 pounds (1000 N) to the bushing.
 - (d) The bushing in the guide lug must pass the pressure test.

- 1 If the bushing fails the pressure test:
 - a Remove and discard the bushing.
 - b Clean the guide lug.
 - c Replace the bushing in accordance with the Special Adhesive and Bonding Procedures chapter of Hartzell Propeller Inc. Standard Practices Manual 202A (61-01-02).
