**HARTZELL PROPELLER INC.**  
**SERVICE LETTER**  
**HC-SL-61-376**

**Tool Modification and Alternate Propeller Mounting Hardware**

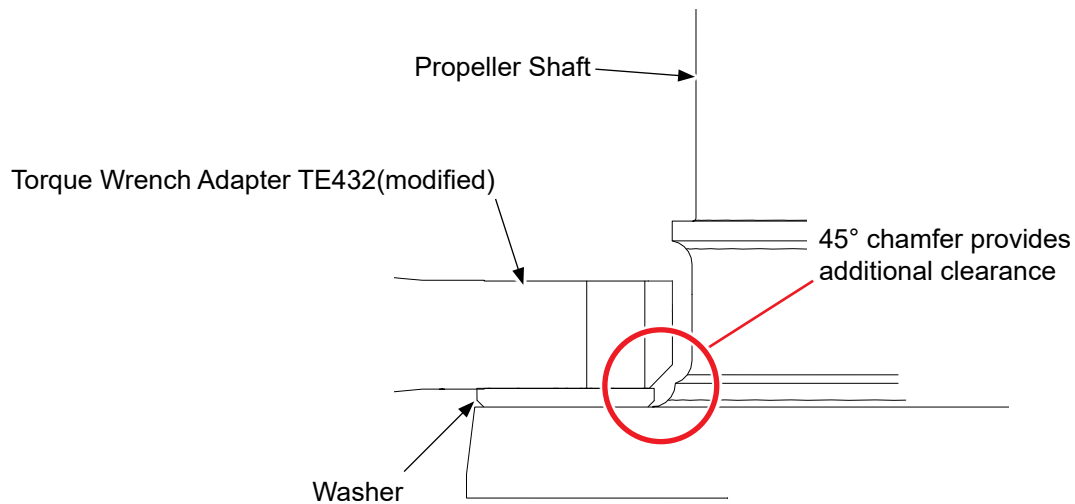
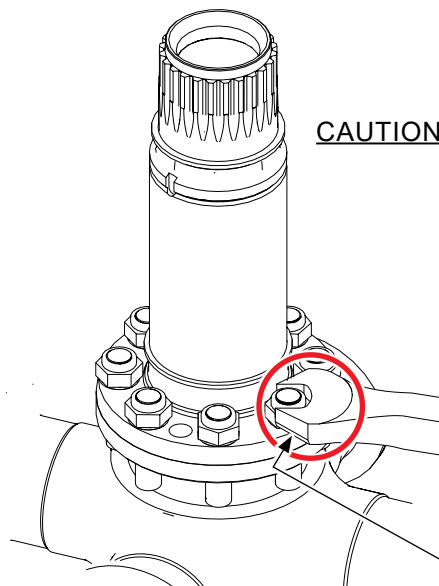
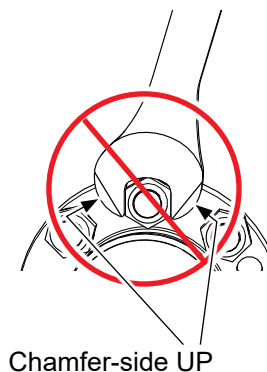
**Modified Torque Wrench Adapter  
Figure 1**

**CAUTION 1:** DO NOT LET THE TORQUE WRENCH ADAPTER CONTACT THE ADJACENT NUTS OR THE PROPELLER SHAFT FLANGE RADIUS WHEN LOOSENING OR TIGHTENING THE MOUNTING NUTS.

**CAUTION 2:** ALWAYS USE THE MODIFIED TORQUE WRENCH ADAPTER WITH THE CHAMFER-SIDE DOWN.
