SERVICE LETTER

Service Letter No. 3024/19/ARL2 - 2nd issue
This Service Letter supersedes the issue dated 18 June 2019.

Subject: ARRIEL 2 All variants
Reduce the occurrences of centrifugal compressor rubbing.

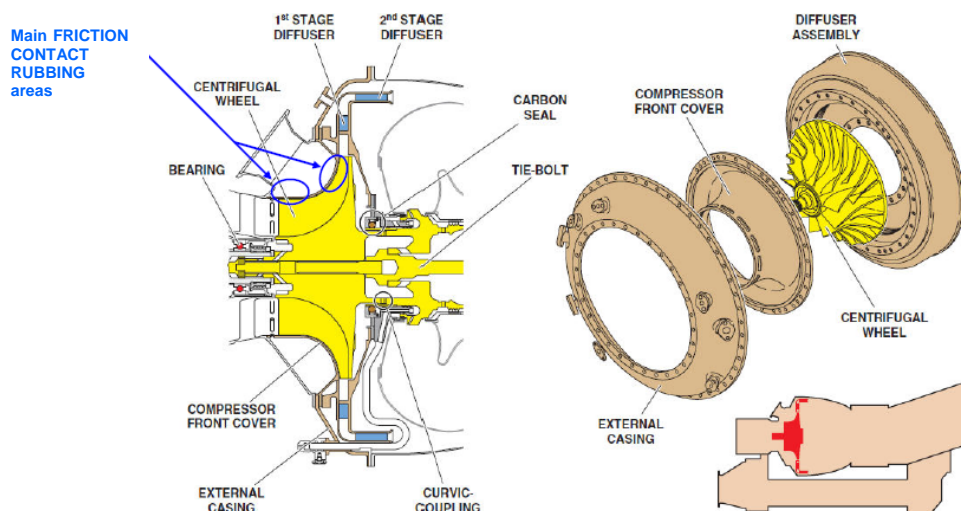
The occurrence of a rubbing phenomenon between the centrifugal compressor and its cover may lead to in-flight effects such as non-sustained surges, drops or N1 variations. Ground effects such as friction noises, seizing or non-free rotations of the compressor may also occur.

Rubbing may be detected by abnormal noises when the free rotation of the gas generator rotating assembly is being inspected.

Damaged covers and centrifugal impellers may also cause high repair costs related to exceeded dimensional criteria.

- **After engine start-up:** Respect a minimum stabilization time of 30s from the stabilized N1 rating **in FLIGHT position**, with full low collective pitch before pulling collective power.
- **Before engine shutdown:** Respect a minimum stabilization time of 30s from the stabilized N1 rating **in IDLE position**. Transient ratings from FLIGHT position to IDLE position should not be counted as part of this stabilization time.
