BY TEXTRON AVIATION

# Multi-Engine Turboprop Communiqué

Communiqué ME-TP-0028  
November 2021

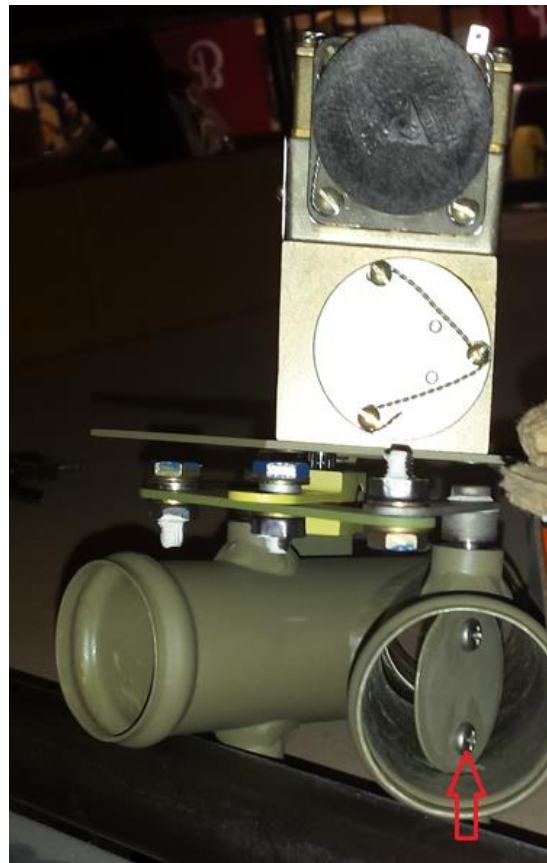
The environmental bleed air bypass valves control the bleed airflow through or around the heat exchanger. The direction of airflow is changed by a set of butterfly disks which are attached to the actuator shaft with two MS51957-26 screws. In the event that these screws come loose, the butterfly disks may fall off. Even though the bypass valves are operating properly electrically, they may still cause erratic cabin temperature issues. If this is the case, we recommend removing the connecting hoses and checking to make sure the butterfly disks are still in place. If not, the butterfly disk can be reinstalled and secured with Loctite 271. Refer to picture below.

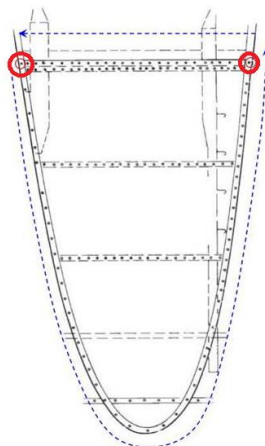
The fasteners in the red circles are MS20426E6-9.

The rest are a combination of MS20426AD5-5, -6 and -7 depending on the grip length.

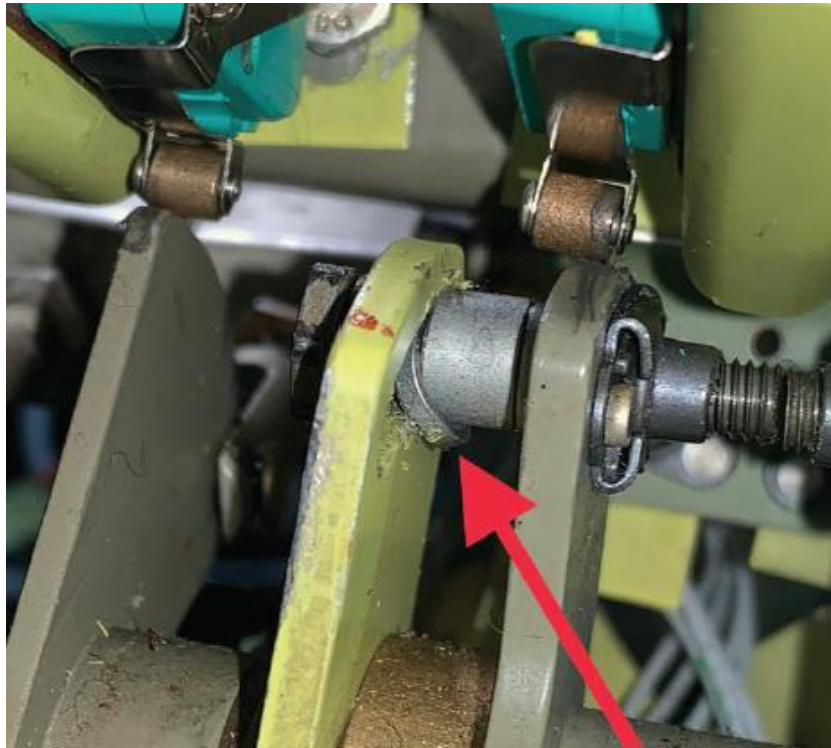
**Damaged Switch Actuators**

The set of micro switches installed on the power lever quadrant in the King Air control various systems in the airplane and they are critical to the safe operation of these systems. These switches need to be adjusted to the specifications found in the Maintenance Manuals. It is critical that these adjustments are done correctly. A short cut to this procedure is to bend the actuator arm which is not the correct procedure; this practice will lead to unreliable results and damage to other components associated with this installation. The pictures that follow provide samples of the damage that this practice causes. We have also included the correct adjustment technique that should be used.

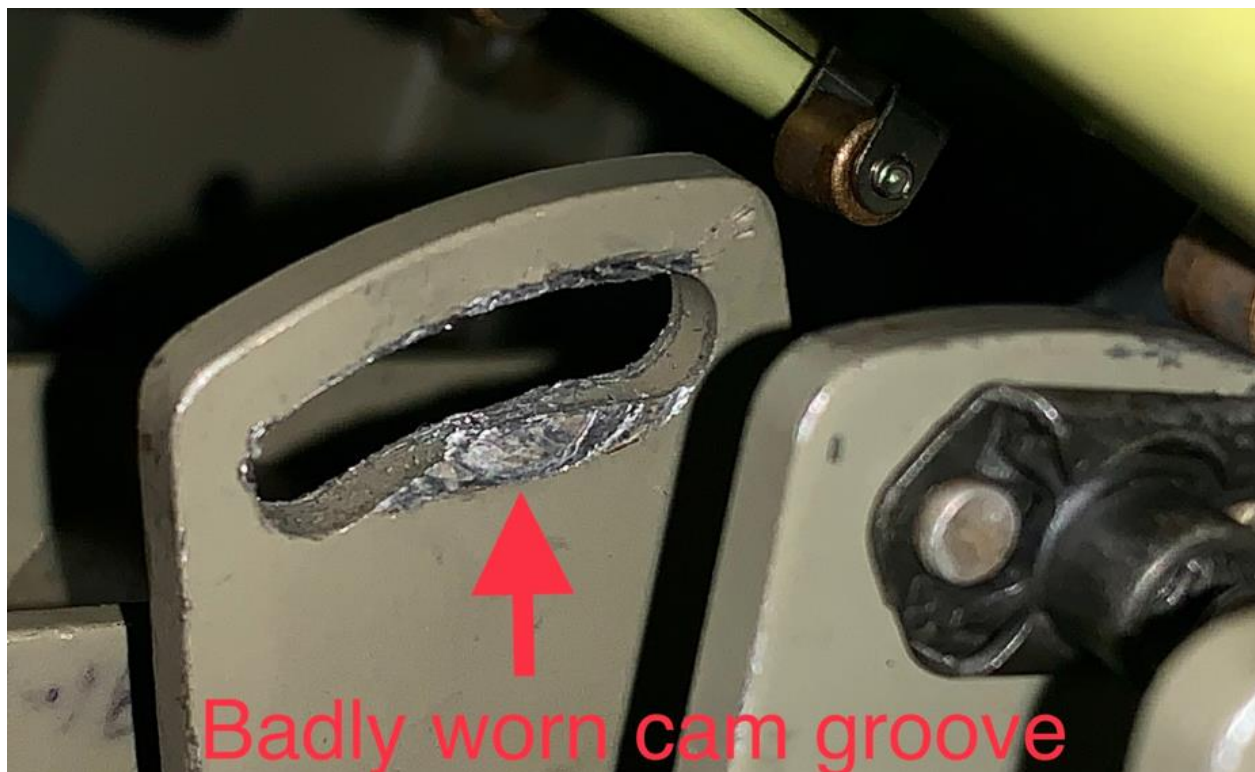
**Worn hardware (i.e. spacers, washers, worn cams) may prevent achievement of a positive switch adjustment. Replace worn hardware as required.**
