BY TEXTRON AVIATION

Multi-Engine Turboprop Communiqué

Communiqué ME-TP-0033
January 2023

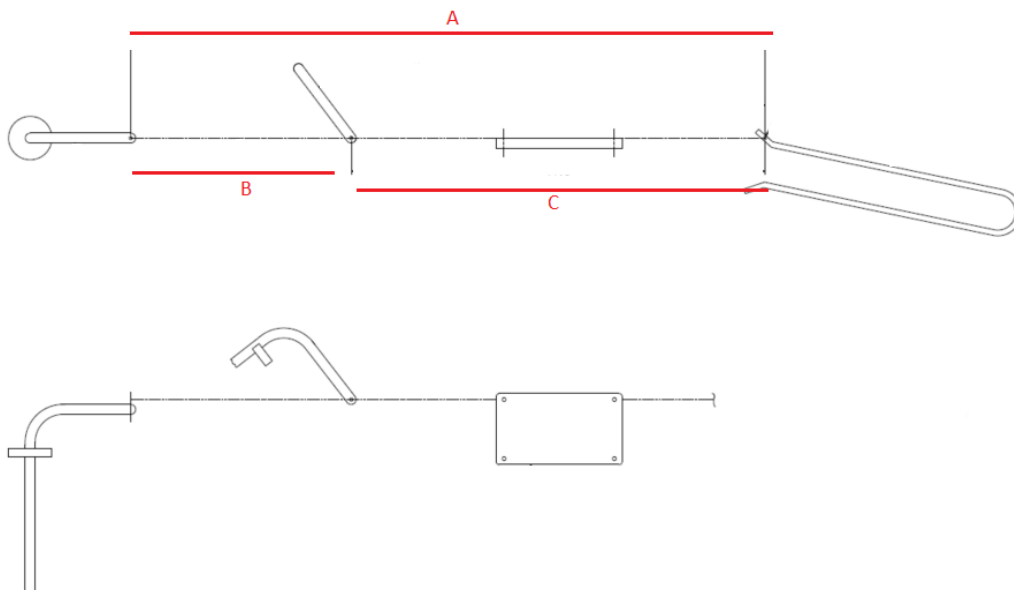
The Maintenance Manual for some airplanes and SB 27-3459 for the rest, directs you to make sure you are using the correct gust lock in your airplane. The gust locks do not have part numbers printed on them. We have developed a chart to help identify if the correct gust lock is installed by measuring the sections of chain between the components of the gust lock. The sketch below shows how it should be measured.

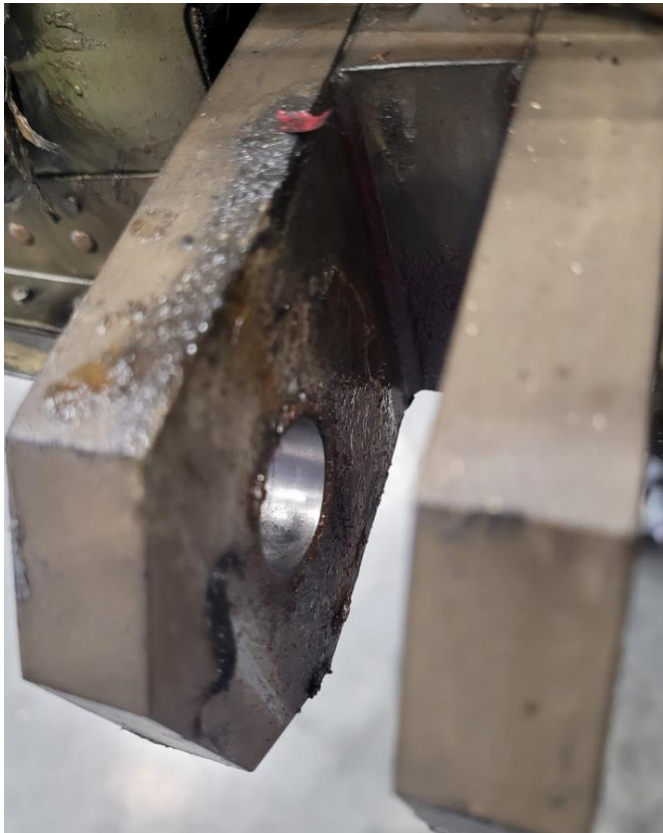
The wing fitting configuration on the lower forward location on these airplanes is the clevis type fitting with five prongs and a wing bolt going through the prongs connecting the center section wing with the outboard wing. It is possible for moisture to ingress between the wing fitting plates and the bushings and onto the wing bolt. This moisture

can lead to corrosion causing the wing bolt to seize inside the bolt bore of the wing fitting. See pictures below as samples as reported by operators.

Wing Fitting Corrosion

In preparation for the removal of the wing bolt, it is recommended that the area be saturated with penetrating oil, such as mouse milk or something similar. Applying penetrating oil several hours prior to the removal of the bolt can assist in the bolt sliding through. It is important that you use the alignment pin, part number 10996, per the SIRM instructions.

One measure of prevention against this from occurring again is to saturate the area with the corrosion preventive material called out in the SIRM during reassembly.

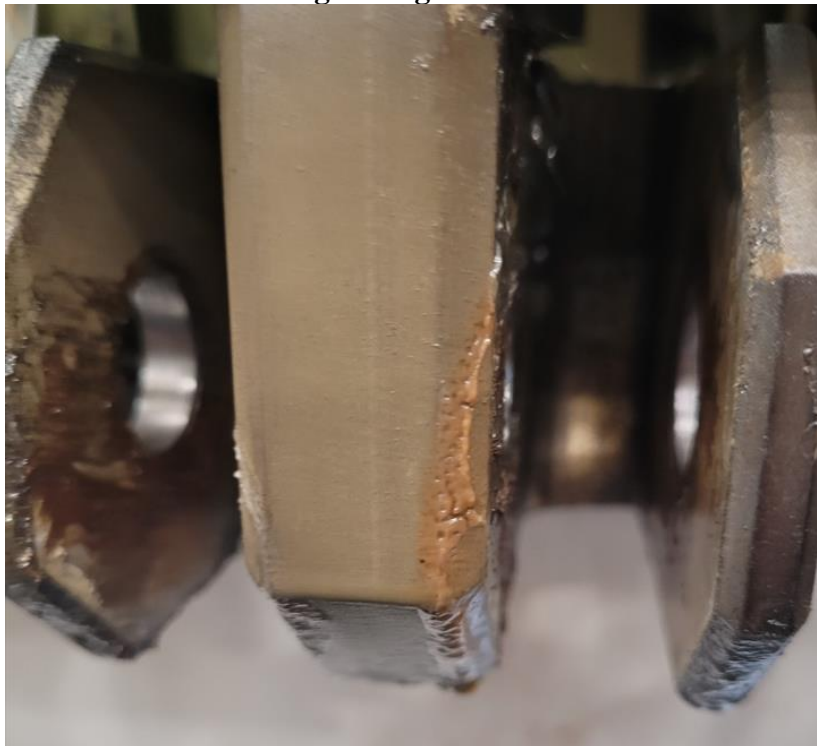
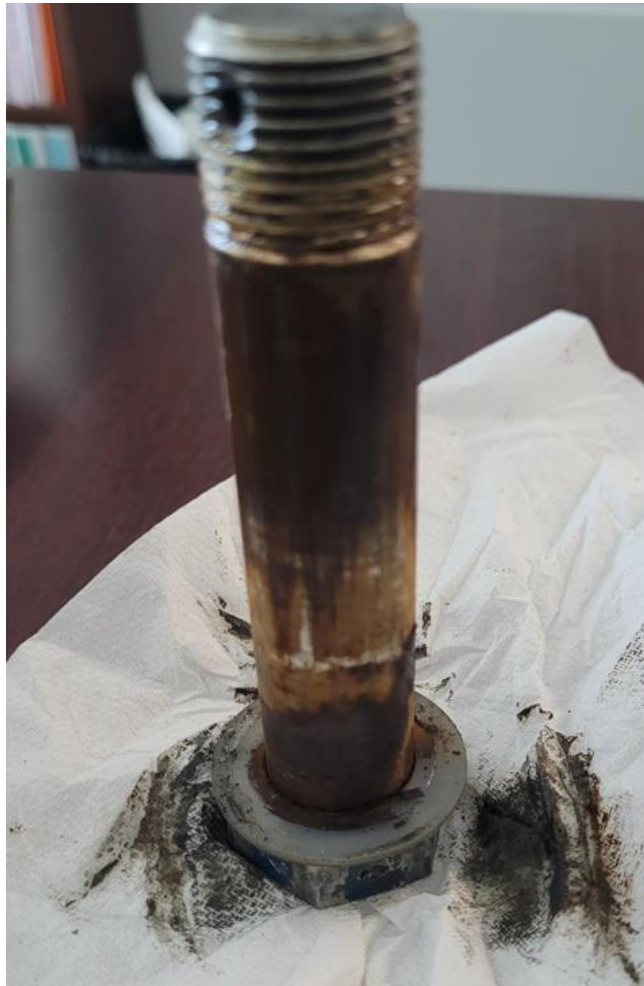
Corroded Wing Bolt

With the wing bolts in the other locations still installed, we can now start with the procedure of removing the lower forward wing bolt. Light taps with a hammer using the alignment pin should be enough to get the bolt moving. If that does not result with the bolt sliding out, you can use a wrench on the bolt head and apply rotation inputs while the tapping with the hammer continues. Stubborn wing bolts may require more drastic measures such as the use of a powerful rivet gun. A 9X rivet gun, like the one shown below, and a “mushroom” aluminum rivet gun head has been required in the past to remove a stubborn wing bolt. Extreme care must be exercised while using this gun so that it does not slip causing damage to wing structure.

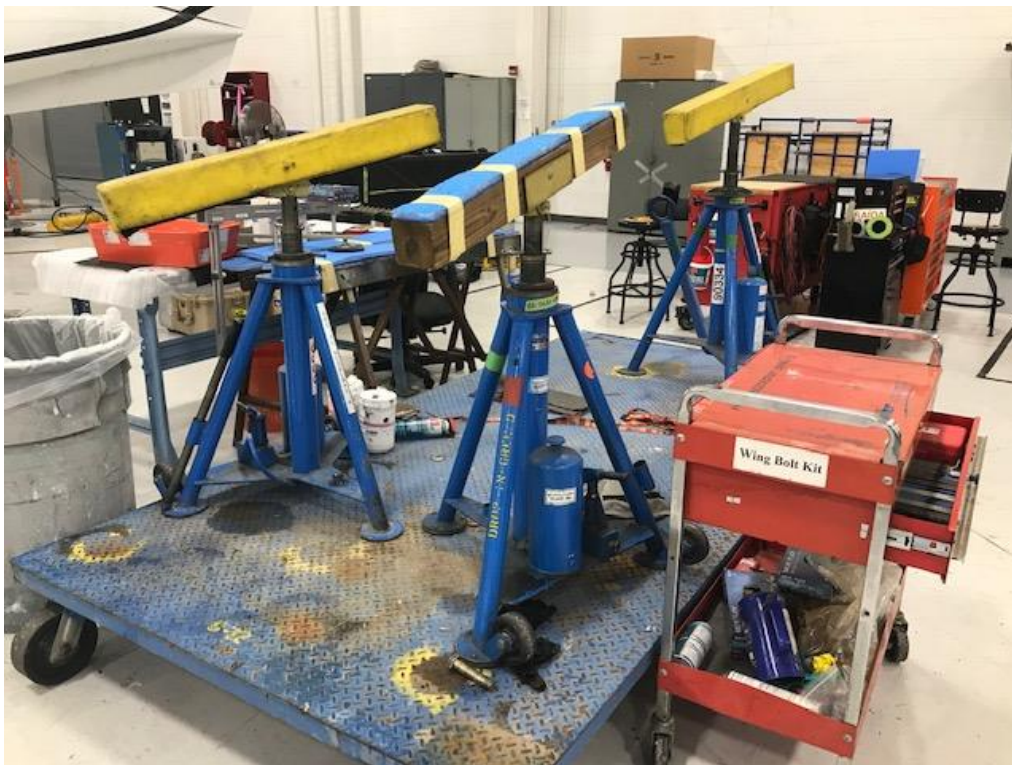
Modified Jacks to Support the Wing

Another technique used is to find a way to “unload” the wing by applying light force to the underside of the wing using modified cradles as shown in the pictures below. The padded areas of the cradles are aligned along the main spar, carefully jacking the cradles up and down along the spar may help in finding the “happy spot” where the wing bolt would be free. This method can also be used for the second condition, described above, where we suspect that the wing bolt is “pinched” between the wing fitting lobes. However, in the case where we suspect that the bolt is pinched, we may also want to loosen the other wing bolts to be able to align the wing bolt lobes, so the bolt is free to move. Removing or loosening the other wing bolts will require that the wing is supported further.
