BY TEXTRON AVIATION

Multi-Engine Turboprop Communiqué

Communiqué ME-TP-0034
August 2023

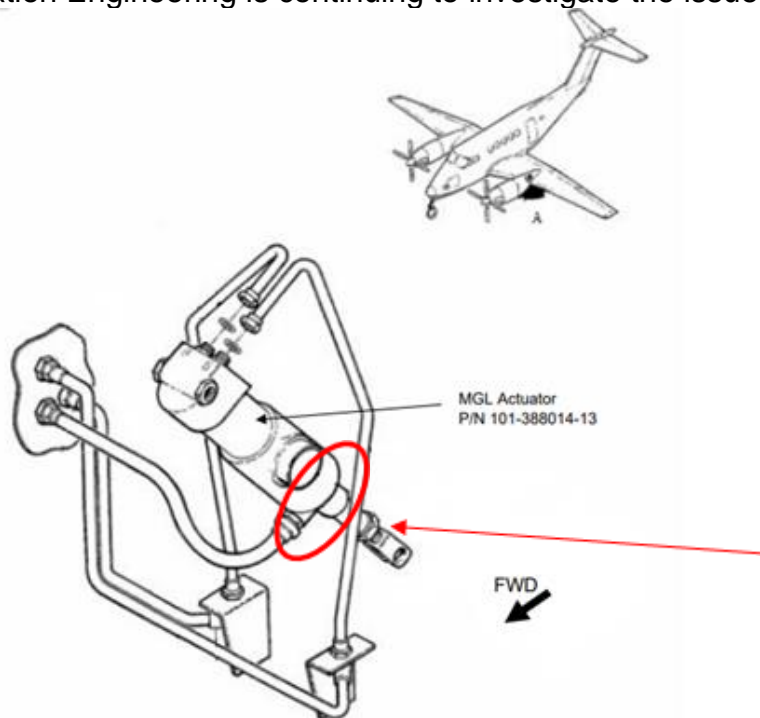
Area of Focus

Textron Aviation has seen some sporadic actuator cracks in the field on main landing gear actuator part numbers 101-388014-1/-13. Textron Aviation would recommend that any operator returning actuators for repair or overhaul bring this issue to the attention of the entity conducting the repair/overhaul. The overhauler should be advised to pay particular attention to the area surrounding the outer fillet radius on the actuating end of the actuator unit.

Based on laboratory inspections on three different cracks found in the field, the cracking is believed to have initiated from the inside of the actuator cylinder housing making it unlikely to be detected by a visual inspection until the crack has propagated through the thickness of the actuator cylinder housing to the outer surface.

The supplier of this actuator unit has since made design improvements to the internal radius of the actuator housing to alleviate the stress concentration associated with the fillet radius and made it less susceptible to crack initiation.

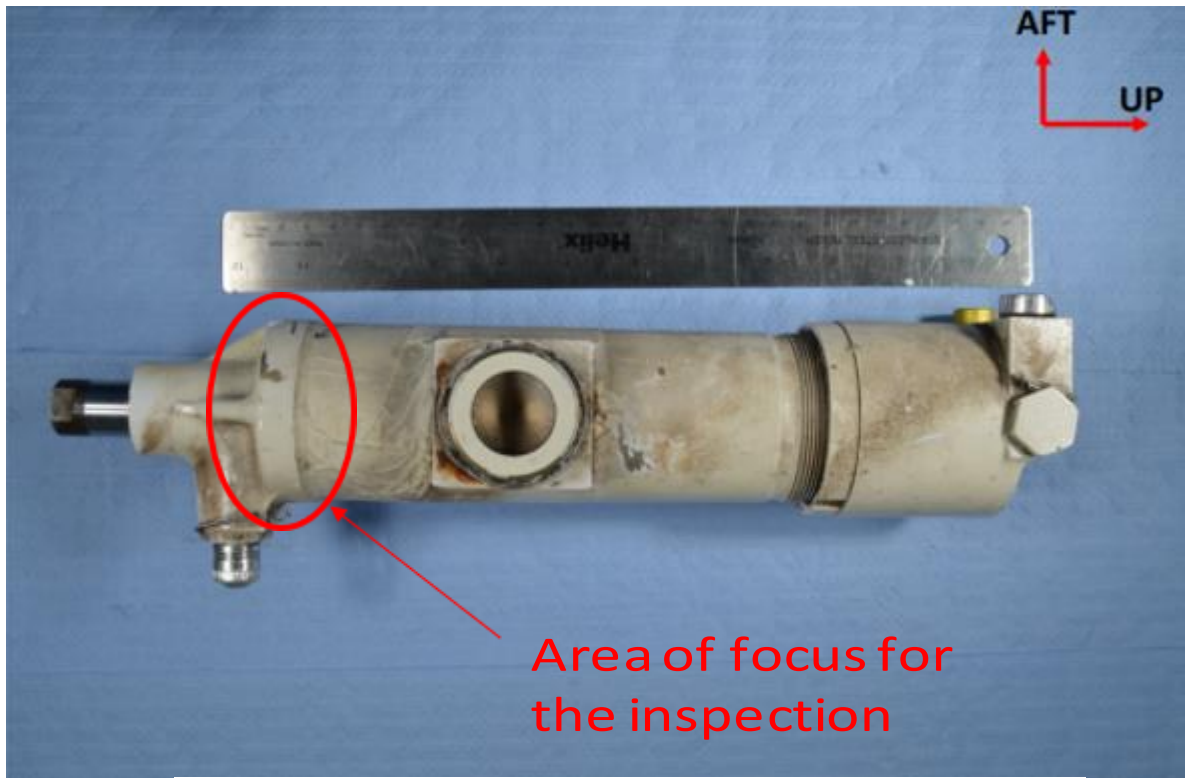
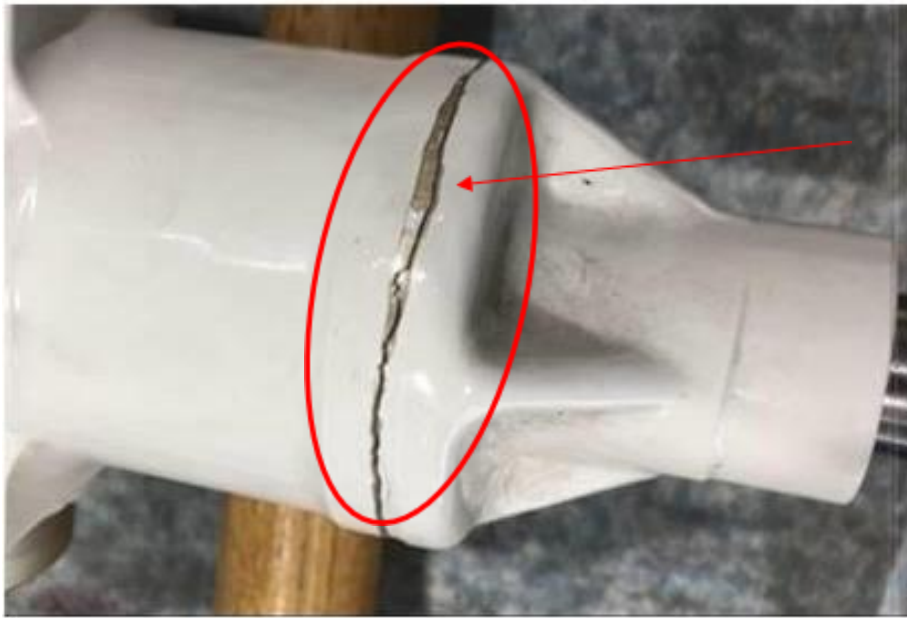
Example of Cracked Actuator

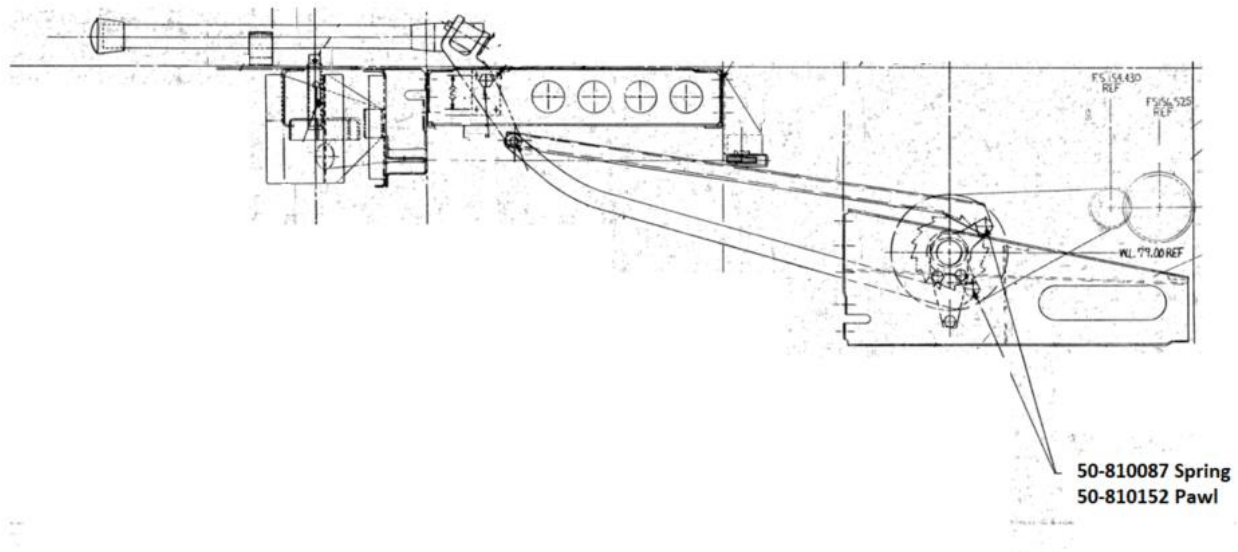
The Pilot's Operating Handbook (POH) provides the flight crew with instructions on how to operate the emergency landing gear extension system. See sample below. This procedure cautions against continuing pumping the emergency landing gear handle after the three green gear down lights illuminate. Continue pumping of the emergency landing gear handle puts the emergency extension system in a bind. When this happens, the handle can no longer be moved making resetting the system impossible.

When the landing gear handle is lifted and turned clockwise as directed by the POH, this engages a ratchet assembly via an upper and lower link. This ratchet assembly is turning against the spring tensions and two pawls which engage the teeth of the ratchet assembly. When the handle is pumped after the green lights coming on, this puts a binding force between the teeth of the ratchet assembly and the pawls. To free the pawls from the teeth, we need to gain access to this area and pry the pawls free from the ratchet assembly teeth. This mechanism is located just aft of the landing gear handle under the floor. Once free, you are able to move the handle and reset the system. It is important to inspect the mechanism for any damage that may have occurred.

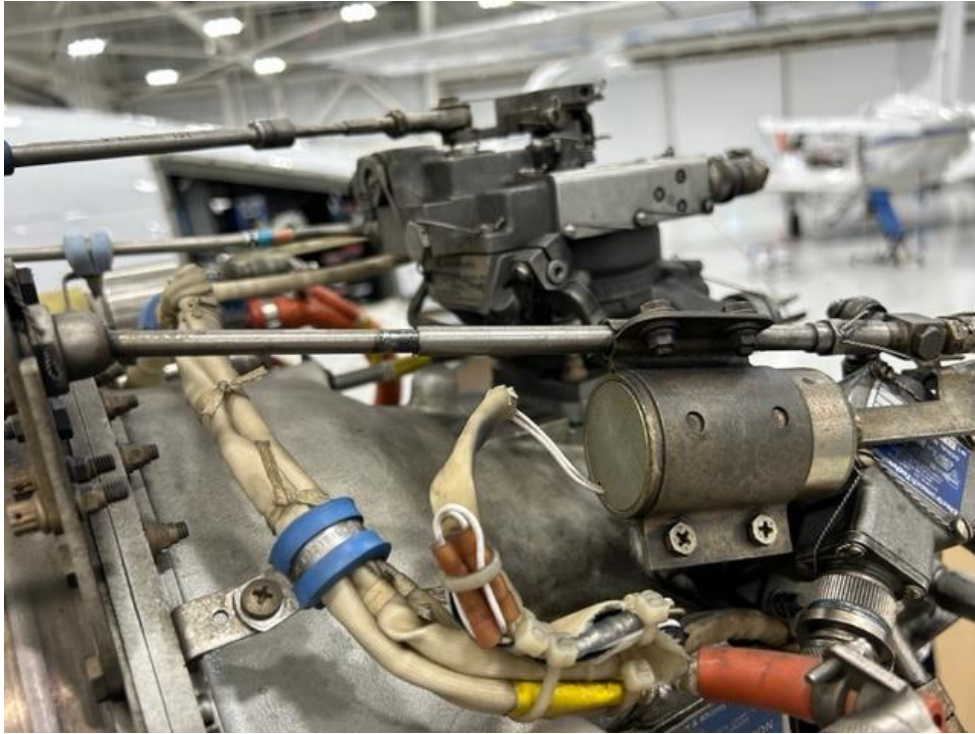
We have had reports of the ground idle solenoid system circuit breakers tripping. Investigation revealed that insulation of the wires of the solenoid at the point of exit have broken down allowing the wires to contact the solenoid body, tripping the circuit breaker. A possible solution is to add high temperature RTV at the point of exit such as RTV-736 or equivalent. See pictures below.

Ground Idle Solenoid without support or RTV

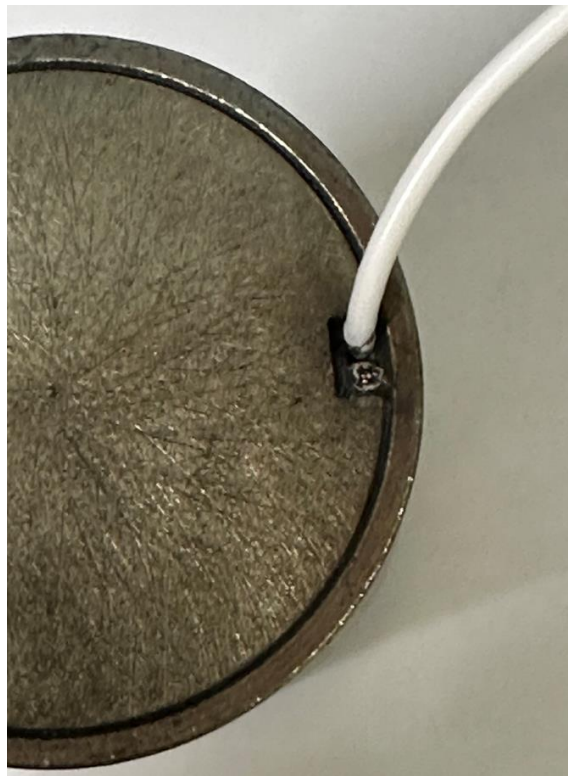
Ground Idle Solenoid with a Broken Wire

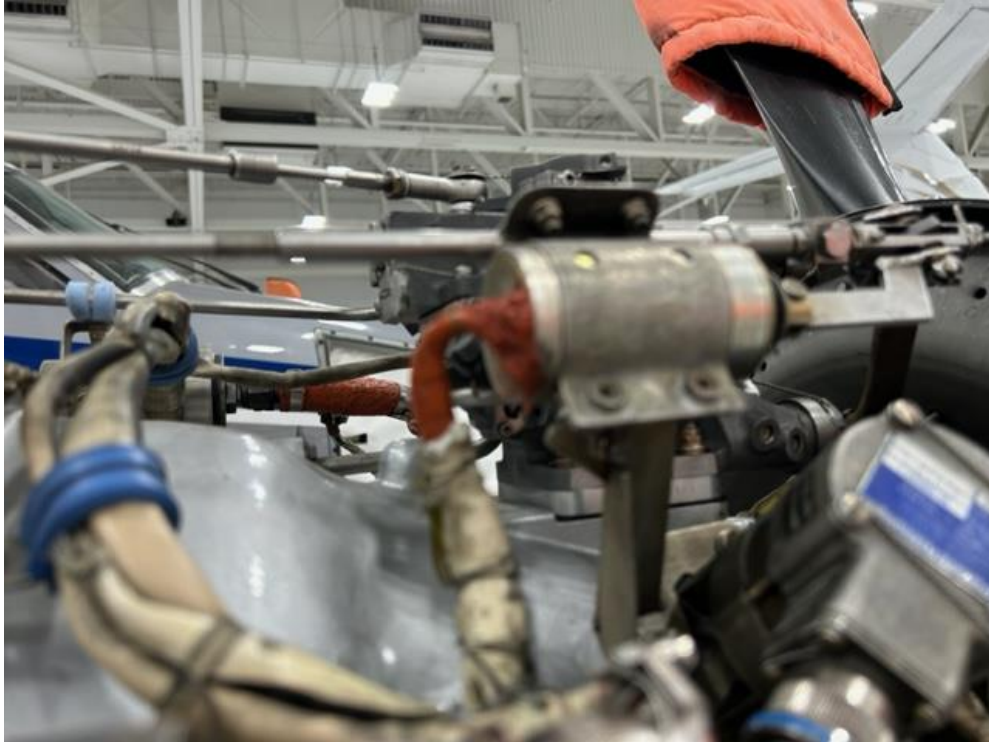
Ground Idle Solenoid with support and RTV
