## Multi-Engine Turboprop Communiqué

Communiqué ME-TP-0035  
January 2024

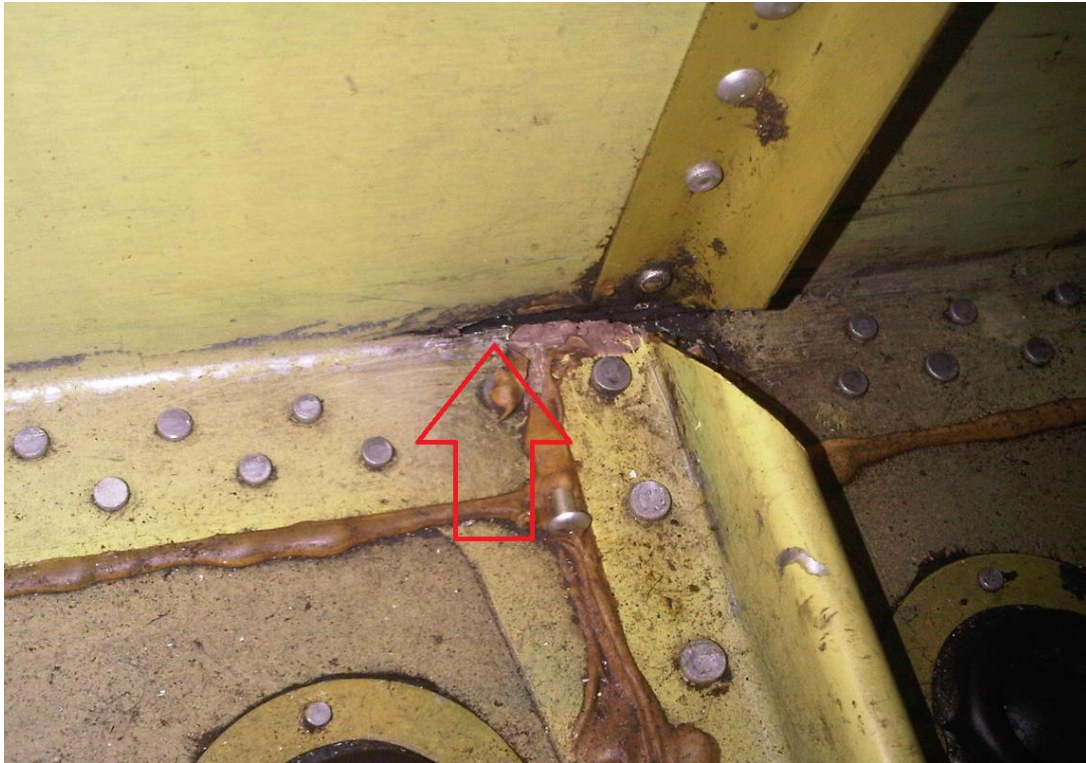
**Main Spar Assembly Looking Forward At Aft Seal Plate**

- Ram air door on the nose, LH side on the 90/F90/100 series; RH on the 200/300 series.
- Cabin door seals.
- Also, please refer to the picture below. This is an image of the main spar as it crosses the fuselage under the cabin floor. The red arrow is pointing to the seal plate on the aft side of the spar assembly where it meets with the belly skin of the airplane. A crack on the radius of this seal plate as shown by the red arrow, as well as forward side of the spar assembly, can result in pressure vessel leaks.

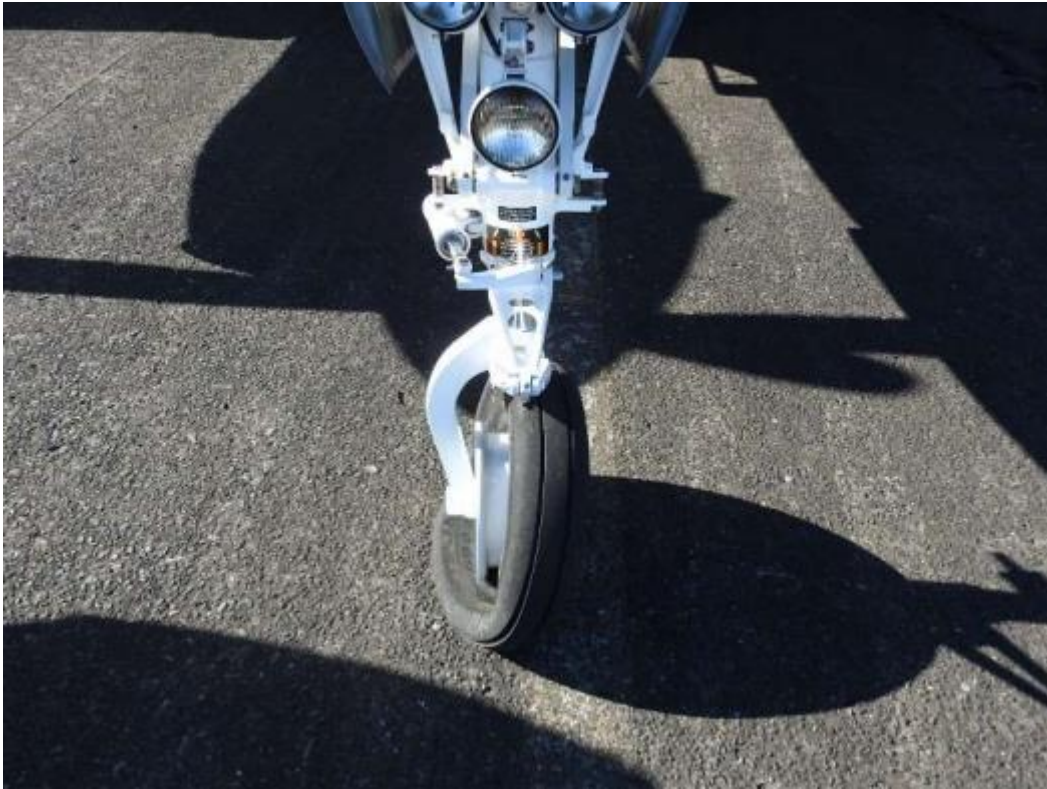
**Nose Tire Rolled off the Rim**

Reports of the nose tire rolling off the rim are not frequent, but they can happen (see picture below). One of the reasons a nose tire could roll off the rim is if the airplane lands with a deflated nose tire; however, it is more likely that the airplane was forced to turn using differential power and brakes. It is possible to drag the nose of the airplane sideways using differential power and brakes. When this is done, the nose tire is dragged sideways and can force it off its rim. Extreme caution should be exercised when maneuvering the airplane in limited spaces. If the nose steering mechanism is at its limit and you need to turn tightly, it is best to shut down and maneuver the airplane using the tow tractor and not utilize differential power and brakes. Apart from the risk of rolling the nose tire off its rim, it also causes an unnecessary risk of introducing FOD into the engines as this requires large amounts of power that could result in flat spotting the main tires as the airplane pivots on the inside main tires. It is also important that the nose wheel is straight when doing high power engine runs.
