## Multi-Engine Turboprop Communiqué

Communiqué ME-TP-0037  
September 2024

### ATA 20 – Bird Strike Inspection-Leading Edge Damage Limits

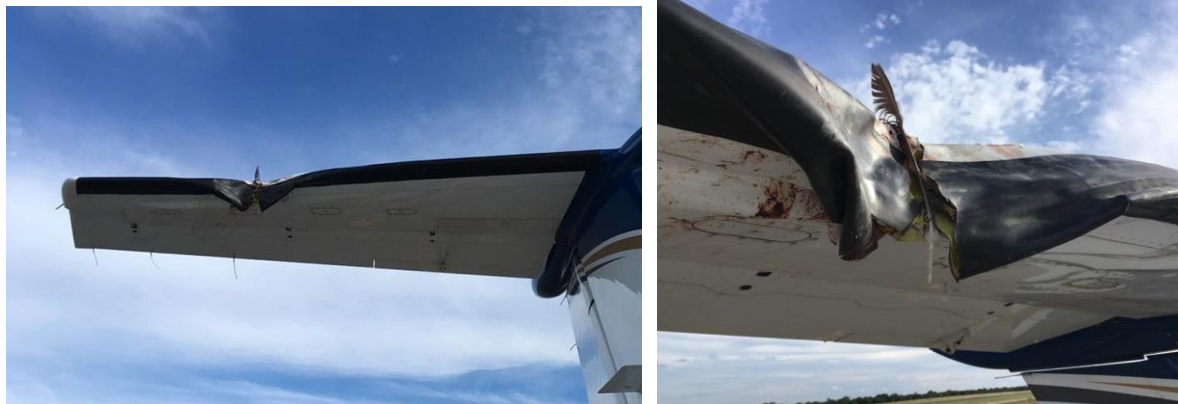
Airplanes occasionally experience leading edge damage. Bird strikes are the most common event, however there are other instances where a leading edge can be damaged by being struck by fuel trucks, ladders, etc. Technical Support often gets calls from operators looking “bird strike damage limits.”

**Horizontal Stabilizer Bird Strike**

You will not find a section in the King Air Maintenance Manuals titled “Bird Strike Damage Limits,” however, there are leading edge dent limits that are called out in the King Air Structural Inspection and Repair Manual under the Aerodynamic Smoothness Requirements section in Chapter 20-10-03 and associated figure 209.

This section provides leading edge limits applying an aerodynamic smoothing material to the affected damaged area if the damage is below the published limits. Any damage that exceeds these limits will have to be repaired by replacing the affected skin or some other form of repair. It is recommended that you contact the Textron Aviation Structures Team for assistance for a factory approved repair procedure for the damage. This team can be contacted at [Structures@txtav.com](mailto:Structures@txtav.com)

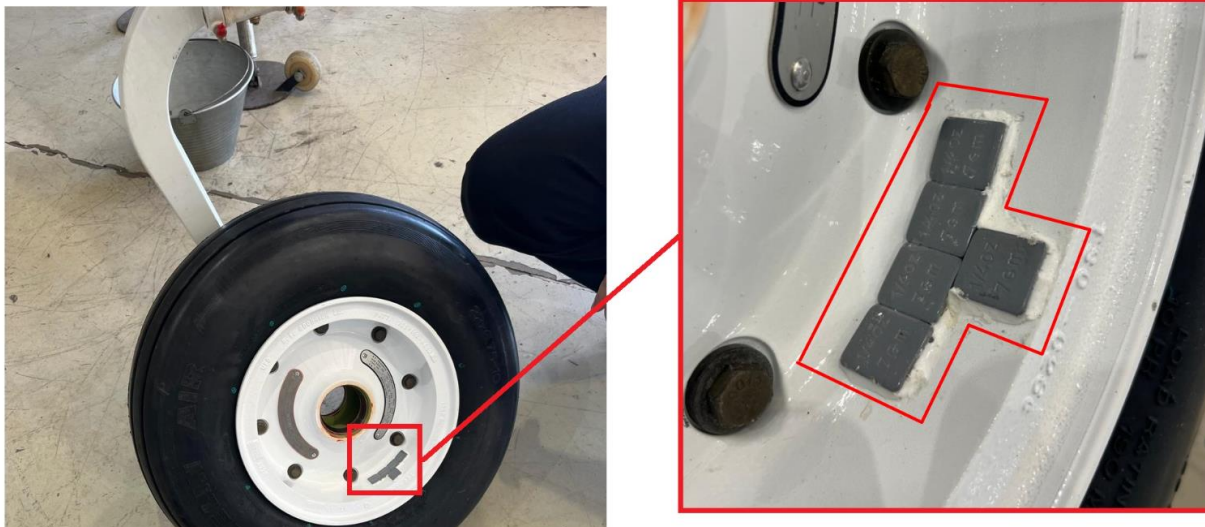
Some operators are receiving nose wheel and tire assemblies from overhaul shops with balance weights bonded to the rim as shown below and have asked if this is acceptable. Textron Aviation has consulted with the manufacturer of the wheels who have declared that using weights of this type is not acceptable and it is NOT an approved method.

The reason provided is that there is the chance that these weights can depart the airplane during normal operation creating a FOD hazard for the airplane or other airplanes operating at the airport.

Refer to the wheel Component Maintenance Manual (CMM) for the approved method to balance the wheel. Please note that there are no published procedures to balance the wheel and tire assembly. The CMM provides the procedures on how to balance the wheel without the tire. The tire must be mounted on the wheel using standard procedures, noting the location of the mark on the tire denoting its heavy point.

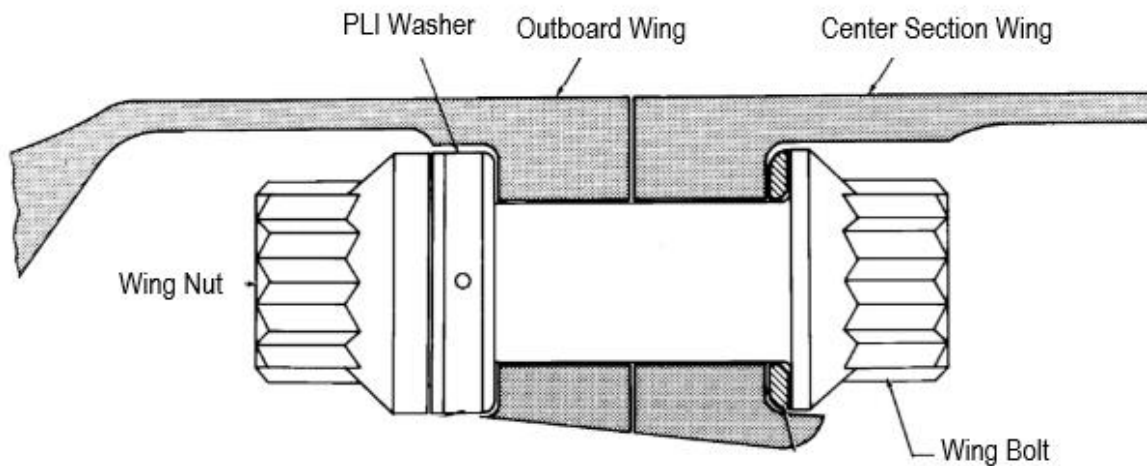
**Lower Forward Wing Fitting Configuration Without Kit Installed  
Figure 1**

Wing fitting and bolt/nut configuration with the bathtub fitting and a wing bolt and regular nut configuration, is an indication that the kit has NOT been incorporated (Figure 1). Wing fitting and bolt/barrel nut configuration is an indication that the kit has been incorporated. See Figure 2. Another thing to notice is that on an airplane where the kit has NOT been incorporated, the Pre-Load Indicating (PLI) washer is installed under the nut; however, on airplanes WITH the kit, the PLI washer is installed under the bolt head.

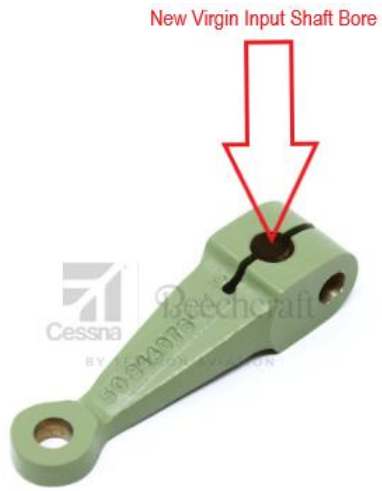
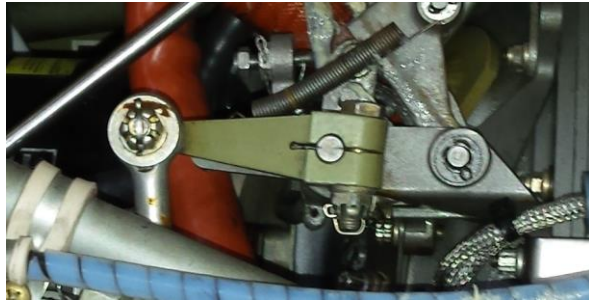
Recently, Technical Support received a report that during a maintenance event the FCU Control Arm (a.k.a. the Beechcraft green arm) serrations were not engaged to the FCU input shaft.

The engine was received from an overhaul facility where a new green arm was installed. The green arm did not have internal serrations to keep the arm securely engaged. The new green arms come from the factory with a virgin input arm bore, see picture below. The internal locking serrations on the green arm are created when the attaching hardware is torqued to the specified torque values of 90-100 In-Lbs.

An improperly installed arm can lead to engine rigging difficulties, or worse case scenario, the green arm may slide off the FCU input shaft during operation.
