BY TEXTRON AVIATION

Multi-Engine Turboprop Communiqué

Communiqué ME-TP-2016-08 Rev 1
Original Issued July 2016
Revision Issue December 2021

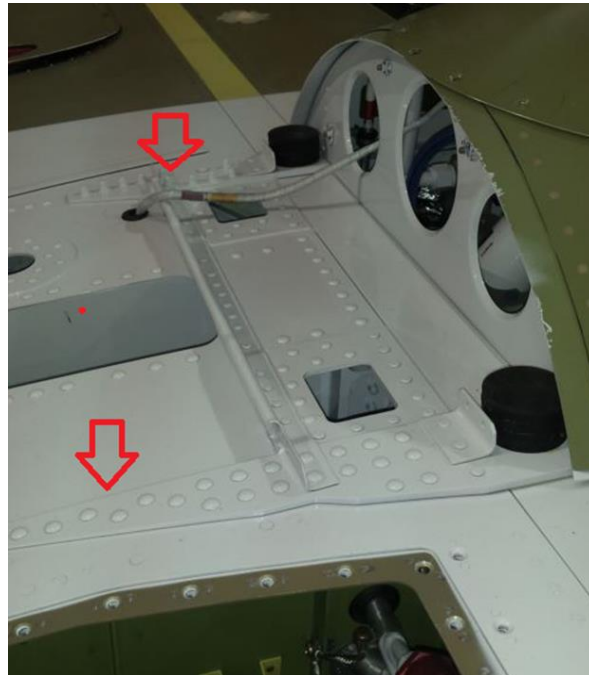
Nacelle Splice Plates

The nacelle splices plates are located under the nacelle turtle back. There are two per side and they run longitudinal. Refer to the illustrations on the following pages. For airplanes without wing lockers, the turtle back should to be removed. As an alternative, the nacelle splice plate edge may be inspected through the main landing gear wheel well. For airplanes with wing lockers, the splice plates are exposed when the lockers are removed. Model 350ER airplanes will have to deal with external fuel tanks, but the intent of the inspection is met by inspecting the edge of the part as seen through the main landing gear wheel well area. This inspection procedure is included in the SIRM

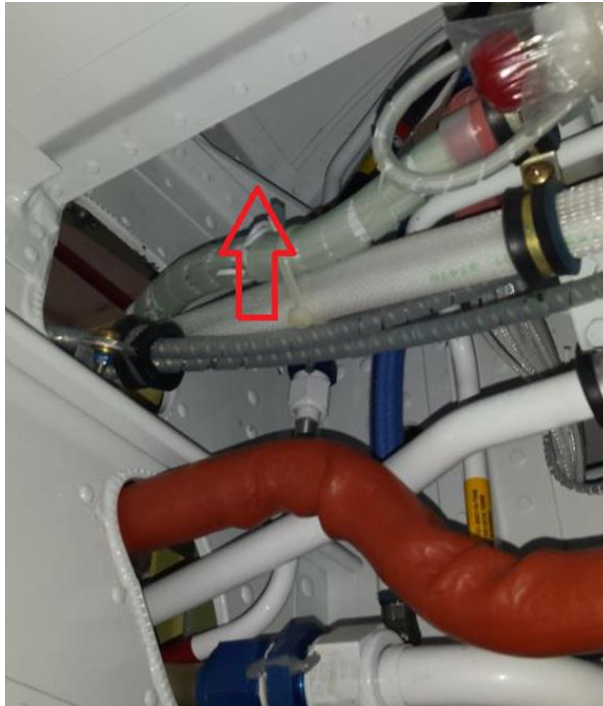
Edge Part Visible thru Wheel Well

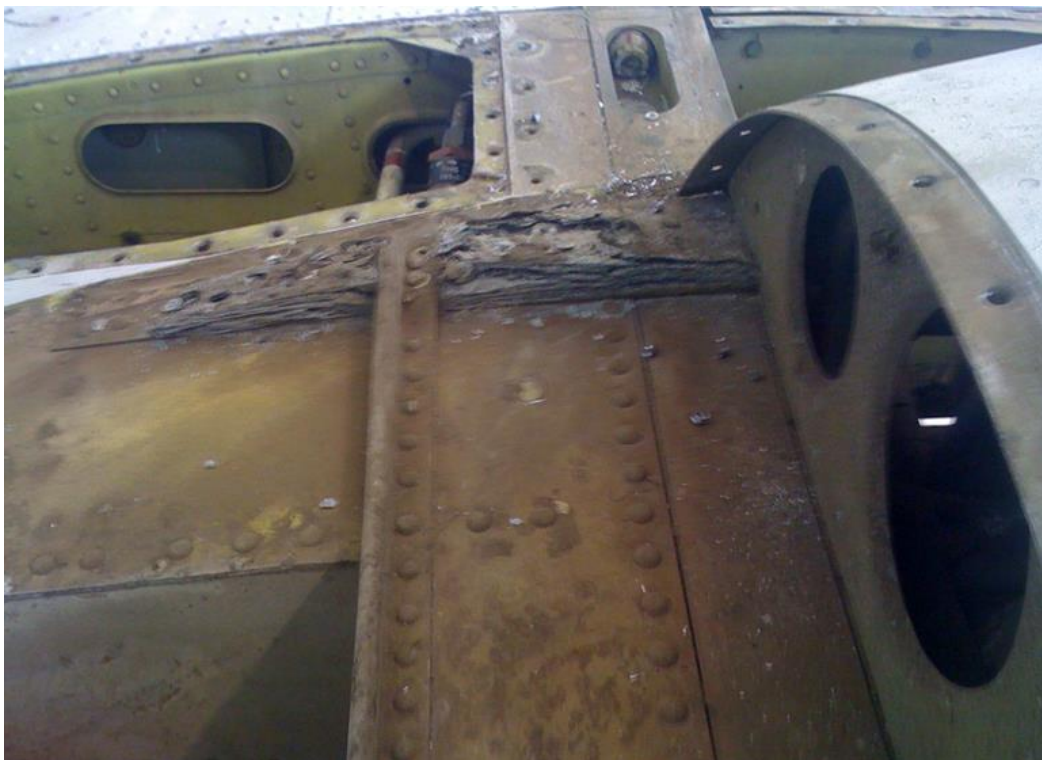
A Severely Corroded Example
