BY TEXTRON AVIATION

Multi-Engine Turboprop Communiqué

Communiqué ME-TP-0036
May 2024

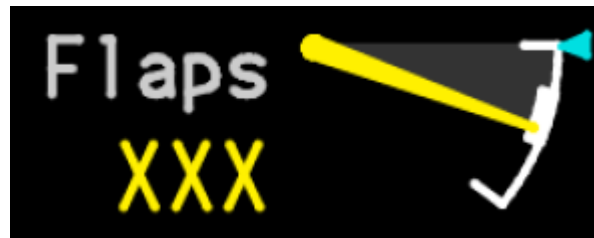
Position Mis-compare or Asymmetric Flaps

If there is a mis-compare of the handle position and the flap or if a flap asymmetry is detected, then the flap pointer will turn yellow, and a yellow XXX will appear.

Possible faults are the flaps are physically not in the correct angle range for the selected position, the 3 discrete inputs for handle position are valid but incorrect or the RH RVDT data is not correctly showing the angle of the flap.

For troubleshooting it is recommended to utilize the MFD's capabilities to view the RVDT signals and the handle and asymmetry switches discrete inputs directly.

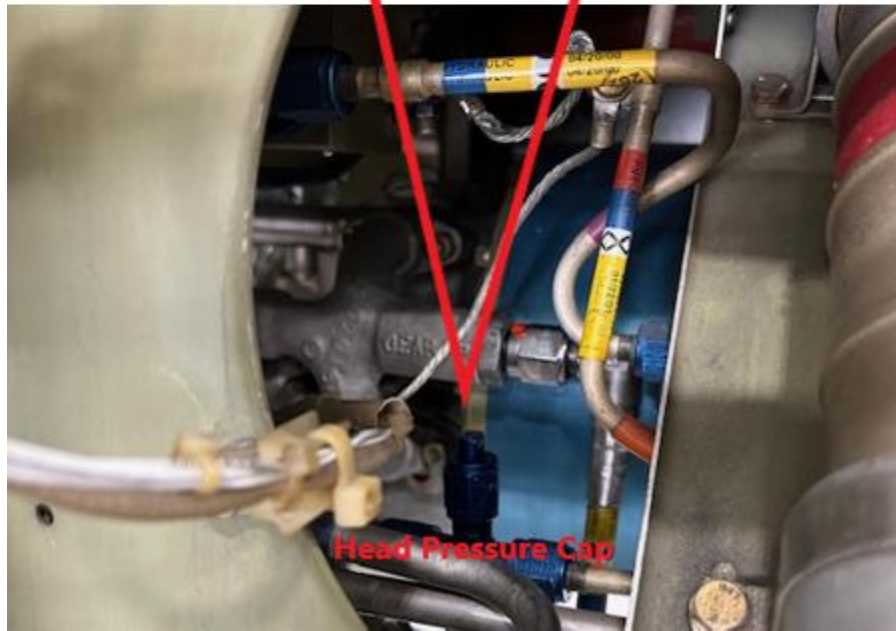
1. Cap for the Line to the Reservoir

Picture 1 below shows where to connect air pressure to the line to the reservoir to apply the head pressure, however this line is very difficult to get to without removing the leading edge. Picture 2 show the area with the leading edge removed allowing easier access to this line.

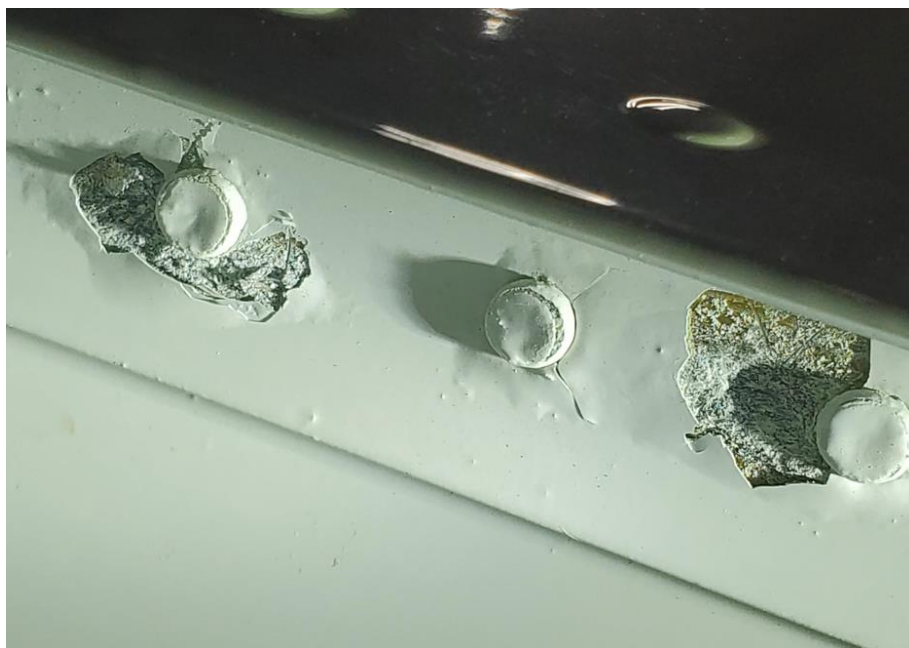
Angle Corrosion Example

The pictures below show what is typically being found on the vertical stabilizer spar. In the same area, corrosion on the rudder hinge plates and associated hardware has also been found. Some of this corrosion is sufficient enough that the affected components have to be replaced.

The replacement of the vertical stabilizer spar angles requires the stabilizer assembly to be supported to prevent any shifting of the structure. Questions have been asked as to how to support the assembly. The picture below is one example on how the assembly can be supported. The part numbers of the two angles are 101-640010-9 for the RH and -10 for the LH. The hardware used for the installation of the angles is combination of:

It is recommended that you take note of the fasteners installed before they are removed.
