INDICATING/RECORDING SYSTEMS - COCKPIT OVERHEAD DIMMING POTENTIOMETER REPLACEMENT

The 22M185 Dimming Potentiometer in the cockpit overhead is obsolete.

MTB-31-04
Page 1 of 6

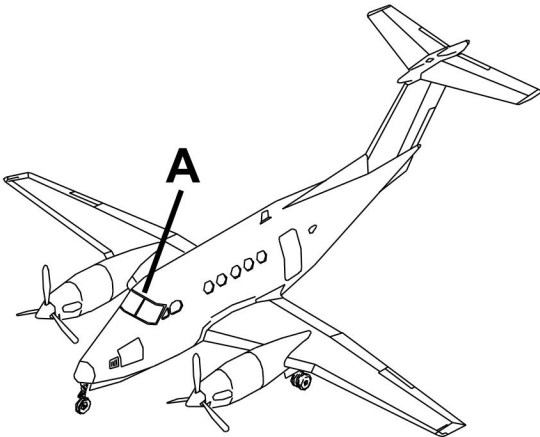
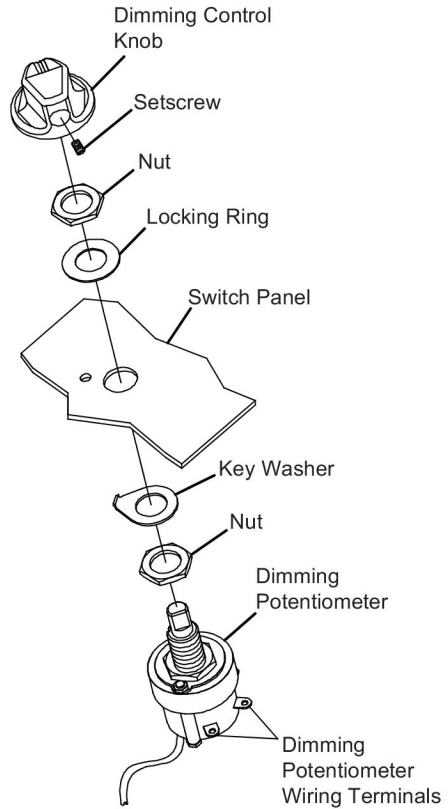
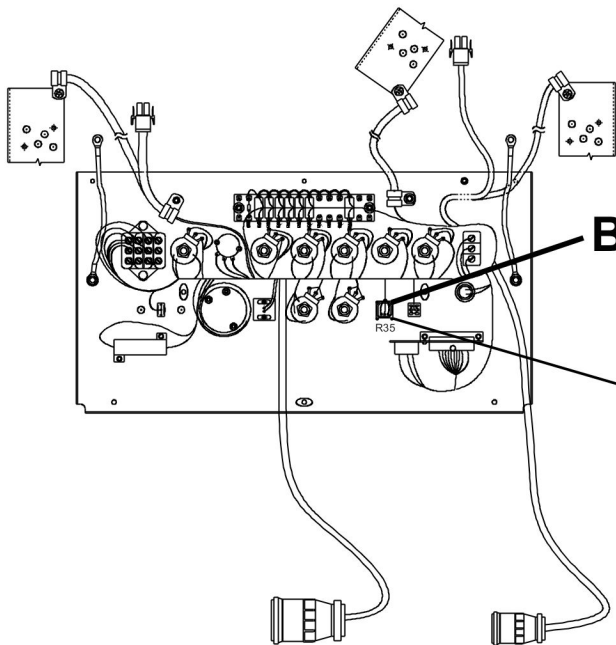
Figure 1. Dim Potentiometer Installation (Sheet 1)

- 22M185 Dimming Potentiometer (R35) (Discard)
- L11756 Dimming Potentiometer (R35) (1 Required)

NOTE: The model shown is a B200, yet the location of the dim potentiometer is the same for all models.

2. (Refer to Figure 1, Sheet 1.) Remove and retain the setscrew from the dimming control knob.
 - A. Keep the dimming control knob.
3. Remove the nut and the locking ring that attach the 22M185 Dimming Potentiometer to the overhead panel assembly.

4. Remove and keep all screws and knobs from the overhead electroluminescent panel assembly.
5. Remove and keep the electroluminescent panel assembly.
6. Remove the screws that attach the overhead instrument panel assembly to the overhead panel assembly.

- A. Keep the screws and overhead electroluminescent panel assembly.
7. Disconnect the 22M185 Dimming Potentiometer from the wire bundle assembly as follows:

- B. Use a soldering iron to disconnect the wires from the dimming potentiometer terminals.
8. Remove the nut and the key washer from the 22M185 Dimming Potentiometer.
9. Remove and discard the 22M185 Dimming Potentiometer from the airplane.
10. (Refer to Figure 1, Sheet 2.) Do the wiring changes as follows:
 - A. Install one M81824/1-2 Splice on the J13-21-R35SP1-20 Electrical Wire and the J13-22-R35SP1-20 Electrical Wire. (Refer to the King Air Standard Practice Chapter 20 – Airframe, Electrical Wiring – Maintenance Practices).
 - B. Using a heat gun, install the 106242G44 Heat Shrink Tubing over the electrical wires.
11. Connect the new L11756 Dimming Potentiometer to the wire bundle assembly as follows:
 - A. Identify the wires and the terminals on the dimming potentiometer.

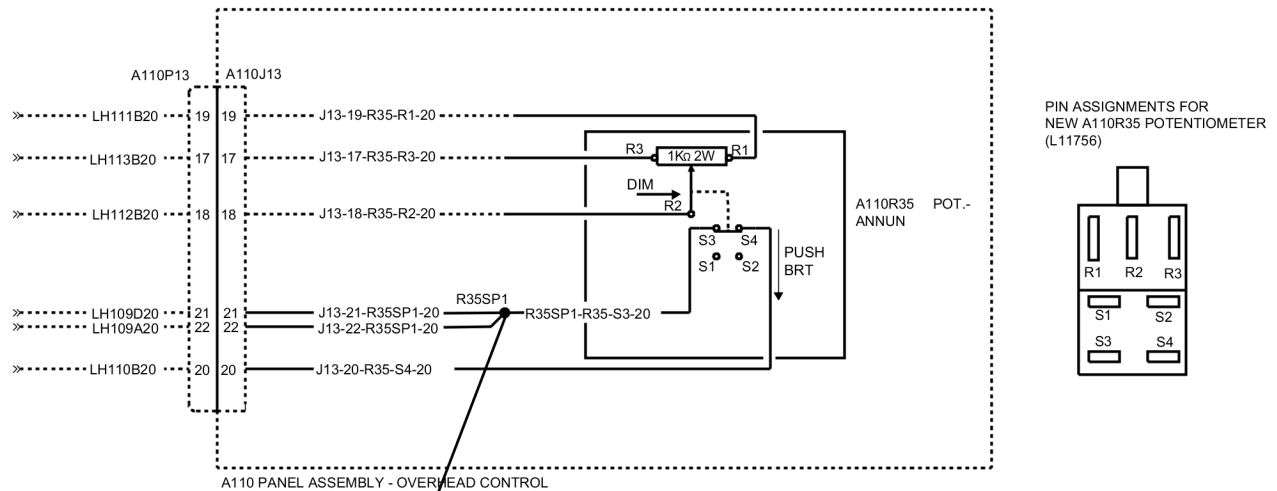
After Modification

M81824/1-2
 Splice
 (1 Required)
