## **SERVICE BULLETIN**

MANDATORY MTB-44-01

CABIN SYSTEMS - AVANCE L3 SYSTEM WIRING MODIFICATION TO PREVENT TCAS FAIL MESSAGE

Super King Air B300

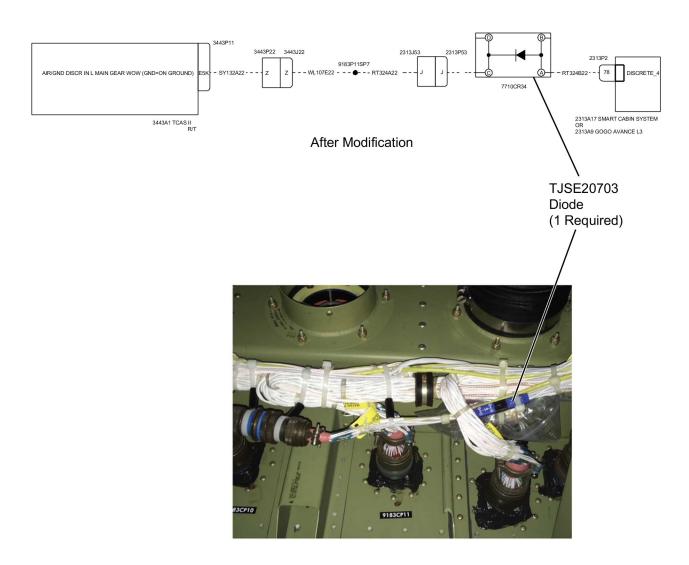
Figure 1. Diode Installation (Sheet 1)

### **Before Modification**

- 3. Do the wiring modification.
  - A. (Refer to Figure 1.) Cut the RT324B22 Wire.
  - B. Install the TJSE20709 Diode on the RT324B22 Wire. (Refer to the King Air Standard Practice Chapter 20 Airframe, Electrical Wiring Maintenance Practices).
