AIR CONDITIONING - ELECTRIC HEATER THERMAL FUSE REPLACEMENT

B200GT	BY-397, BY-399		
B300	FL-1255, FL-1256, FL-1259 thru FL-1261		
B300C	FM-98

MTL-21-02
November 10, 2021	Page 1 of 4

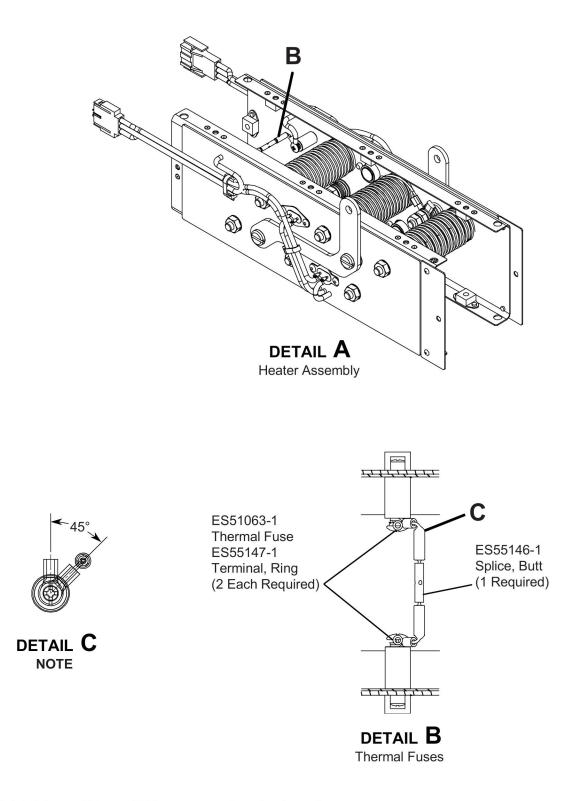
Figure 1. Thermal Fuse Installation (Sheet 1)

Incorrect value of the thermal fuse installed in the heater assembly. The fuses that were installed will open at a lower temperature than designed and the heater will stop working even though working within the designed temperature range.

NOTE: Rotate Thermal Fuses 45-Degree away from heater coils.
