INDICATING/RECORDING SYSTEMS - COLLINS ENVIRONMENTAL CONTROLLER (IEC) AND POWER SUPPLY (PWR) IAPS MODULES INSPECTION/REPLACEMENT

<b>MODEL</b>	<b>SERIAL NUMBERS</b>
Super King Air B200GT	BY-426, BY-428 thru BY-433
Super King Air B200CGT	BZ-6, BZ-7
Super King Air B300	FL-1290, FL-1291, FL-1293 thru FL-1297
Super King Air B300C	FM-106, FM-107

MTL-31-01  
Page 1 of 3

**SUBJECT:** INDICATING AND RECORDING SYSTEM - IEC-X00X - REPLACEMENT OF LOW RELIABILITY TRANSISTORS

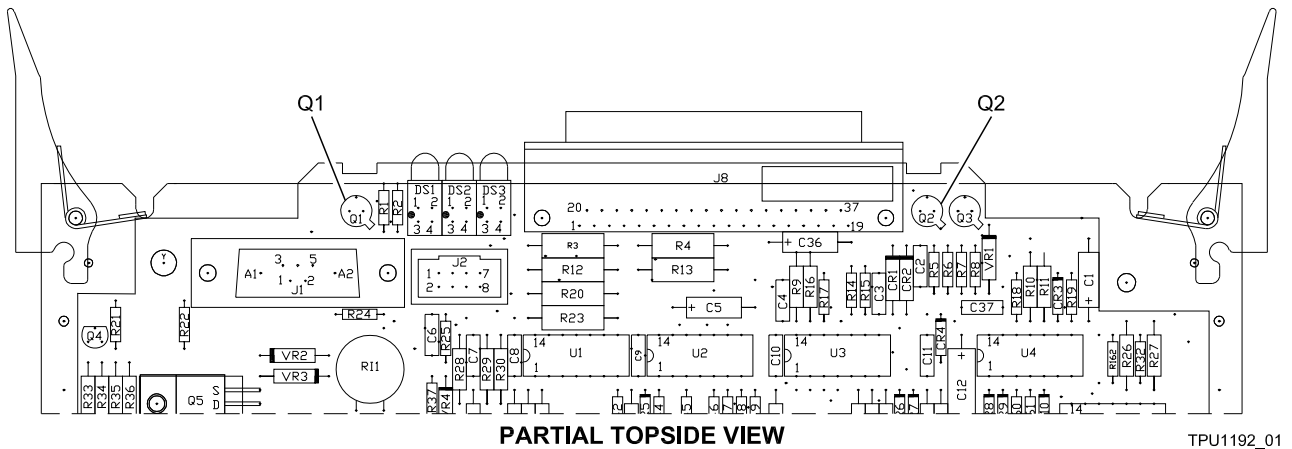
Transistor Q1 and Q2 Location Diagram  
Figure 1

Transistors may fail resulting in loss of IAPS power.

- (2) Refer to Figure 1, locate transistor Q1 and Q2 on the IEC-3001 Environmental Control Card A1, CPN 687-0894-001.

- (3) If either transistor Q1 or Q2 has a date code of 2119, or is not visible, continue to Step 3.A.(3)(a). If the date code on both transistor Q1 and Q2 is not 2119, proceed to Step 3.A.(4).

- (a) Remove conformal coat from around component(s) to be replaced in accordance with the General Repair Procedures in the referenced CMMPL.
- (b) Locate, remove, and discard transistors Q1 and/or Q2. Install new transistors Q1 and/or Q2, CPN 352-0551-010. Ensure the new transistor, CPN 352-0551-010, does not have a date code of 2119.

- NOTE:** Only replace resistors Q1 and/or Q2 if it has a date code of 2119, or if the date code is not able to be read. If only one (1) component has the date code of 2119, only the affected component needs to be replaced.

- (c) Reapply conformal coat in accordance with the Repair Procedures in the referenced CMMPL around replaced component(s).
- (4) If MOD chart is not already on the circuit card, cut the word MOD and seven (7) squares from MOD chart, CPN 280-3778-050. Remove protective backing, then apply MOD chart to circuit card.

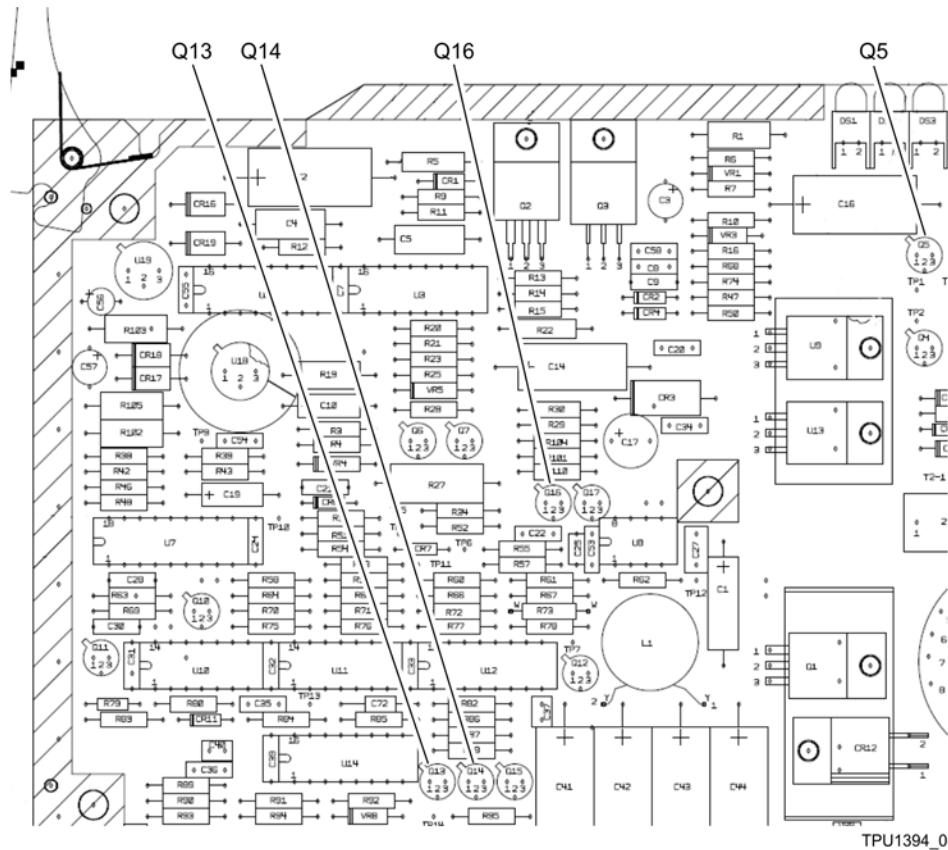
PWR-3000 or PWR-4000, Power Supply Circuit Card A1, CPN 687-0896-001, Component Location Diagram  
Figure 1

Transistors may fail resulting in loss of Integrated Avionics Processing System (IAPS) power.

- (2) Using Figure 1, locate transistors Q5, Q13, Q14, Q16 on the PWR-3000 or PWR-4000 Power Supply Circuit Card A1, CPN 687-0896-001.

- (3) Refer to Figure 1. If transistors Q5, Q13, Q14, or Q16 have a date code of 2119 or is not visible, proceed to Step 3.A.(3)(a). If the date code on transistors Q5, Q13, Q14, and Q16 is not 2119, proceed to Step 3.A.(4).
- (a) Remove conformal coat from around component(s) to be replaced in accordance with the General Repair Procedures in the referenced CMMPL.
  - (b) Locate, remove, and discard any 2119 date coded transistors amongst transistors Q5, Q13, Q14, Q16. Replace any removed 2119 date coded transistors with new non-2119 date coded transistors, CPN 351-0551-010.

**NOTE:** Only replace 2119 date coded transistors, or if the date code is not able to be read. If only one (1) component has the date code of 2119, only the affected component needs to be replaced.

- (c) Reapply conformal coat in accordance with the Repair Procedures in the referenced CMMPL around replaced component(s).
- (4) If MOD chart is not already on the circuit card, cut the word MOD and 10 squares from MOD chart, CPN 280-3778-050. Remove protective backing, then apply MOD chart to circuit card.
- (5) Use permanent ink to mark SB B on the MOD chart.
- (6) Reassemble the unit in accordance with the assembly instructions in the Assembly section of the referenced CMMPL.
