NAVIGATION - GPS-4000S GLOBAL POSITIONING SYSTEM SOFTWARE UPDATE

MTL-34-01
Page 1 of 3

**NO SUPPORT TO PERFORM LOCALIZER PERFORMANCE WITH VERTICAL (LPV)
AND REQUIRED NAVIGATION PERFORMANCE (RNP) LESS THAN 0.3 NAUTICAL
MILE APPROACHES OVER ALASKA**

NAVIGATION - GPS-4X00() - SOFTWARE UPDATE FOR UNIVERSAL TIME COORDINATED (UTC) TIME OFFSET AND GNSS POSITION NEAR 180 DEGREES WEST LONGITUDE (CONVERTS BLACK LABEL CPN 822-2189-100 TO BLACK LABEL CPN 822-2189-101)

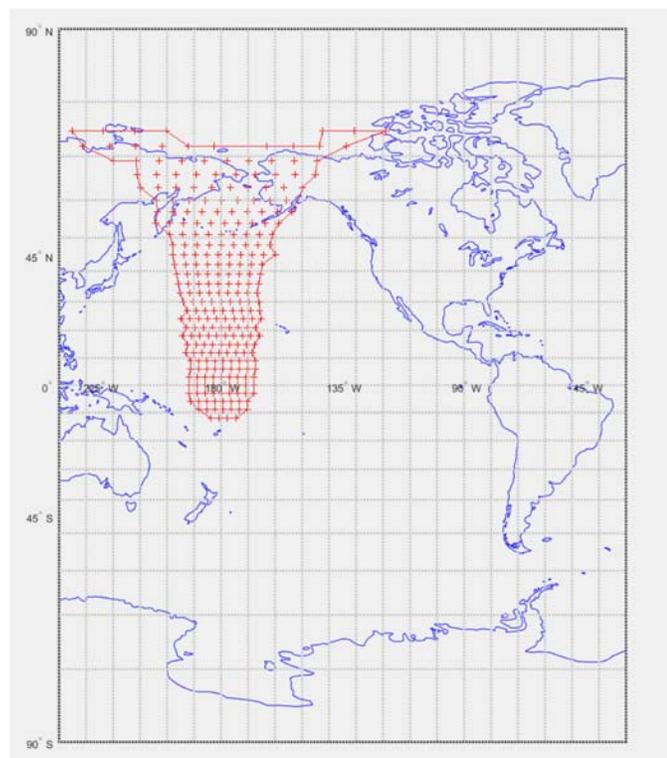
Map
Figure 1

- (1) The Root Cause has been identified as an improper implementation in the computation of the longitude at which the GPS signal penetrates the ionosphere when the satellite is located across 180 degrees W Longitude.
- (2) The affected region is limited to the area within the solid red line boundary indicated in the attached map. The region extends 20 degrees on either side of 180 degrees W Longitude and extends from the Northern Hemisphere to 10 degrees Latitude in the Southern Hemisphere. Refer to Figure 1.

- (3) The potential reduction in position accuracy caused by the computational issue prevents the GPS-4000S, CPN 822-2189-100, from supporting LPV approaches at LPV-equipped airports in the affected region.
- (4) Un-announced, but bounded reduced positional accuracy in the affected region limits operations to RNP 0.3 NM, or higher (Positional error will be bounded to 0.3 NM but may not be bounded by the protection level (HPL) that is output by the GNSS).

- (1) A software update that corrects this issue is targeted to be available in Q1 2020.
- (2) Until that software update is available, operational limitations will need to be applied. The operational limits are:
 - (a) Do not use the GPS-4000S, CPN 822-2189-100, to perform LPV approaches at airports in Alaska listed below. There are no airports outside of Alaska that are in the affected region that support LPV approaches at the time of this SIL publication. LPV-equipped airports will be monitored on every database update and if additional LPV-equipped airports are identified, this SIL will be updated.
 - (b) Do not perform operations that require an accuracy better than RNP 0.3 NM (For example, 0.1, 0.11, 0.15, etc.) in the region identified in the above map (+/- 20 degrees of 180 degrees W Longitude) or at the airports in Alaska listed below.
