MANDATORY**MTL-34-01****TITLE**

NAVIGATION - GPS-4000S GLOBAL POSITIONING SYSTEM SOFTWARE UPDATE

MTL-34-01

NAVIGATION - GPS-4X00() - SOFTWARE UPDATE FOR UNIVERSAL TIME COORDINATED
(UTC) TIME OFFSET AND GNSS POSITION NEAR 180 DEGREES WEST LONGITUDE
(CONVERTS BLACK LABEL CPN 822-2189-100 TO BLACK LABEL CPN 822-2189-101)

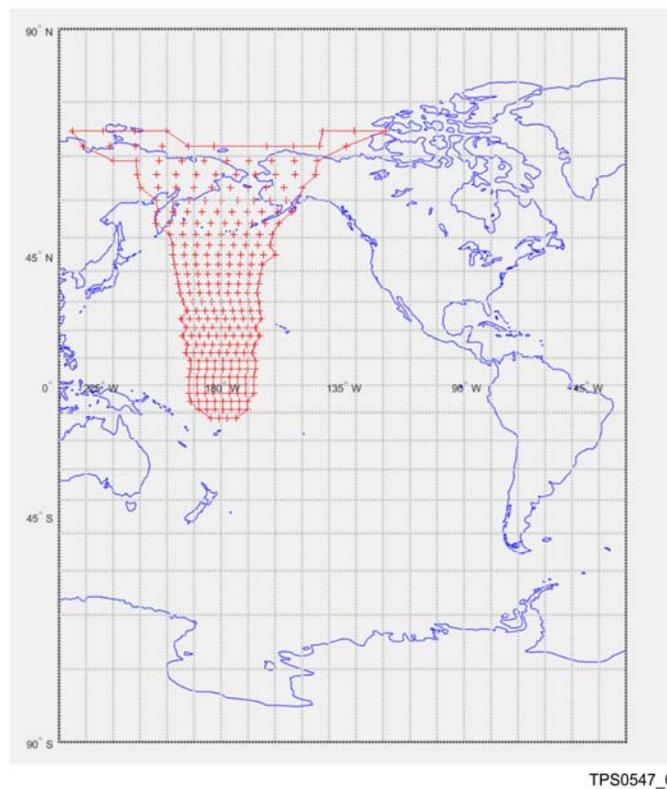
Map
Figure 1

- (1) The Root Cause has been identified as an improper implementation in the computation of the longitude at which the GPS signal penetrates the ionosphere when the satellite is located across 180 degrees W Longitude.
- (2) The affected region is limited to the area within the solid red line boundary indicated in the attached map. The region extends 20 degrees on either side of 180 degrees W Longitude and extends from the Northern Hemisphere to 10 degrees Latitude in the Southern Hemisphere. Refer to Figure 1.

- (3) The potential reduction in position accuracy caused by the computational issue prevents the GPS-4000S, CPN 822-2189-100, from supporting LPV approaches at LPV-equipped airports in the affected region.
- (4) Un-announced, but bounded reduced positional accuracy in the affected region limits operations to RNP 0.3 NM, or higher (Positional error will be bounded to 0.3 NM but may not be bounded by the protection level (HPL) that is output by the GNSS).

- (1) A software update that corrects this issue is targeted to be available in Q1 2020.
- (2) Until that software update is available, operational limitations will need to be applied. The operational limits are:
 - (a) Do not use the GPS-4000S, CPN 822-2189-100, to perform LPV approaches at airports in Alaska listed below. There are no airports outside of Alaska that are in the affected region that support LPV approaches at the time of this SIL publication. LPV-equipped airports will be monitored on every database update and if additional LPV-equipped airports are identified, this SIL will be updated.
 - (b) Do not perform operations that require an accuracy better than RNP 0.3 NM (For example, 0.1, 0.11, 0.15, etc.) in the region identified in the above map (+/- 20 degrees of 180 degrees W Longitude) or at the airports in Alaska listed below.
