NAVIGATION - TRANSMITTAL OF COLLINS AEROSPACE SERVICE BULLETIN ATL-4000-34-D,
NAVIGATION - ALT-4000 - EVALUATION OF SURFACE MOUNT FERRITE BEAD USED ON THE POWER
SUPPLY

MTL-34-03
Page 1 of 3

SUBJECT: NAVIGATION - ALT-4000 - EVALUATION OF SURFACE MOUNT FERRITE BEAD USED ON THE POWER SUPPLY (SUPERSEDES ALT-4000-34-C, 523-0831894)

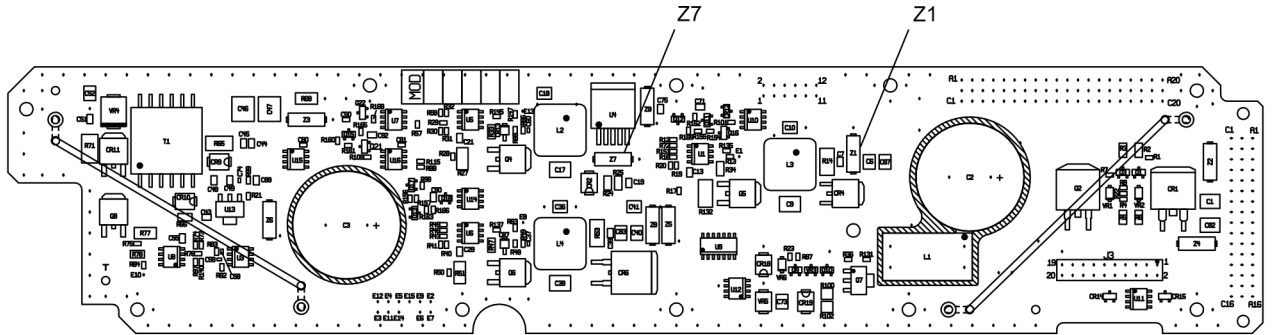
TPS6445_16

Remove and replace two (2) surface mount ferrite beads on the power supply circuit card assembly.

Power Supply Circuit Card A2A4, CPN 828-2633-007, Component Location Diagram
Figure 1

- (1) Remove outer cover from the unit. Retain both the cover and the screws removed from the cover.
 - (a) Locate, remove, discard, and replace surface mount ferrite bead A2A4Z1 and A2A4Z7, CPN 852-3002-030, on the Power Supply Circuit Card A2A4, CPN 828-2633-007. Refer to Figure 1.

- a. Power OFF the UUT using the respective ALT-1000 or ALT-4000 Test Panel.
- b. Replace ferrite bead A2A4 Z1 and Z7 CPN 852-3002-030 on the Power Supply Circuit Card Assembly 828-2633-007.
 - Refer to Figure 1 for the location of Z1 and Z7.
- c. On completion of bead replacement repeat test starting with Step 3.A.(4)(b)5..

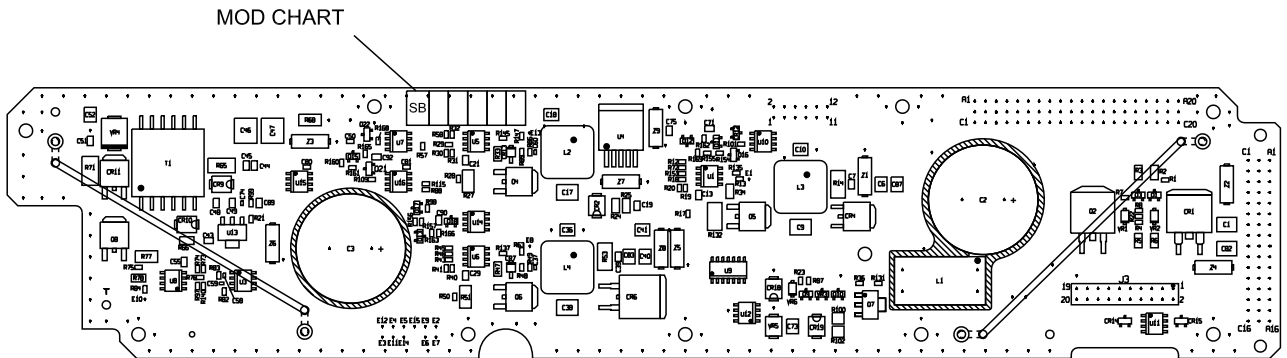
TPS6445_04

Power Supply Circuit Card A2A4, CPN 828-2633-007, MOD Chart Location Diagram
Figure 2

- (b) Refer to Figure 2. If MOD Chart, CPN 280-3778-110, is not already on the Power Supply Circuit Card A2A4, CPN 828-2633-007, then remove protective backing from MOD Chart, CPN 280-3778-110, and apply to circuit card in approximate location shown in Figure 2.

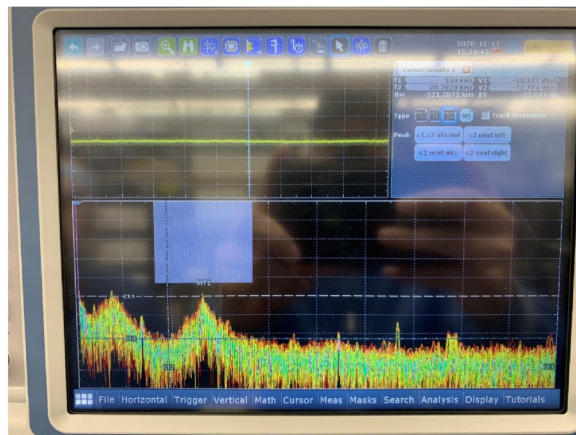
TPS6445_14

Successful Test Indication
Figure 10

- a. If the MASK remains GREY during the observation period, the unit PASSES.
- b. If the MASK remains PINK or RED during the observation period, the unit FAILS.
- c. If the MASK alternates from GREY to PINK or GREY to RED during the observation period, the unit FAILS.

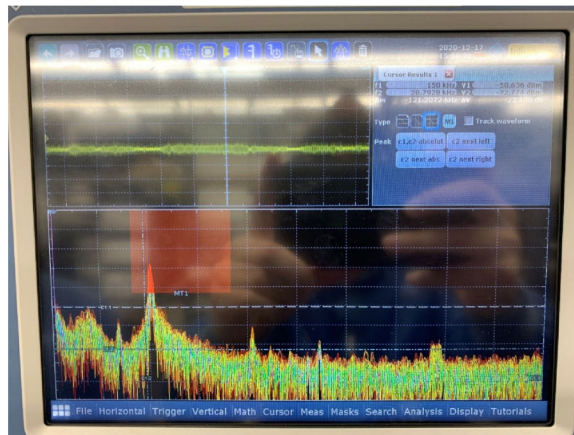
TPS6445_15

Failed Test Indication
Figure 11
