NAVIGATION - TRANSMITTAL OF COLLINS AEROSPACE SERVICE BULLETIN ALT-4000-34-14,
NAVIGATION - ALT 4000 POWER SUPPLY ROBUSTNESS IMPROVEMENT

SUBJECT: NAVIGATION - ALT-4000 - POWER SUPPLY ROBUSTNESS IMPROVEMENT

This is the initial release of Service Bulletin (SB) ALT-4000-34-14 for the ALT-1000 and ALT-4000 Radio Altimeter Transceiver.

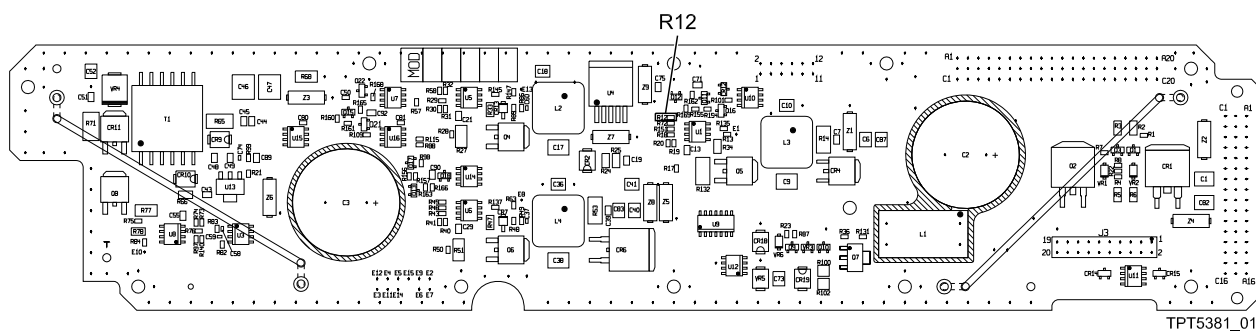
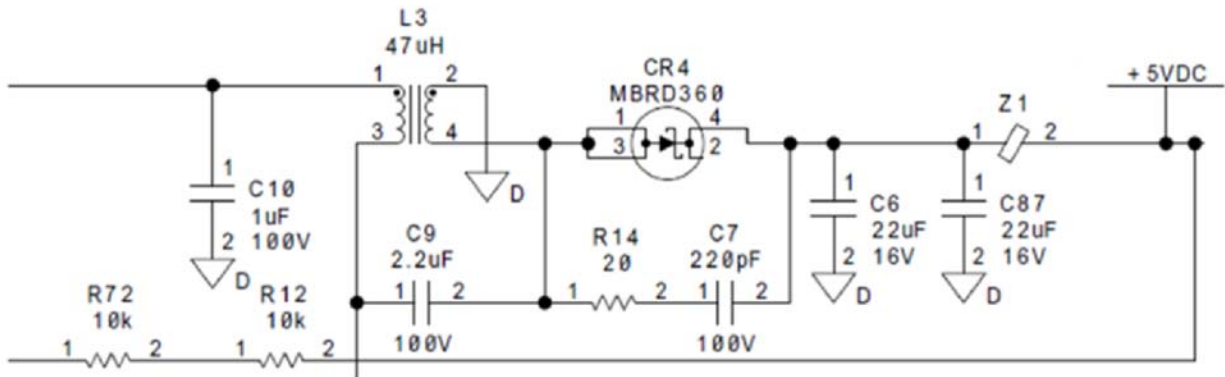
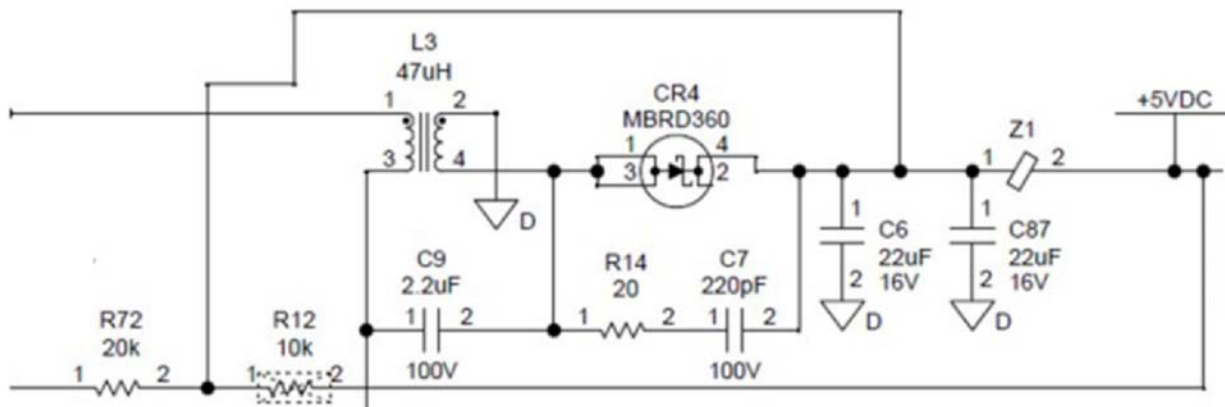
Power Supply Circuit Card A2A4, CPN 828-2633-007, Resistor R12, Component Location Diagram
Figure 1 (Sheet 1 of 2)

Certain Radio Altimeters are exhibiting erroneous altitude indications of approximately 1400 feet during flight above 2600 feet instead of No Computed Data (NCD) indication. This results in a nuisance radio altitude being displayed. The indications may be prolonged or momentary.

- (2) Locate, remove, and discard 10 Kilo Ohm (KOhm) resistor R12, CPN 705-2438-440, as shown in Figure 1.
