PNEUMATIC - ENGINE FLOW PACK T-FITTING INSPECTION

MODEL	SERIAL NUMBERS
B300C	FM-66, FM-67, FM-71, FM-73, FM-74, FM-76, FM-78, FM-79, FM-82, FM-84, FM-85, FM-86, FM-90, FM-91
B300	FL-1080, FL-1083, FL-1112, FL-1114, FL-1118, FL-1120, FL-1157, FL-1164, FL-1167, FL-1190, FL-1191, FL-1192, FL-1198, FL-1221, FL-1225, FL-1232

MTL-36-01
Page 1 of 6

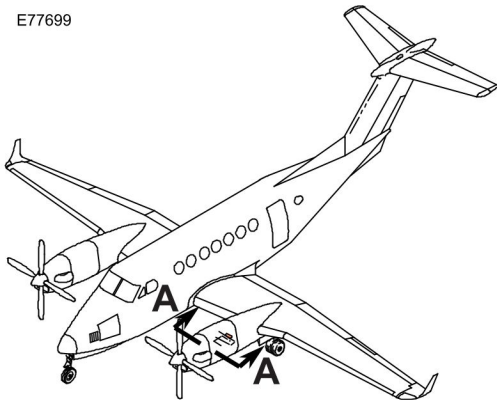
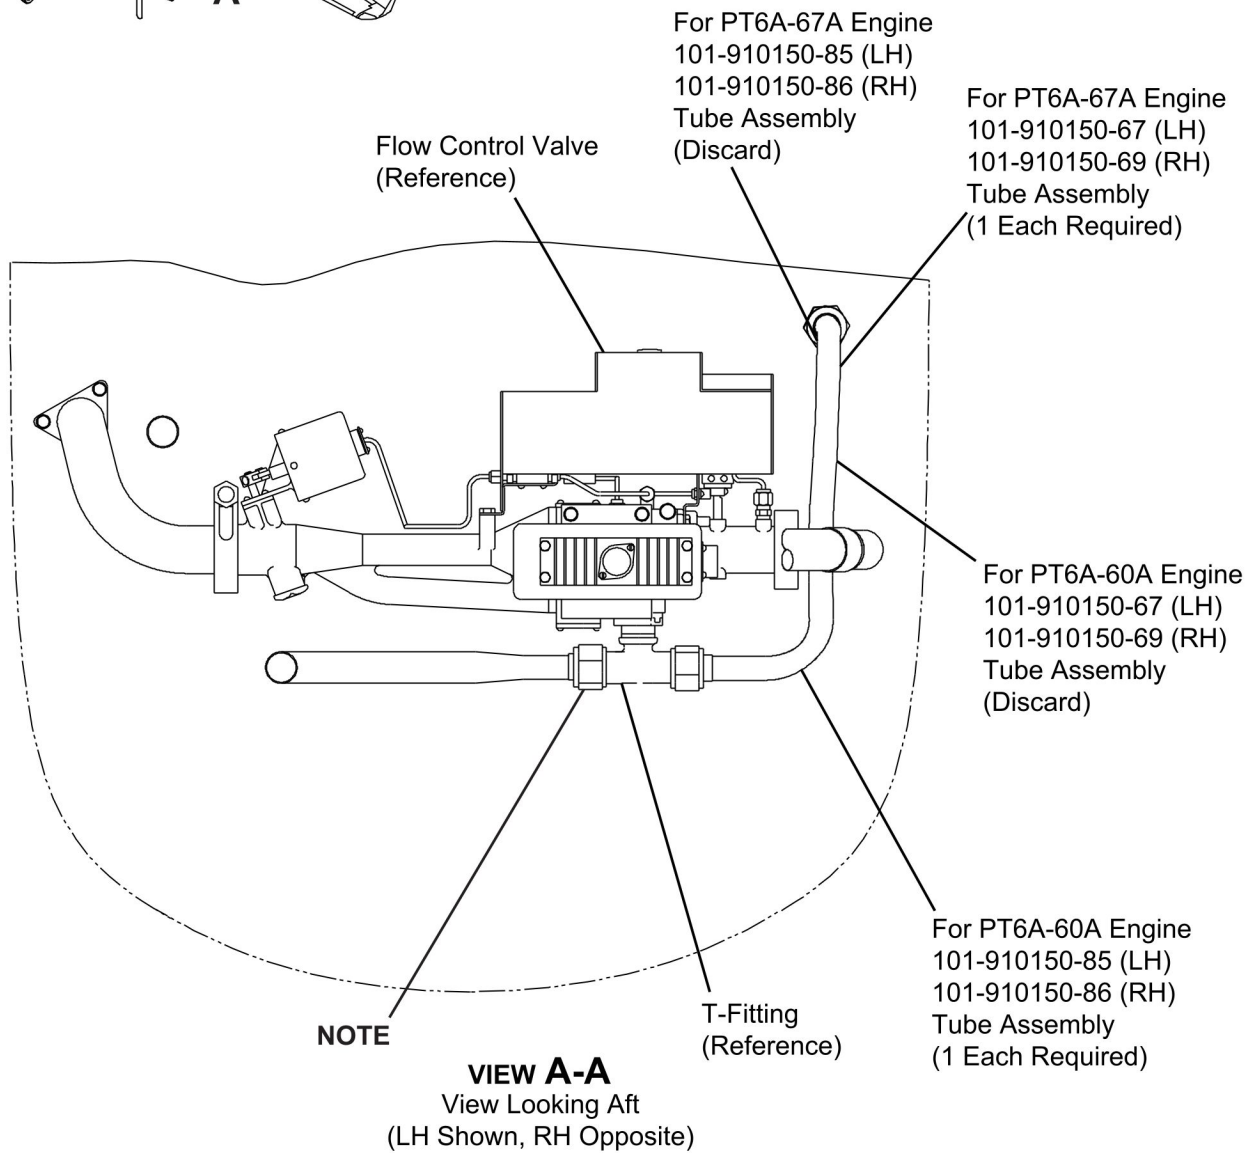
Figure 1. Engine Bleed Air System Tube Assembly Replacement (Sheet 1)

The T-fitting on the left and right engine bleed air system flow pack may not have been installed properly, thus causing engine bleed air to leak into the left and right cowlings.

4. (Refer to Figure 1, Sheet 1 and 2.) For airplanes fitted with PT6A-67A engine, do an inspection of the LH engine bleed air system tube assembly.
 - A. If 101-910150-67 Tube Assembly is installed, go to Step 6.

NOTE: The heat shield is not shown for clarity.

- (1) Remove and keep the heat shield that surrounds the T-Fitting.

- (2) Disconnect both ends of the 101-910150-85 Tube Assembly from the bulkhead union and T-fitting.
 - (a) Remove and discard the 101-910150-85 Tube Assembly.

- (3) Tighten the T-Fitting. (Refer to the Beechcraft King Air Standard Practices Manual, Chapter 20, Tubing, Hose and Fittings - Maintenance Practices.)

- (4) Insulate the 101-910150-67 Tube Assembly with BS272-HH Fiberglass Insulation and wrap with 002X3W Aluminum Foil Tape.
 - (5) Connect new 101-910150-67 Tube Assembly to the bulkhead union and T-fitting.

- (a) Torque the nuts at both ends. (Refer to the Beechcraft King Air Standard Practices Manual, Chapter 20, Torque Application - Maintenance Practices.)

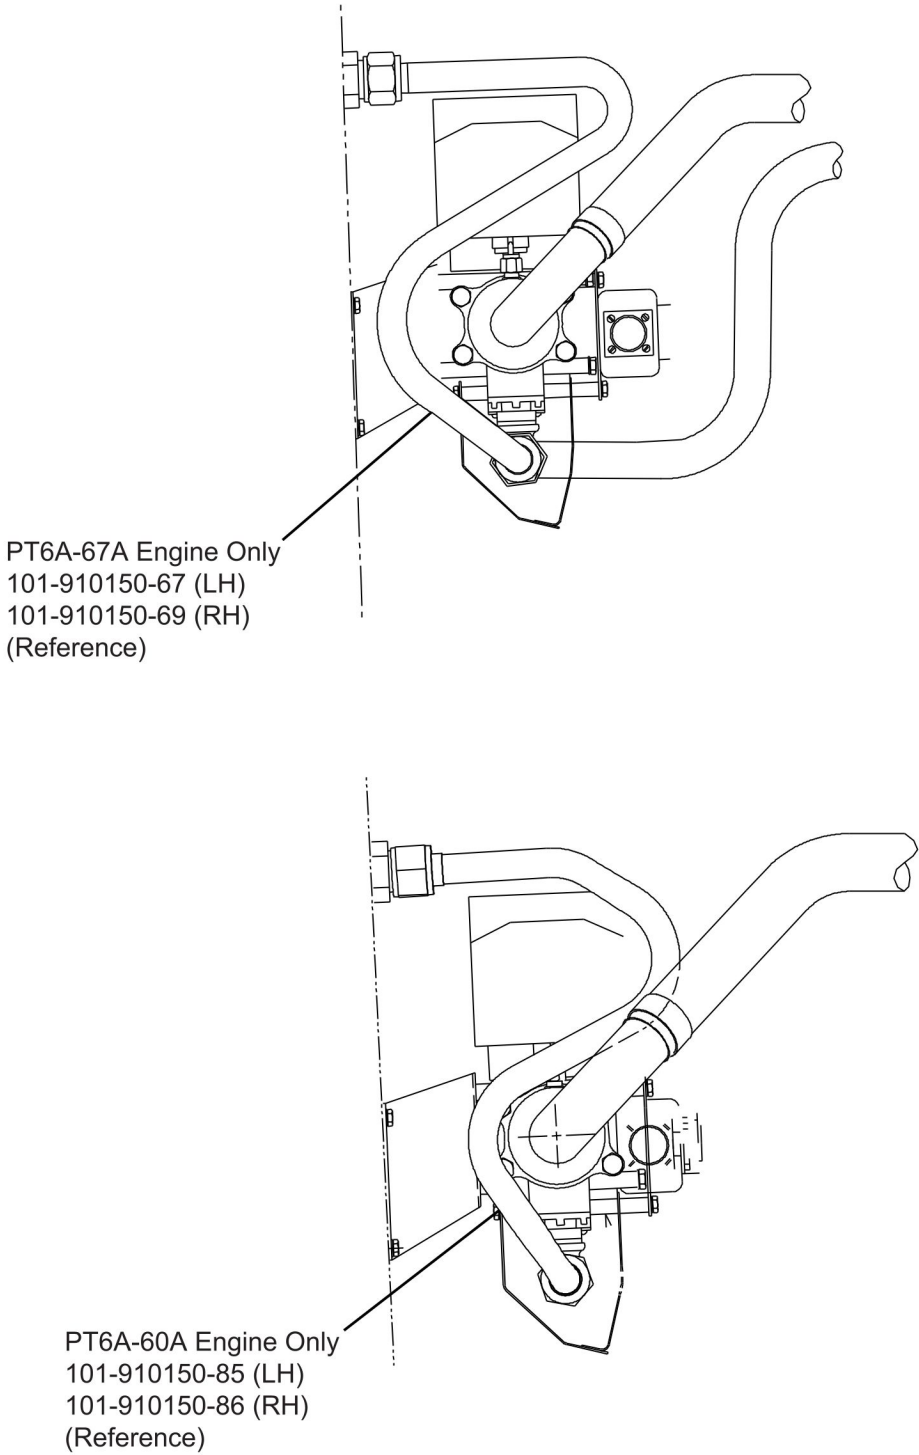
Figure 1. Engine Bleed Air System Tube Assembly Replacement (Sheet 2)

- (6) Go to Step 6.
5. (Refer to Figure 1, Sheet 1 and 2.) For airplanes fitted with PT6A-60A engine, do an inspection of the LH engine bleed air system tube assembly.

- (1) Remove and keep the heat shield that surrounds the T-Fitting.
 - (2) Disconnect both ends of the 101-910150-67 Tube assembly from the bulkhead union and T-fitting.

- (a) Remove and discard the 101-910150-67 Tube Assembly.
 - (3) Tighten the T-Fitting. (Refer to the Beechcraft King Air Standard Practices Manual, Chapter 20, Tubing, Hose and Fittings - Maintenance Practices.)

- (4) Connect new 101-910150-85 Tube Assembly to the bulkhead union and T-fitting.
 - (a) Torque the nut at both ends. (Refer to the Beechcraft King Air Standard Practices Manual, Chapter 20, Torque Application - Maintenance Practices.)
