SERVICE LETTER

MTL-36-02

PNEUMATIC - FLOW CONTROL VALVE INSULATION INSPECTION

Insulation and foil tape on the left and right flow control valves could be missing.

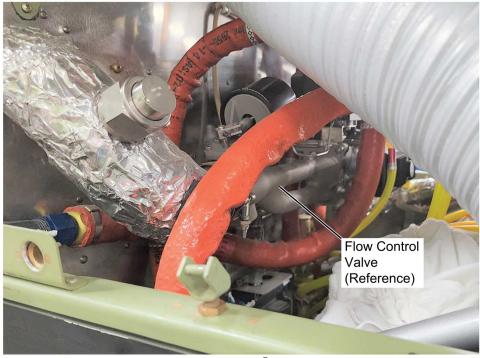
DETAIL A

Before Insulation Installation View Looking Outboard at Left Engine (Model 200GT Shown)

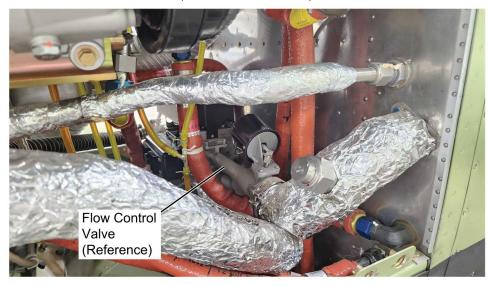
DETAIL A

Before Insulation Installation View Looking Outboard at Right Engine (Model 200GT Shown)
