MANDATORY**MTL-53-02****TITLE**

FUSELAGE - FORWARD FUSELAGE FASTENER INSPECTION

MODEL	SERIAL NUMBERS
B200GT	BY-178 thru BY-395, BY-397 thru BY-406
B200CGT	BZ-1, BZ-2
B300C	FM-51 thru FM-100, FM-102
B300	FL-769 thru FL-1257, FL-1259 thru FL-1261, FL-1263, FL-1264, FL-1266, FL-1268, FL-1270 thru FL-1272

August 16, 2022

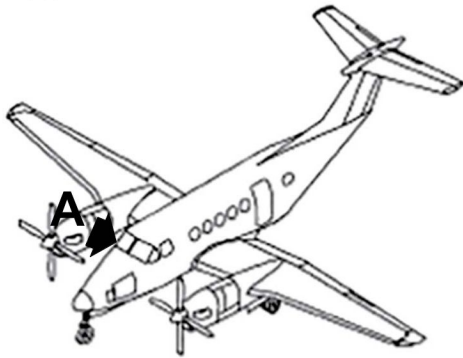
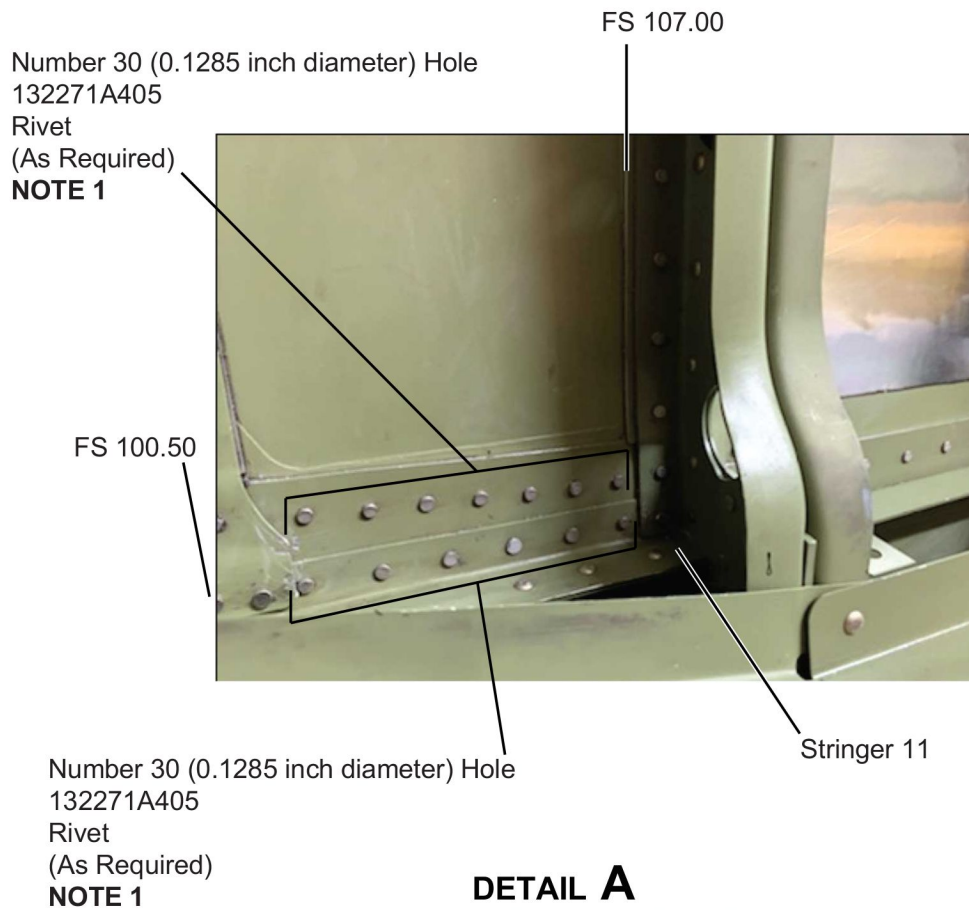
Figure 1. Model B200 Airplanes Rivet Installation (Sheet 1)

During inspection it was found that the rivets might not have been installed in the lap joint between Fuselage Station (FS) 100.50 to FS 107.00 on the left and right sides.

NOTE: The Left and Right Side have the same number of Rivets.
(7 rivets on top row and 6 Rivets on the bottom row)

4. Install missing rivets as follows:
 - A. Measure and identify the center location between the rivets that have the widest space.
NOTE: The distance between adjacent rivets must maintain a minimum of 0.50-inch and the edge distance must be 1.5 times the rivet diameter.

- B. From the inboard side of Stringer 11, mark and drill a Number 30 (0.1285 inch diameter) hole as required to match the number of holes as shown in the figures through the stringer, the lap joint of the upper and lower skin, and the FOD shield.

- C. (Model B200 Series Airplanes, Refer to Figure 1, Sheet 1.)
 - Left side top row should have 7 rivets and the bottom row should have 6 rivets.
 - Right side top row should have 7 rivets and the bottom row should have 6 rivets.

NOTE 1: Counter Sink 100 Degrees X 0.222 to 0.228 Inch Diameter
Outboard of the FOD shield (As Required).

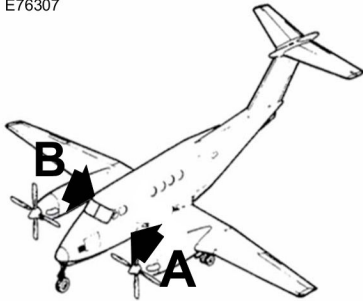
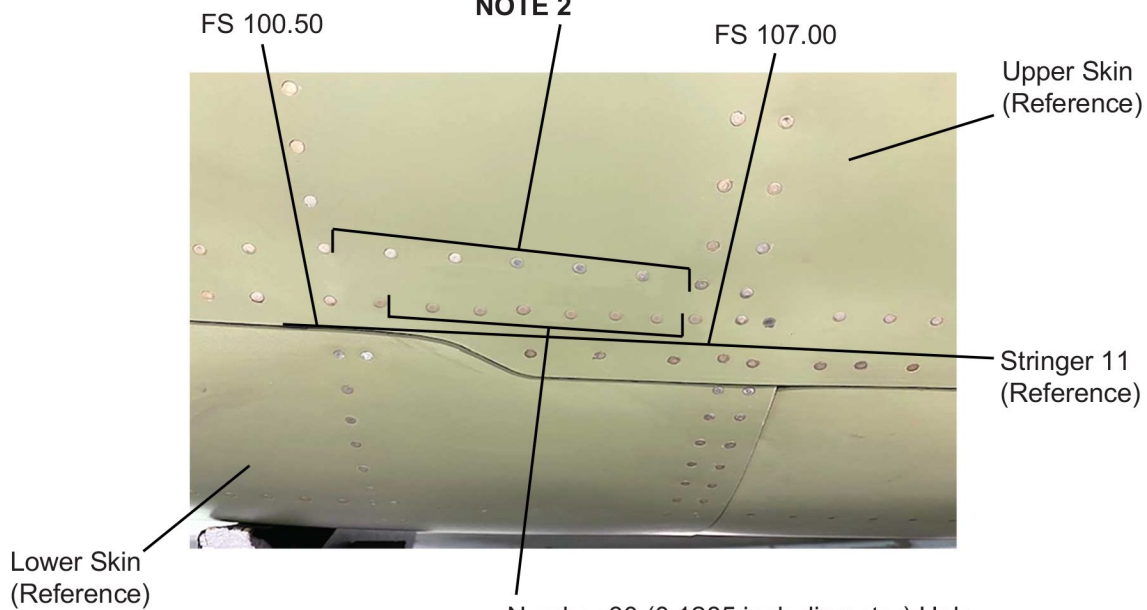
Figure 2. Model B300 Airplanes Rivet Installation (Sheet 1)

NOTE 2: Top row should have 5 rivets.
 Bottom row should have 6 rivets.

NOTE: The distance between adjacent rivets must maintain a minimum of 0.50-inch and the edge distance must be 1.5 times the rivet diameter.
 - B. From the outboard side of the lap joint, mark and drill a Number 30 (0.1285 inch diameter) hole as required to match the number of holes as shown in the figures through the lap joint of the upper and lower skin.

- (1) (Model B300 Series Airplanes, Refer to Figure 2, Sheet 1 and 2.)
 - Left side top row should have 5 rivets and the bottom row should have 6 rivets.

Number 30 (0.1285 inch diameter) Hole
 Counter Sink 100 Degrees X 0.222 to 0.228 Inch Diameter
 132271A404
 Rivet
 (As Required)
NOTE 2

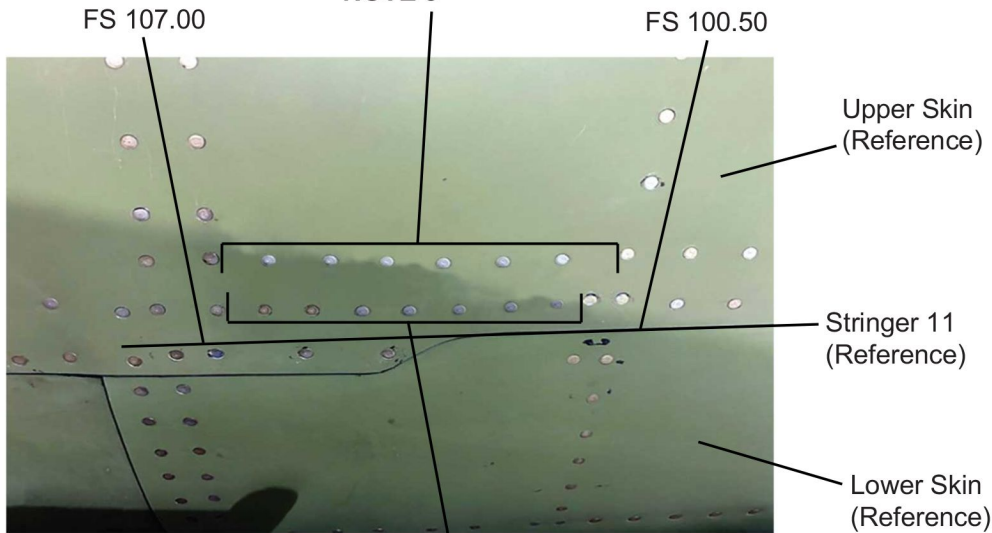
Figure 2. Model B300 Airplanes Rivet Installation (Sheet 2)

NOTE 3: Top row should have 6 rivets.
Bottom row should have 7 rivets.

- Right side top row should have 6 rivets and the bottom row should have 7 rivets.
 - C. Counter sink all drilled holes to 100 degrees x 0.222 to 0.228 inch diameter.

Number 30 (0.1285 inch diameter) Hole
Counter Sink 100 Degrees X 0.222 to 0.228 Inch Diameter
132271A404
