MANDATORY**MTL-53-04****TITLE**

FUSELAGE - FORWARD FUSELAGE FASTENER INSPECTION

MTL-53-04
Page 1 of 11

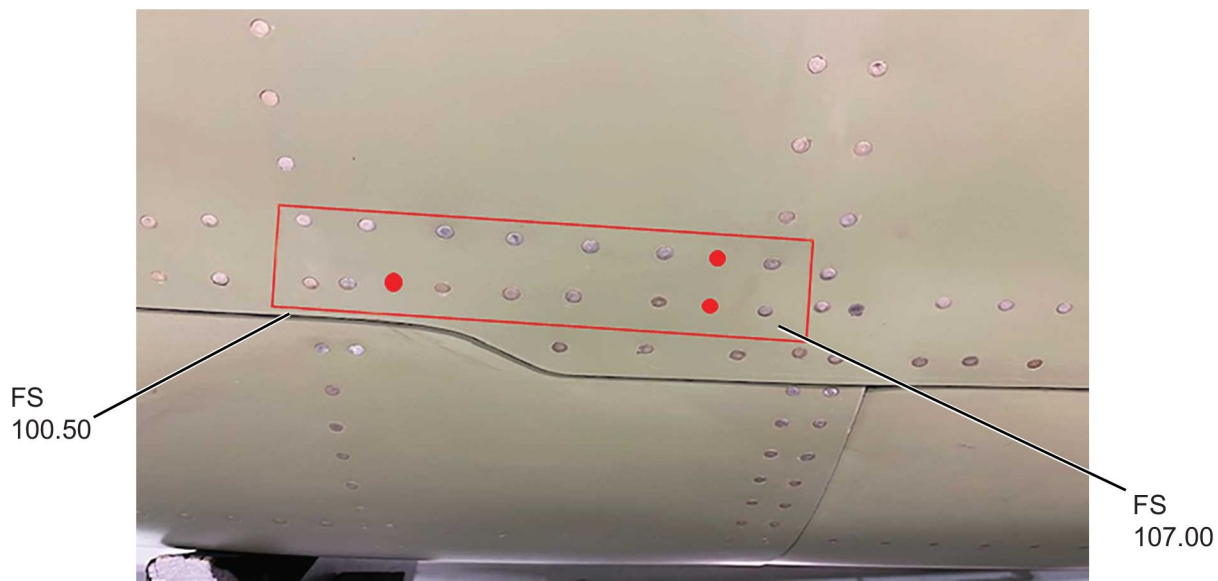
Figure 1. Rivet Inspection Area (Sheet 2)

NOTE: The rivets and red circle marks inside the red box show a possible configuration that would have a total amount of 16 or more rivets and marks.

5. (Refer to Figure 1, Sheet 2.) Install the CM3827AD4-4 Rivets into the marked areas on the left side of all B200 and B300 models as follows:

- A. From the inboard side of the lap joint, drill a Number 30 (0.1285 inch diameter) hole as required for each of the marked locations on the left side.
- B. Debur all drilled holes.
- C. From the outboard side, counter sink all drilled holes to 100 degrees x 0.222 to 0.228 inch diameter.
- D. Apply Color Chemical Film Treatment to all bare metal.
- E. Install a CM3827AD4-4 Rivet, as required, wet with U470637 Sealant into all drilled holes. (Refer to the Beechcraft Structural Inspection and Repair Manual, Chapter 20, Fastener Installation and Removal.)
- F. If the rivet installation is needed on the right side, go to the steps that follow:
 - (1) If the rivets needs to be installed on the right side, go to Step 8.
 - (2) If only the left side needed rivets to be installed, go to Step 13.

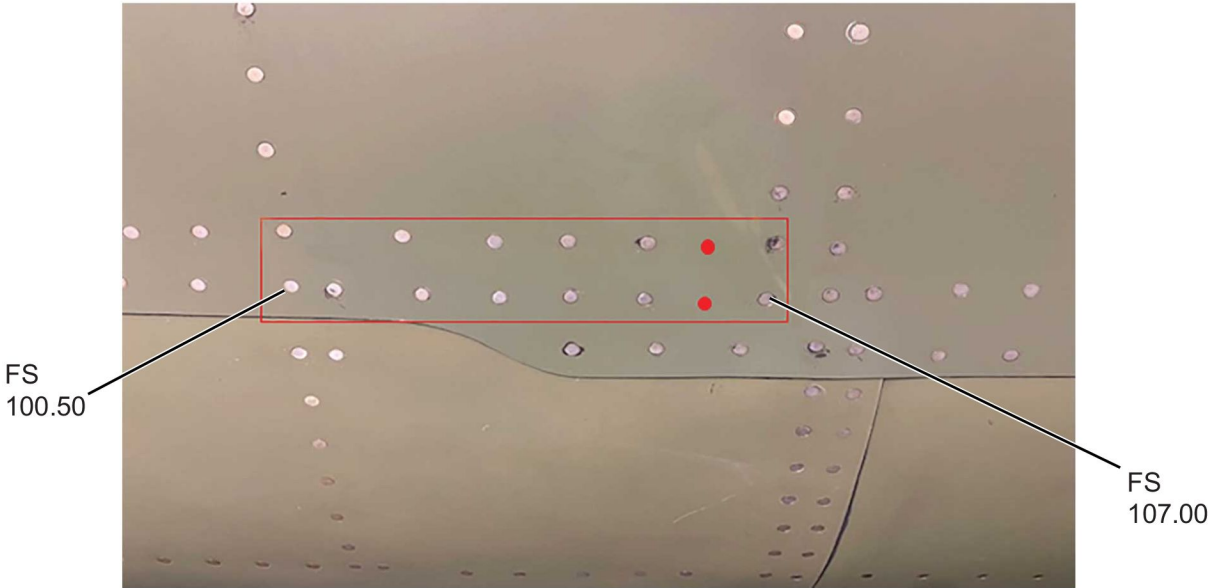
Figure 1. Rivet Inspection Area (Sheet 3)

NOTE: The rivets and red circle marks inside the red box show a possible configuration that would have a total amount of 15 or less rivets and marks.

6. (Refer to Figure 1, Sheet 3.) Remove the previously installed rivets on the left side on all B200 and B300 airplanes as follows:

- A. Remove all the rivets, on the left side, that were installed between FS 100.50 and FS 107.00. (Refer to the Beechcraft Structural Inspection and Repair Manual, Chapter 20, Fastener Installation and Removal.)

- B. From the inboard side of the lap joint, drill a Number 30 (0.1285 inch diameter) hole as required for each of the marked locations.
 - C. Debur all drilled holes.

- D. From the outboard side, counter sink all drilled holes to 100 degrees x 0.222 to 0.228 inch diameter.
 - E. Apply Color Chemical Film Treatment to all bare metal.

- F. Install a MS20427F4-4 Rivet, as required, wet with U470637 Sealant into all drilled holes. (Refer to the Beechcraft Structural Inspection and Repair Manual, Chapter 20, Fastener Installation and Removal.)
