MANDATORY**MTL-53-04****TITLE**

FUSELAGE - FORWARD FUSELAGE FASTENER INSPECTION

May 08, 2023

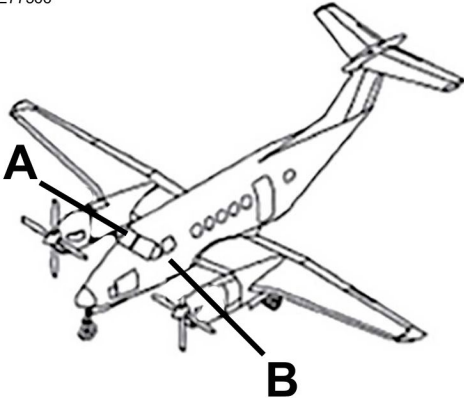
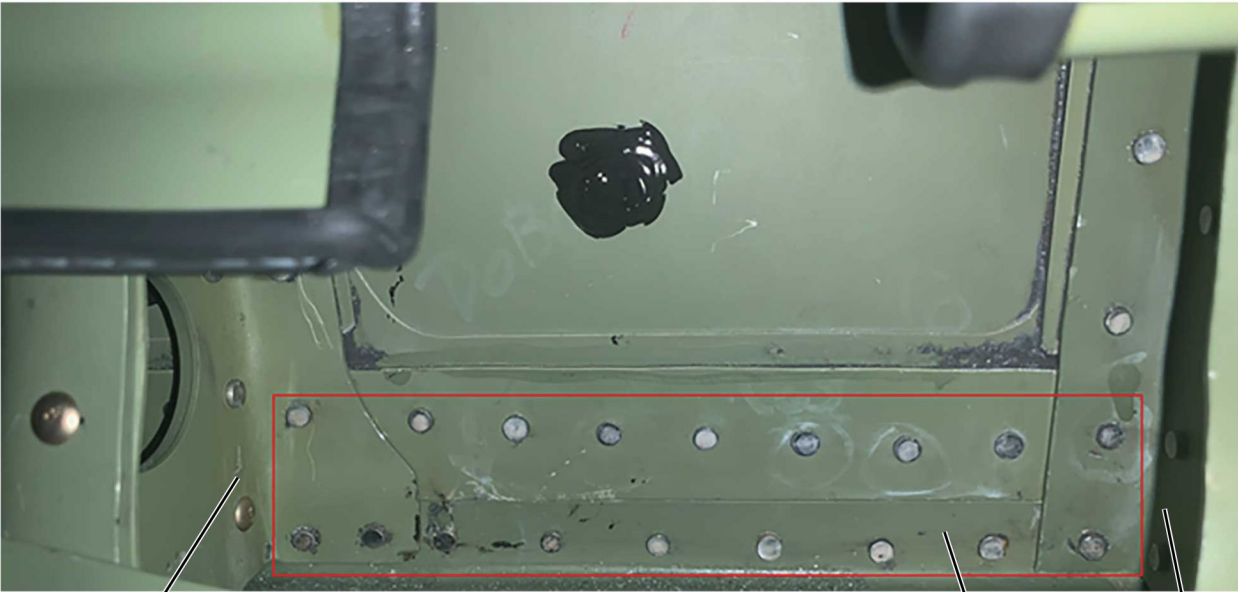
Figure 1. Rivet Inspection Area (Sheet 1)

During inspection it was found that there might be an insufficient amount of rivets between Fuselage Station (FS) 100.50 to FS 107.00 on the left and right sides of the fuselage.

2. (Refer to Figure 1, Sheet 1.) Count the number of rivets installed between FS 100.50 and FS 107.00 on the left and right sides as follows:
- NOTE:** FS 100.50 to FS 107.00 and Stringer 11 is located at the forward fuselage below the windscreen approximately halfway down the fuselage. The seam lines for the fuselage skin panels can be used for locating the location of FS 107.00 while FS 100.50 will be the next forward vertical row of rivets. (Refer to the applicable Model Maintenance Manual, Chapter 6, Dimensions and Areas, Airplane Stations - Description and Operations.)

NOTE: The rivets inside the red box show the area where the rivets need to be counted on the left and right sides of the fuselage.

- (1) If there are 16 rivets or more on the left side and 16 rivets or more on the right side, go to Step 17.
 - (2) If there are 15 rivets or less on the left side or 15 rivets or less on the right side, go to Step 3.

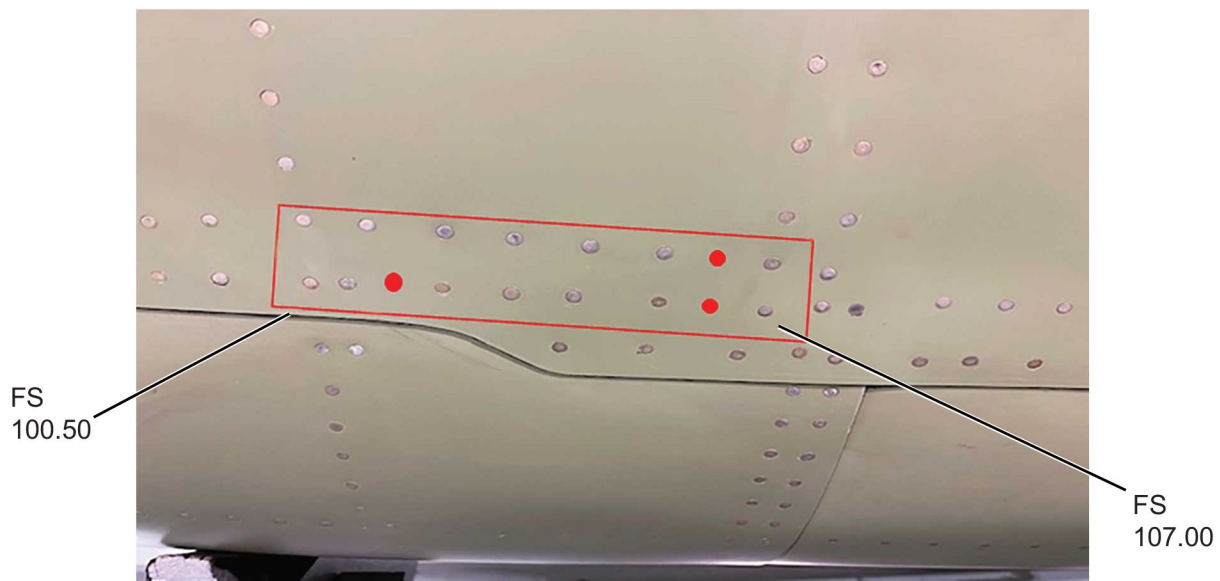
Figure 1. Rivet Inspection Area (Sheet 2)

NOTE: The rivets and red circle marks inside the red box show a possible configuration that would have a total amount of 16 or more rivets and marks.

5. (Refer to Figure 1, Sheet 2.) Install the CM3827AD4-4 Rivets into the marked areas on the left side of all B200 and B300 models as follows:

- A. From the inboard side of the lap joint, drill a Number 30 (0.1285 inch diameter) hole as required for each of the marked locations on the left side.
- B. Debur all drilled holes.
- C. From the outboard side, counter sink all drilled holes to 100 degrees x 0.222 to 0.228 inch diameter.
- D. Apply Color Chemical Film Treatment to all bare metal.
- E. Install a CM3827AD4-4 Rivet, as required, wet with U470637 Sealant into all drilled holes. (Refer to the Beechcraft Structural Inspection and Repair Manual, Chapter 20, Fastener Installation and Removal.)
- F. If the rivet installation is needed on the right side, go to the steps that follow:
 - (1) If the rivets needs to be installed on the right side, go to Step 8.
 - (2) If only the left side needed rivets to be installed, go to Step 13.

- B. If the total count of the marks and rivets is 15 or less, go to Step 12.
11. (Refer to Figure 1, Sheet 2.) Install the CM3827AD4-4 Rivets into the marked areas on the right side of all B200 and B300 models without a FOD shield as follows:

- E. Install a CM3827AD4-4 Rivet, as required, wet with U470637 Sealant into all drilled holes. (Refer to the Beechcraft Structural Inspection and Repair Manual, Chapter 20, Fastener Installation and Removal.)

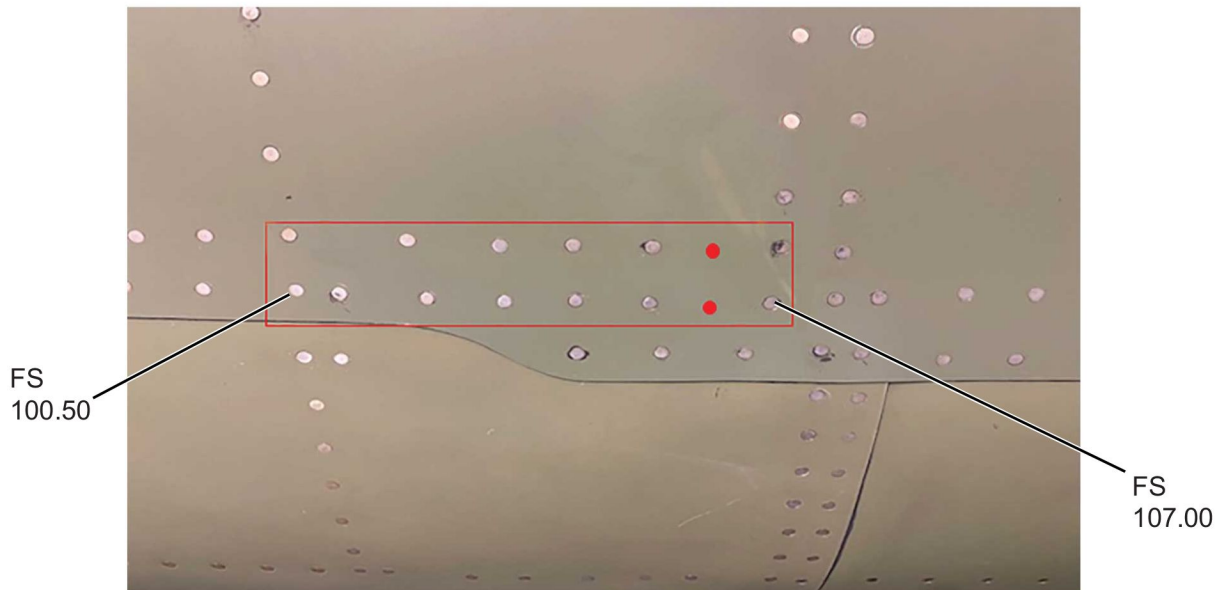
Figure 1. Rivet Inspection Area (Sheet 3)

NOTE: The rivets and red circle marks inside the red box show a possible configuration that would have a total amount of 15 or less rivets and marks.

6. (Refer to Figure 1, Sheet 3.) Remove the previously installed rivets on the left side on all B200 and B300 airplanes as follows:

- A. Remove all the rivets, on the left side, that were installed between FS 100.50 and FS 107.00. (Refer to the Beechcraft Structural Inspection and Repair Manual, Chapter 20, Fastener Installation and Removal.)

- B. From the inboard side of the lap joint, drill a Number 30 (0.1285 inch diameter) hole as required for each of the marked locations.
 - C. Debur all drilled holes.

- D. From the outboard side, counter sink all drilled holes to 100 degrees x 0.222 to 0.228 inch diameter.
 - E. Apply Color Chemical Film Treatment to all bare metal.

- F. Install a MS20427F4-4 Rivet, as required, wet with U470637 Sealant into all drilled holes. (Refer to the Beechcraft Structural Inspection and Repair Manual, Chapter 20, Fastener Installation and Removal.)

12. (Refer to Figure 1, Sheet 3.) Remove the previously installed rivets on the right side on all B200 and B300 airplanes without a FOD shield as follows:

- A. Remove all the rivets, on the right side, that were installed between FS 100.50 and FS 107.00. (Refer to the Beechcraft Structural Inspection and Repair Manual, Chapter 20, Fastener Installation and Removal.)
