MTL-53-04

FUSELAGE - FORWARD FUSELAGE FASTENER INSPECTION

MODEL	SERIAL NUMBERS
B200GT	BY-178 thru BY-395, BY-397 thru BY-406
B200CGT	BZ-1, BZ-2
B300C	FM-51 thru FM-100, FM-102, FM-106, FM-107
B300	FL-769 thru FL-1257, FL-1259 thru FL-1261, FL-1263, FL-1264, FL-1266, FL-1268, FL-1270 thru FL-1272, FL-1295 thru FL-1299, FL-1301 thru FL-1304

During inspection it was found that there might be an insufficient amount of rivets between Fuselage Station (FS) 100.50 to FS 107.00 on the left and right sides of the fuselage.

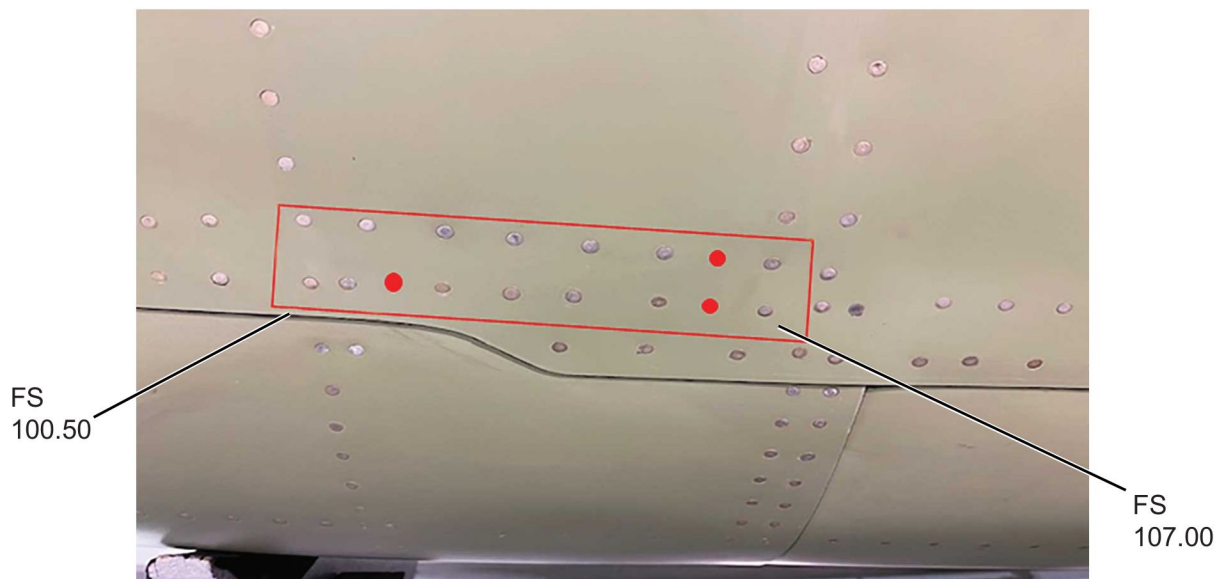
Figure 1. Rivet Inspection Area (Sheet 2)

NOTE: The rivets and red circle marks inside the red box show a possible configuration that would have a total amount of 16 or more rivets and marks.

5. (Refer to Figure 1, Sheet 2.) Install the CM3827AD4-4 Rivets into the marked areas on the left side of all B200 and B300 models as follows:

- A. From the inboard side of the lap joint, drill a Number 30 (0.1285 inch diameter) hole as required for each of the marked locations on the left side.
- B. Debur all drilled holes.
- C. From the outboard side, counter sink all drilled holes to 100 degrees x 0.222 to 0.228 inch diameter.
- D. Apply Color Chemical Film Treatment to all bare metal.
- E. Install a CM3827AD4-4 Rivet, as required, wet with U470637 Sealant into all drilled holes. (Refer to the Beechcraft Structural Inspection and Repair Manual, Chapter 20, Fastener Installation and Removal.)
- F. If the rivet installation is needed on the right side, go to the steps that follow:
 - (1) If the rivets needs to be installed on the right side, go to Step 8.
 - (2) If only the left side needed rivets to be installed, go to Step 13.

11. (Refer to Figure 1, Sheet 2.) Install the CM3827AD4-4 Rivets into the marked areas on the right side of all B200 and B300 models without a FOD shield as follows:

- A. From the inboard side of the lap joint, drill a Number 30 (0.1285 inch diameter) hole as required for each of the marked locations on the left side.
- B. Debur all drilled holes.
- C. From the outboard side, counter sink all drilled holes to 100 degrees x 0.222 to 0.228 inch diameter.
- D. Apply Color Chemical Film Treatment to all bare metal.
- E. Install a CM3827AD4-4 Rivet, as required, wet with U470637 Sealant into all drilled holes. (Refer to the Beechcraft Structural Inspection and Repair Manual, Chapter 20, Fastener Installation and Removal.)
- F. Go to Step 13.

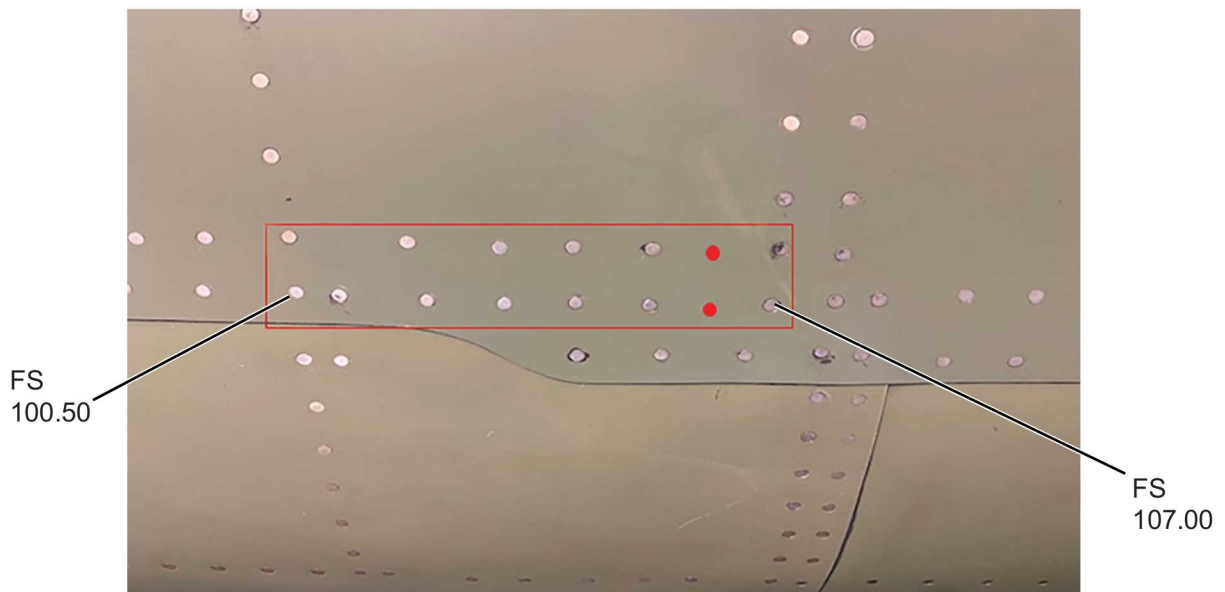
Figure 1. Rivet Inspection Area (Sheet 3)

NOTE: The rivets and red circle marks inside the red box show a possible configuration that would have a total amount of 15 or less rivets and marks.

6. (Refer to Figure 1, Sheet 3.) Remove the previously installed rivets on the left side on all B200 and B300 airplanes as follows:

- A. Remove all the rivets, on the left side, that were installed between FS 100.50 and FS 107.00. (Refer to the Beechcraft Structural Inspection and Repair Manual, Chapter 20, Fastener Installation and Removal.)

- B. From the inboard side of the lap joint, drill a Number 30 (0.1285 inch diameter) hole as required for each of the marked locations.
 - C. Debur all drilled holes.

- D. From the outboard side, counter sink all drilled holes to 100 degrees x 0.222 to 0.228 inch diameter.
 - E. Apply Color Chemical Film Treatment to all bare metal.

- F. Install a MS20427F4-4 Rivet, as required, wet with U470637 Sealant into all drilled holes. (Refer to the Beechcraft Structural Inspection and Repair Manual, Chapter 20, Fastener Installation and Removal.)

12. (Refer to Figure 1, Sheet 3.) Remove the previously installed rivets on the right side on all B200 and B300 airplanes without a FOD shield as follows:

- A. Remove all the rivets, on the right side, that were installed between FS 100.50 and FS 107.00. (Refer to the Beechcraft Structural Inspection and Repair Manual, Chapter 20, Fastener Installation and Removal.)
