MANDATORY**MTL-53-05****TITLE**

FUSELAGE - FILLER SHIM OR FASTENER INSTALLATION AT FUSELAGE STATION 221

MODEL	SERIAL NUMBERS
B300	FL-1237 thru FL-1295, FL-1297, FL-1298
B300C	FM-99 thru FM-106

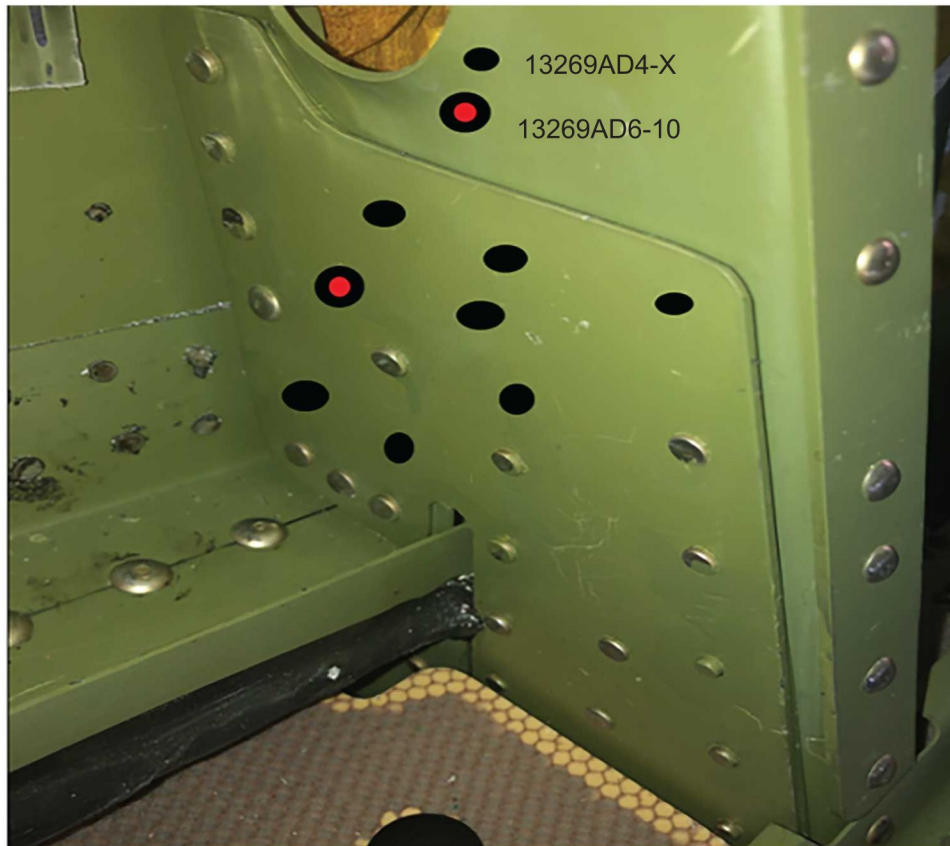
E77654

During inspection it was found that there may be an insufficient amount of fasteners or shims installed on the left or right side at Fuselage Station (FS) 221.

View Looking Forward at FS 221 on the Left Side.

NOTE: The illustration above is an example of a possible configuration of missing fasteners.

- A. Measure and mark all locations that are missing a fastener from the 101-430026-0031 Reinforcement.
- B. Drill the marked areas of the 101-430026-0031 Reinforcement.

- C. If the tooling hole needs a rivet installed, remove and keep the 101-430026-005 Doubler from the forward side of the frame.

- D. Debur all drilled holes.

- E. Apply Color Chemical Film Treatment to all bare metal.
- F. Install the rivets into the drilled holes that do not go through the 101-430026-0005 Doubler. (Refer to the Beechcraft Structural Inspection and Repair Manual, Chapter 20, Fastener Installation and Removal.)

- 132369AD4-5 Rivet into all Number 30 holes.
- 132369AD5-5 Rivet into all Number 21 holes.

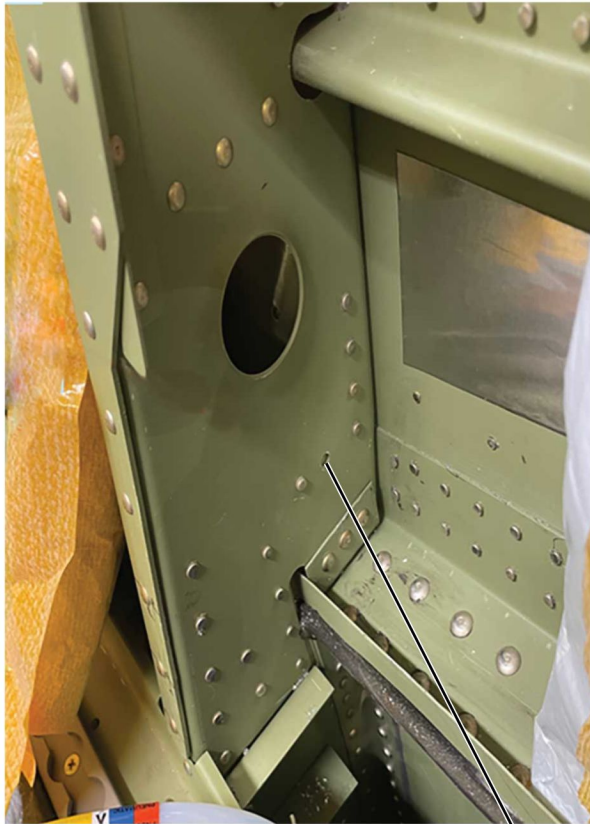
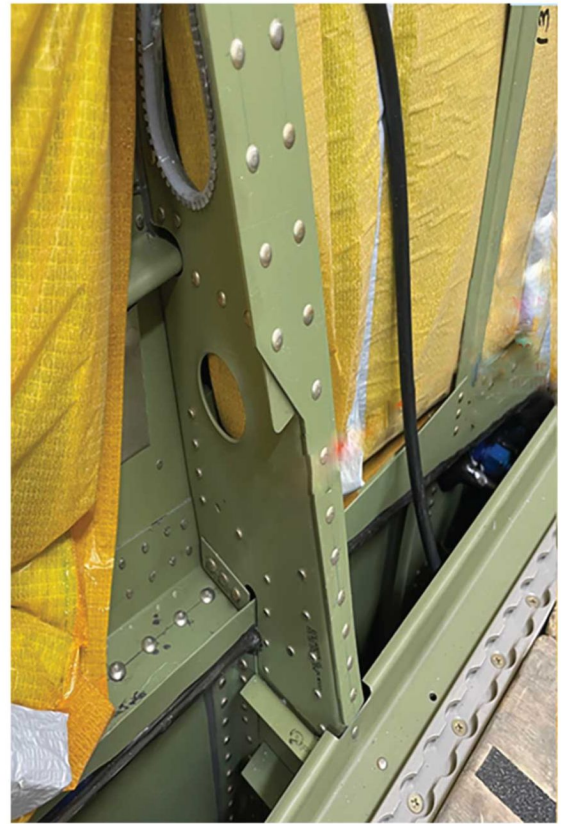
E77655

Left Side
(View Looking Aft)

Right Side
(View Looking Aft)

NOTE: The 101-430026-0035 Shim is placed between the 101-430026-0031 Reinforcement and the frame at F.S. 221 on the left and right sides.

- A. Remove the rivets that were previously installed into the frame at F.S. 221. (Refer to the Beechcraft Structural Inspection and Repair Manual, Chapter 20, Fastener Installation and Removal.)
- B. Match drill and locate all the holes from the frame to the 101-430026-0035 Shim and the 101-430026-0031 Reinforcement.

- C. Debur all the drilled holes.
- D. Apply Color Chemical Film Treatment to all bare metal.

- E. Install the rivets into the drilled holes that do not go through the 101-430026-0005 Doubler. (Refer to the Beechcraft Structural Inspection and Repair Manual, Chapter 20, Fastener Installation and Removal.)
- 132369AD4-4 Rivet into all Number 30 holes.
 - 132369AD6-4 Rivet into all Number 11 holes.
- F. Install the rivets into the drilled holes that go through the 101-430026-0005 Doubler. (Refer to the Beechcraft Structural Inspection and Repair Manual, Chapter 20, Fastener Installation and Removal.)

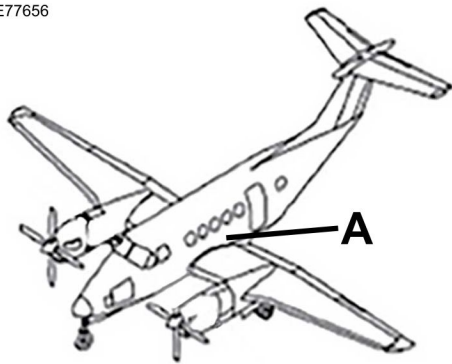
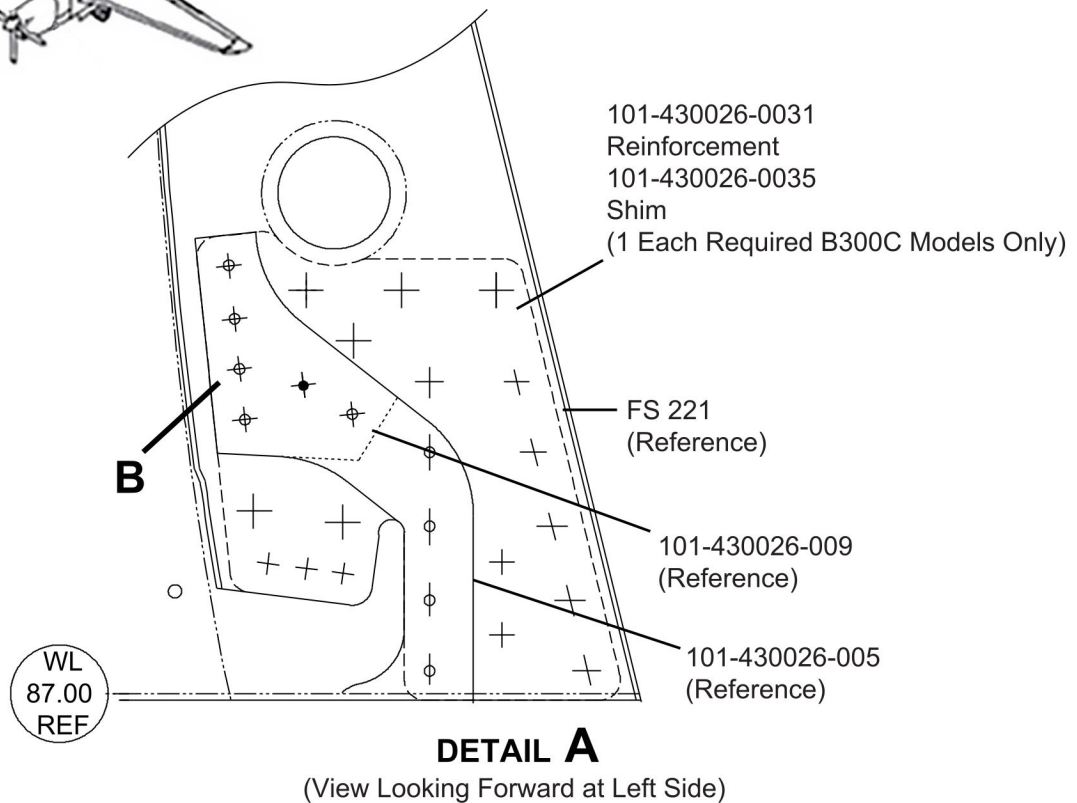
Figure 1. Shim and Fastener Location (Sheet 1)

NOTE: The location of the missing fasteners might be different for each B300.

4. (Refer to Figure 1, Sheets 1 and 2.) Inspect and install fasteners into the 101-430026-0031 Reinforcement on the left side at FS 221 as follows:

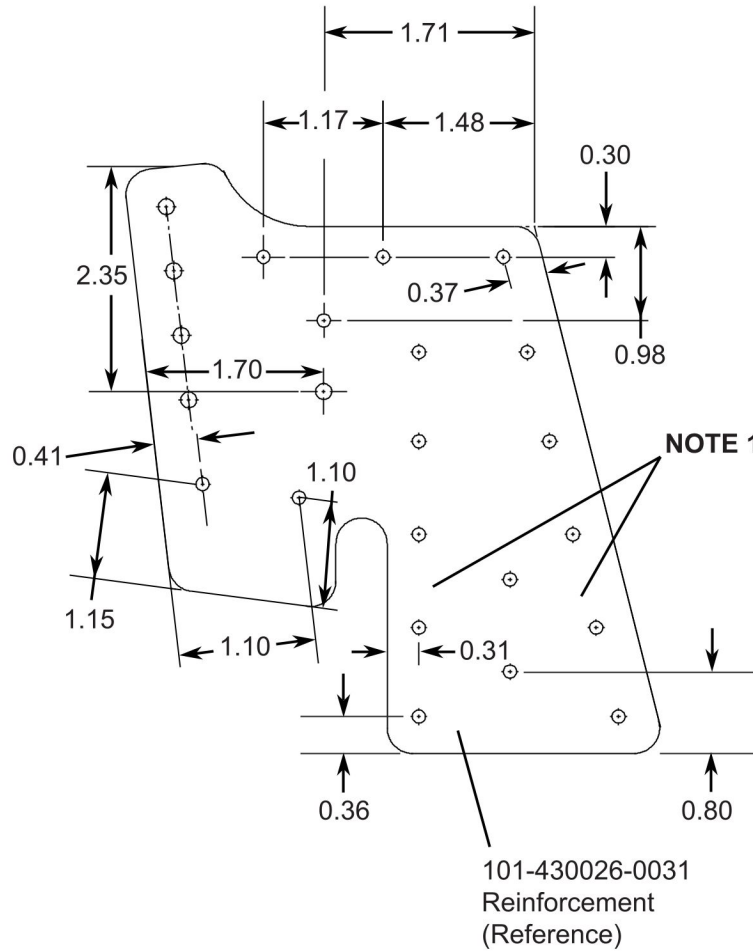
Figure 1. Shim and Fastener Location (Sheet 2)

DETAIL B

NOTE 1: The rivets should be evenly spaced and maintain the minimum edge distance as shown.
