MANDATORY**MTL-53-05****TITLE**

FUSELAGE - FILLER SHIM OR FASTENER INSTALLATION AT FUSELAGE STATION 221

MTL-53-05
Page 1 of 9

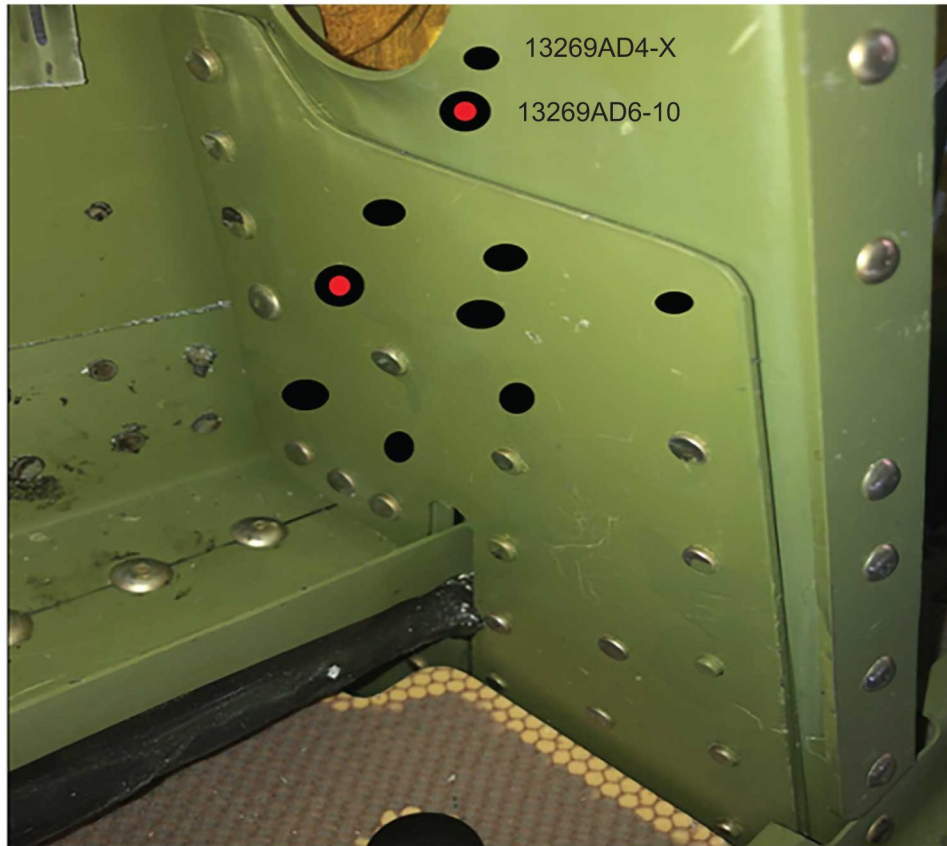
View Looking Aft at FS 221 on the Right Side.

During inspection it was found that there may be an insufficient amount of fasteners or shims installed on the left or right side at Fuselage Station (FS) 221.

NOTE: The illustration above is an example of a possible configuration of missing fasteners.

- A. Measure and mark all locations that are missing a fastener from the 101-430026-0031 Reinforcement.
- B. Drill the marked areas of the 101-430026-0031 Reinforcement.

- C. If the tooling hole needs a rivet installed, remove and keep the 101-430026-005 Doubler from the forward side of the frame.

- D. Debur all drilled holes.

- E. Apply Color Chemical Film Treatment to all bare metal.
- F. Install the rivets into the drilled holes that do not go through the 101-430026-0005 Doubler. (Refer to the Beechcraft Structural Inspection and Repair Manual, Chapter 20, Fastener Installation and Removal.)

- 132369AD4-5 Rivet into all Number 30 holes.
- 132369AD5-5 Rivet into all Number 21 holes.

- G. Install the rivets into the drilled holes that go through the 101-430026-0005 Doubler. (Refer to the Beechcraft Structural Inspection and Repair Manual, Chapter 20, Fastener Installation and Removal.)

- 132369AD4-10 Rivet into all Number 30 holes.
- 132369AD5-10 Rivet into all Number 21 holes.
- 132369AD6-10 Rivet into the Number 11 hole.

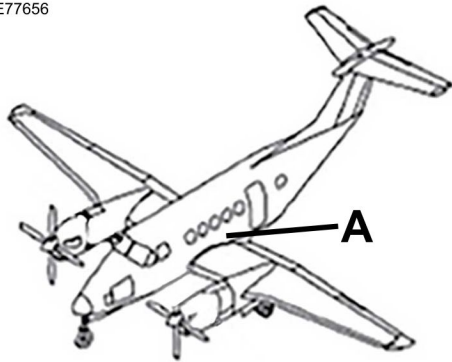
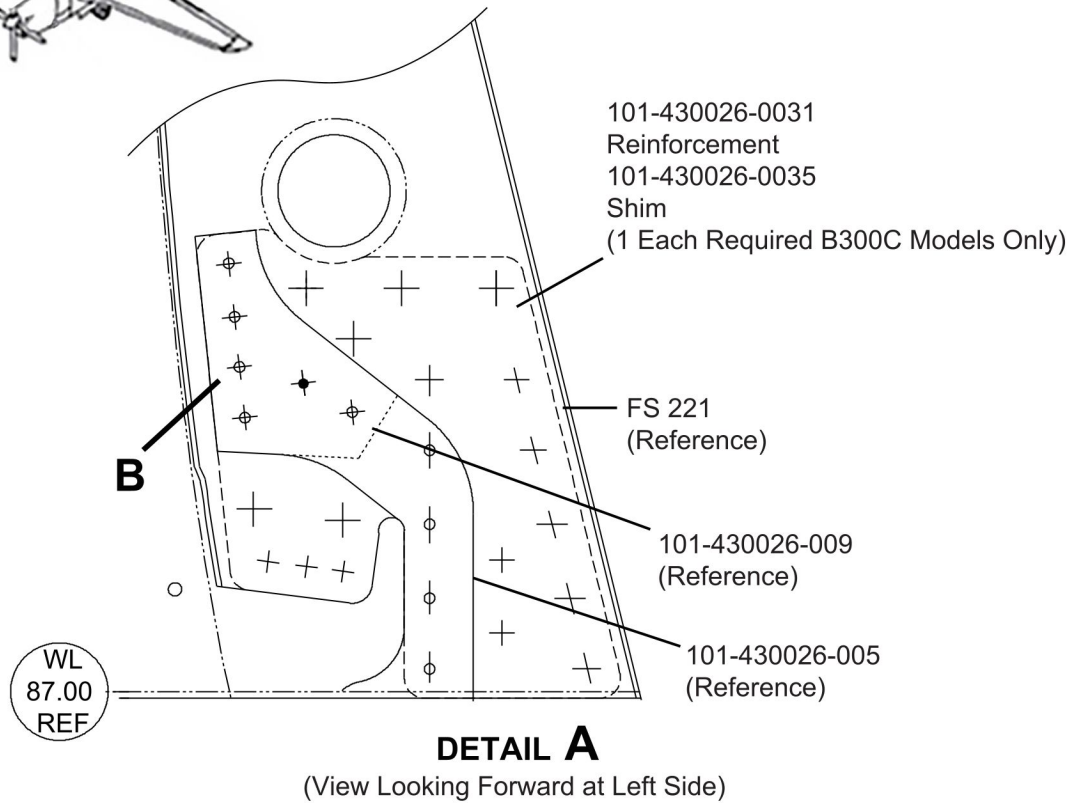
Figure 1. Shim and Fastener Location (Sheet 1)

NOTE: The location of the missing fasteners might be different for each B300.

4. (Refer to Figure 1, Sheets 1 and 2.) Inspect and install fasteners into the 101-430026-0031 Reinforcement on the left side at FS 221 as follows:

5. (Refer to Figure 1, Sheets 1 and 2.) Install the 101-430026-0035 Shim and the 101-430026-0031 Reinforcement on the forward side of the frame at F.S. 221 on the left side as follows:
