STABILIZERS - HORIZONTAL FASTENER REPLACEMENT

MODEL	SERIAL NUMBERS
B200GT	BY-434 thru BY-444
B300	FL-1301 thru FL-1309
B300C	FM-108, FM-109

MTL-55-02
Page 1 of 6

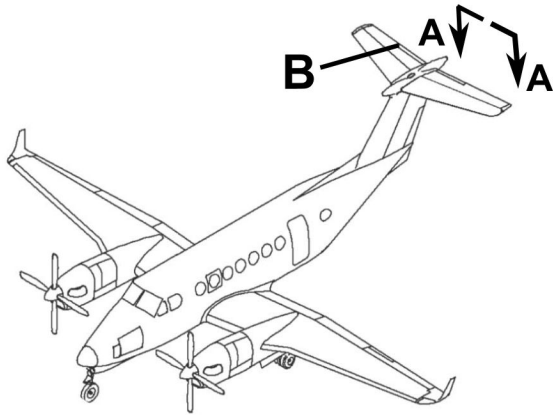
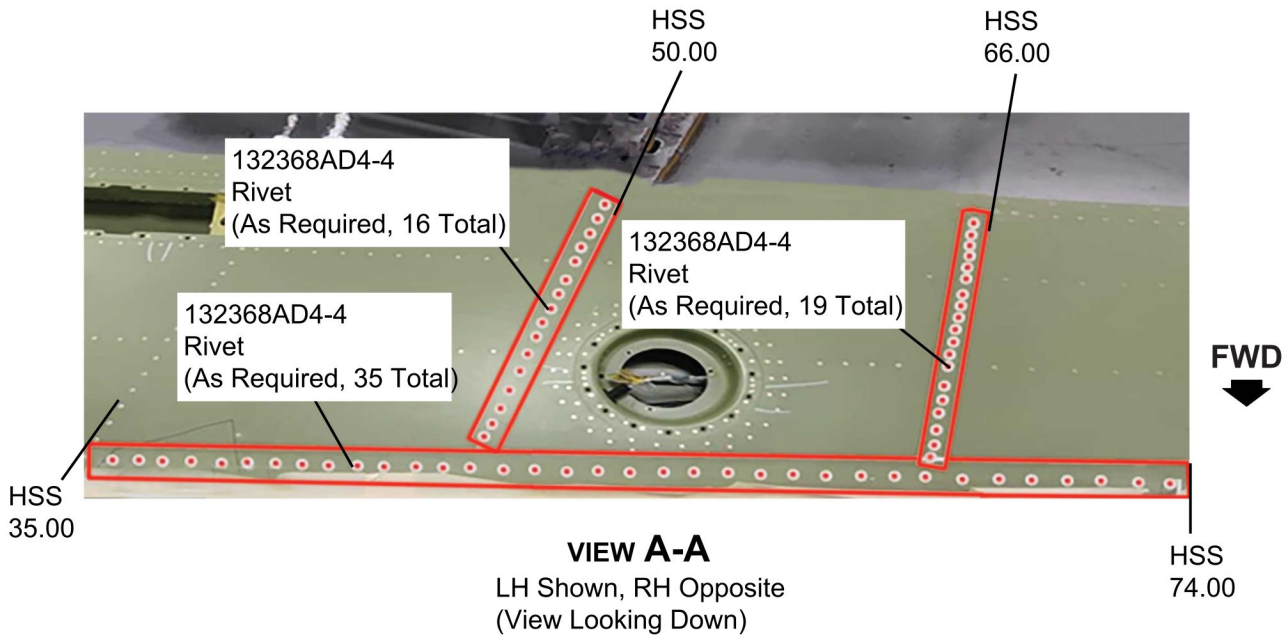
Figure 1. Horizontal Fastener Location (Sheet 1)

Magnetic fasteners might have been installed in the left or right horizontal stabilizers, which might cause interference with the left or right flux detector unit.

NOTE: The highlighted red areas of Figure 1, Sheet 1 located on the upper surfaces of the left and right horizontal stabilizers are the areas that need to be inspected with a magnet.

NOTE: Only the areas highlighted in red needs to be inspected for magnetic fasteners.

- (2) Remove all magnetic fasteners from the left horizontal stabilizer between HSS 35.00 to HSS 74.00. (Refer to the King Air Structural Inspection and Repair Manual, Chapter 20, Fastener Installation and Removal.)
- (3) Remove all foreign object debris (FOD).
- (4) Apply Color Chemical Film Treatment to the rivet holes.
- (5) Apply Corrosion-Resistant Epoxy Primer to the rivet holes.
- (6) (Refer to Figure 1, Sheet 1.) Install either a 132368AD4-4 Rivet or a 132370AD4-4 Rivet as required, into all open rivet holes. (Refer to the King Air Structural Inspection and Repair Manual, Chapter 20, Fastener Installation and Removal.)

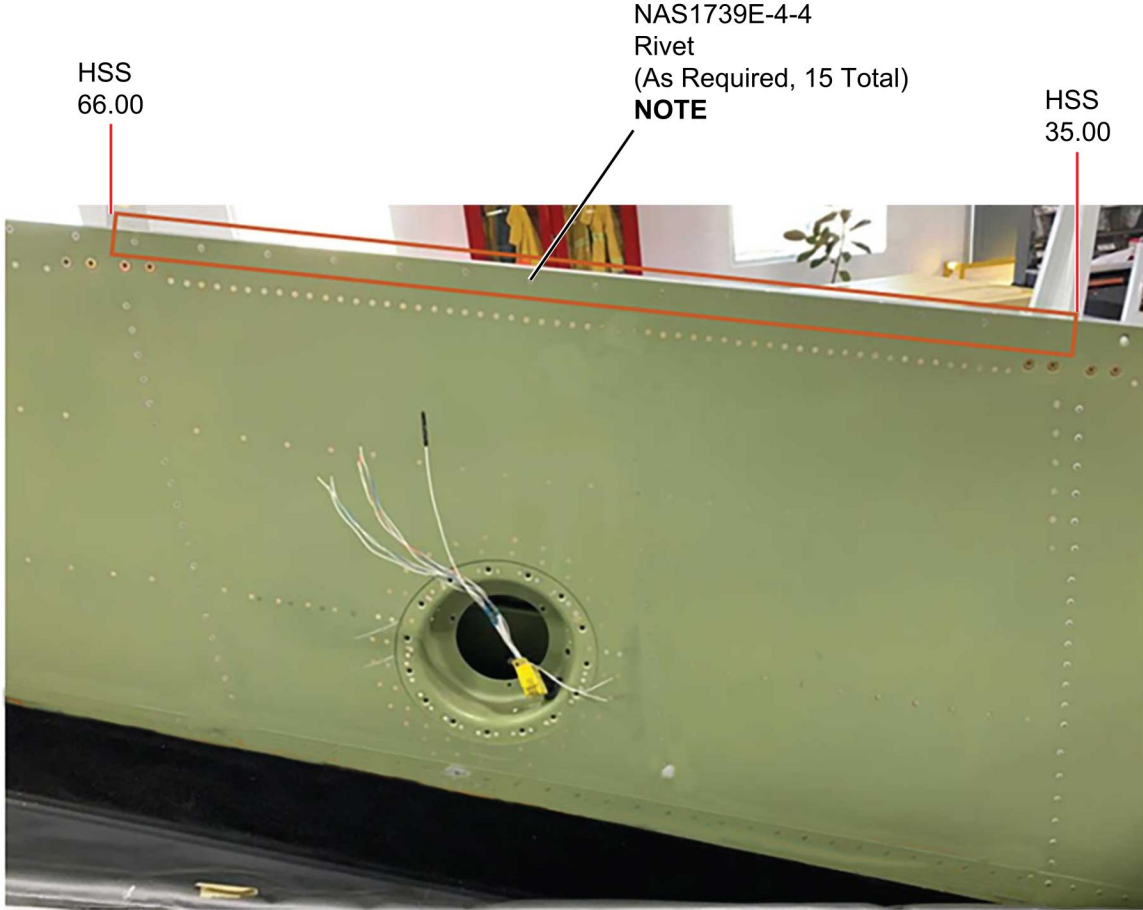
Figure 1. Horizontal Fastener Location (Sheet 2)

DETAIL B

NOTE: Only the rivets that attach the 101-620010-9 Cove Closure needs to be inspected on the upper and lower surfaces.

- (1) Remove the left elevator if required. (Refer to the applicable Maintenance Manual, Chapter 27, Elevator - Removal/Installation.)
- (2) Remove all magnetic fasteners from the trailing edge on the upper and lower surfaces between HSS 35.00 and HSS 66.00 of the left horizontal stabilizer
- (3) Remove all foreign object debris (FOD).
- (4) Apply Color Chemical Film Treatment to the rivet holes.
- (5) Apply Corrosion-Resistant Epoxy Primer to the rivet holes.
- (6) Install the 101-620010-9 Cove Closure with a NAS1739E-4-4 Rivet into all open rivet holes. (Refer to the King Air Structural Inspection and Repair Manual, Chapter 20, Fastener Installation and Removal.)
