AIR CONDITIONING - COCKPIT FOOT WARMER DUCT INSPECTION

MODEL	SERIAL NUMBERS
B200	BB-1978, BB-1988 thru BB-2021
B200C	BL-152 thru BL-171
B200GT	BY-1 thru BY-435
B200CGT	BZ-1 thru BZ-8
B300	FL-493, FL-500 thru FL-1299
B300C	FM-14 thru FM-107

MTL-21-03
Page 1 of 5

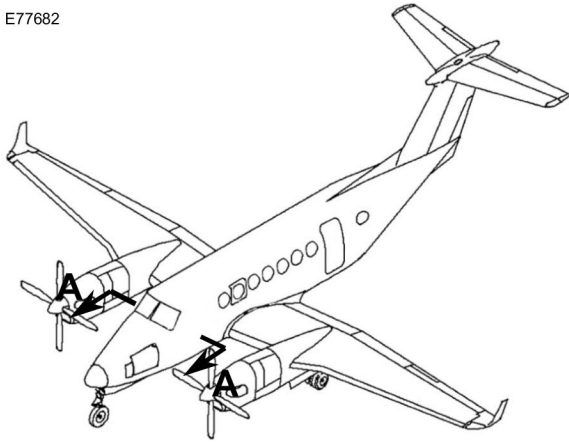
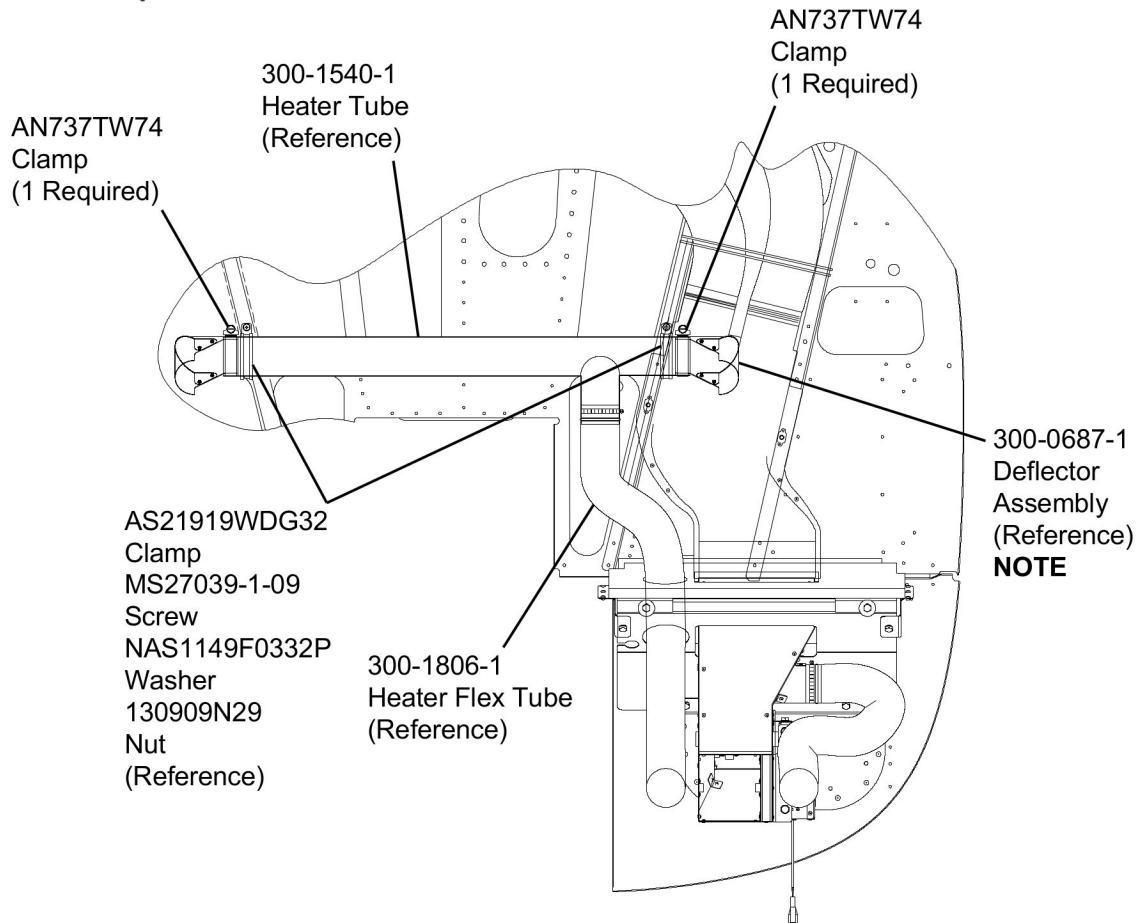
Figure 1. Clamp Installation (Sheet 1)

During initial inspection it has been found that the deflector assembly clamps may not have been installed.

2. (Refer to Figure 1, View A-A.) Do an inspection of the heater tube and deflector assembly for the AN737TW74 Clamps installation.
 - A. If the AN737TW74 Clamps are installed in the deflector assembly, then go to Step 5.

NOTE: Point the 300-0687-1 Deflector Assemblies aft, 30 degrees down from horizontal.

- (10) Place one AN737TW74 Clamp onto the left and right side of the 300-1540-1 Heater Tube.
 - (11) Position the 300-0687-1 Deflector Assembly onto the left and right side of the 300-1540-1 Heater Tube, pointed aft approximately 30 degrees down from horizontal.

- (12) Install the AN737TW74 Clamps to secure the two 300-0687-1 Deflector Assemblies onto the 300-1540-1 Heater Tube.
 - (13) Position the 300-1540-1 Heater Tube and tighten the clamp that attach the 300-1540-1 Heater Tube to the 300-1806-1 Heater Flex Tube.

- (14) Hand tighten the AN737TW74 Clamps and make sure that the rubber sleeve is not turning.
 - (a) If you are able to turn the sleeve, then tighten the clamp for 1/4 turn and check.
