WORKSHEET

CLIENT/OWNER: SKYLINE ACCESS SDN BHD	SERIAL NO. 1089	HOURS 2469.6	LDG/CYCLE 3065	WORKSHEET NO.: MYCAS-SBK-15-001-04
AIRCRAFT TYPE: EC120B	AIRCRAFT: 2469.6	3062-0		WORK/INSP/DESC: 15H/7D ENG. INSP.
REGISTRATION: 9M-SBK	#1 ENGINE: 34099	2469.6	2469.6	WORKPACK REF.: MYCAS-SBK-15-001
BASE/FACILITY: MYCOPTER HANGAR, SUBANG	#2 ENGINE: N/A	8 N/A	2469.6 N/A	LBE REF. NO.: SBK-0003
DATE IN: 26/01/15	DATE OUT: 26/01/15			SHEET: 1 OF: 2

SUBJECT: TIME LIMITS - MAINTENANCE CHECKS

Check for crack in the main rotor hub

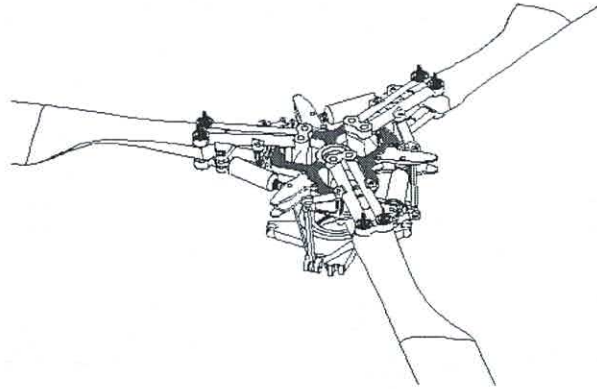
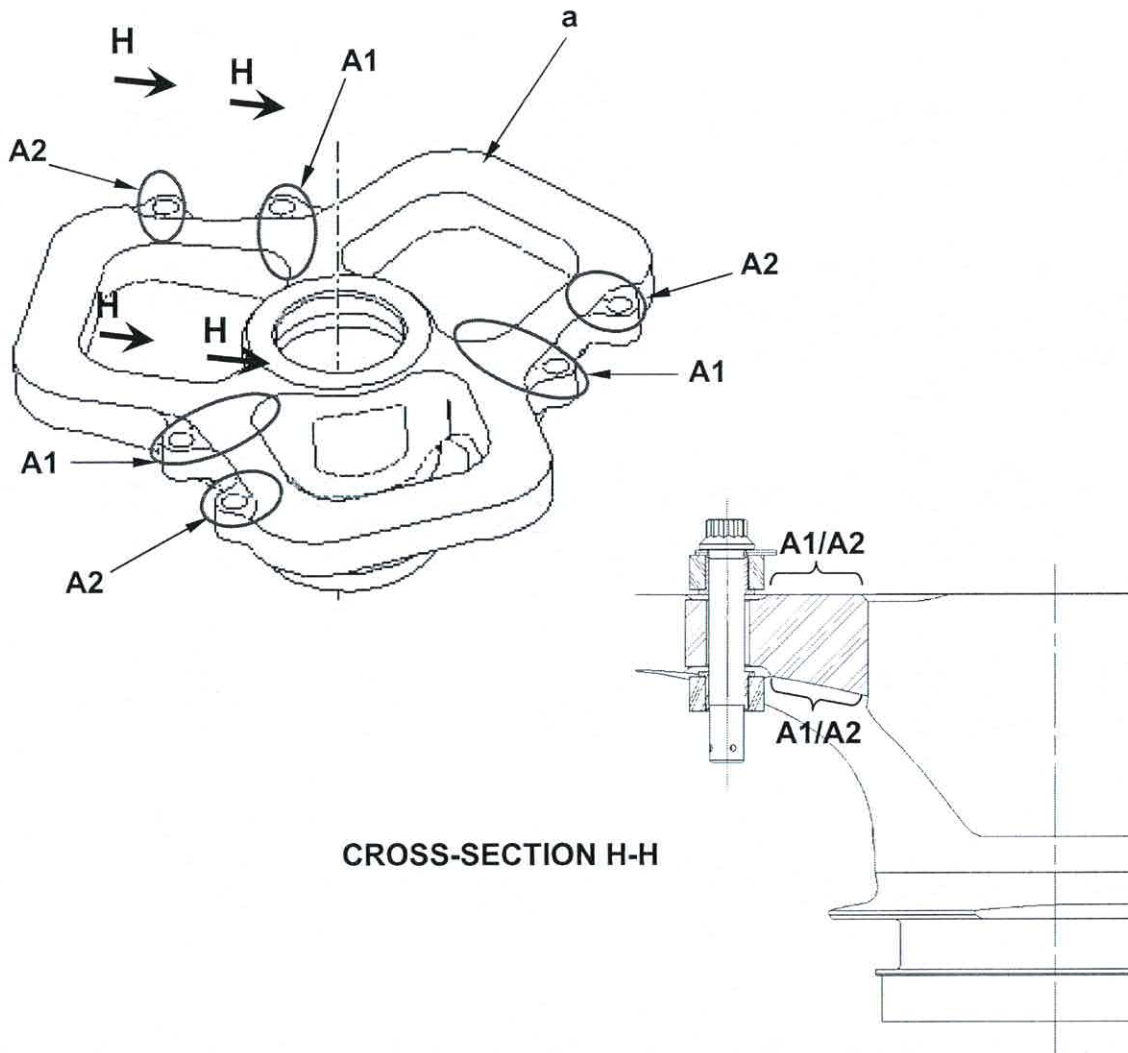
Figure 1: Visual check of the rotor hub

- Visually inspect the inspection areas (A1) and (A2) on the hub (a), and make sure that there is no crack.
- Comply with paragraph 2.B.2.b.

- 3 - If local deterioration is found, leading you to suppose that there could be a crack (scoring, paint spalling, etc.): (as per Figures 1 and 2):
 - . Sand the suspected area(s) using No. 600-grit (fine grit) abrasive paper. Remove only the finish paint until the P05 primer coat becomes visible.
 - . Once again, visually inspect the concerned area(s), and make sure that there is no crack.
 - . Interpret the results in accordance with paragraph 2.B.2.b.1. or paragraph 2.B.2.b.2.

- 1 - If no crack is found:
 - . Install the dome fairing if it was removed previously.
 - . Resume flights.

- 2 - If one or more cracks are found:
 - . Contact EUROCOPTER in accordance with the conditions described in NOTE 1 of paragraph 2.A:
 - . Replace the affected rotor hub (a) with a new rotor hub (1a), (1b) or (1c).
 - . Assemble the rotor hub (1a), (1b) or (1c) and install the MRH as per AMM Task 62-21-00, 4-1.
 - . Resume flights.

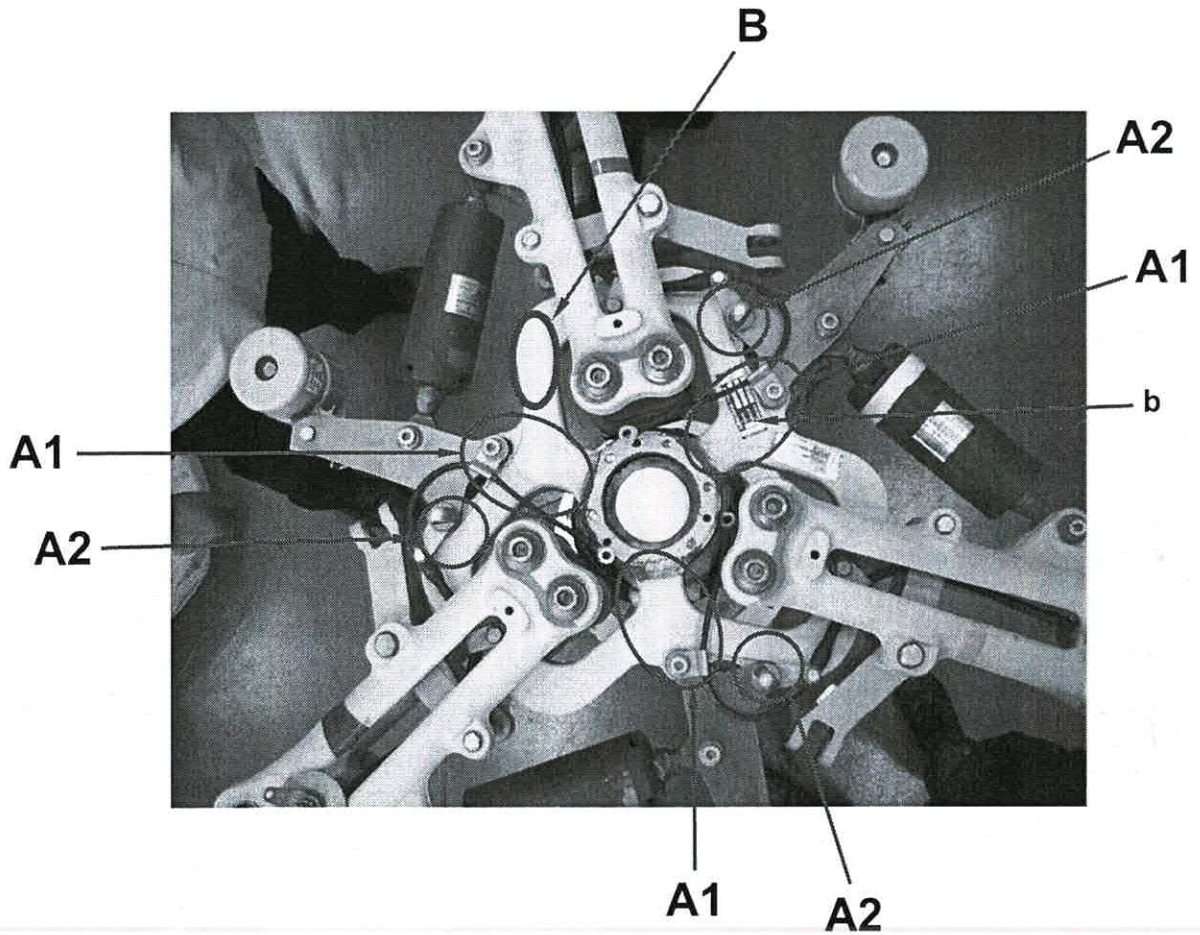
Figure 2: Rotor hub – Identification plate

- During the first check, if the identification plate (b) is in the inspection area (A1) or (A2), remove the plate (b):
 - . Unbond the identification plate (b) using a plastic tool or bronze knife, taking care not to damage the rotor hub. Remove the dome fairing if necessary.
 - . Locate the area (B), and then clean it as per Task 20-10-00, 3-8 (titanium part).
 - . Copy the references marked on the identification plate (b) on the area (B) with indelible ink, as per Task 20-10-00, 3-43.

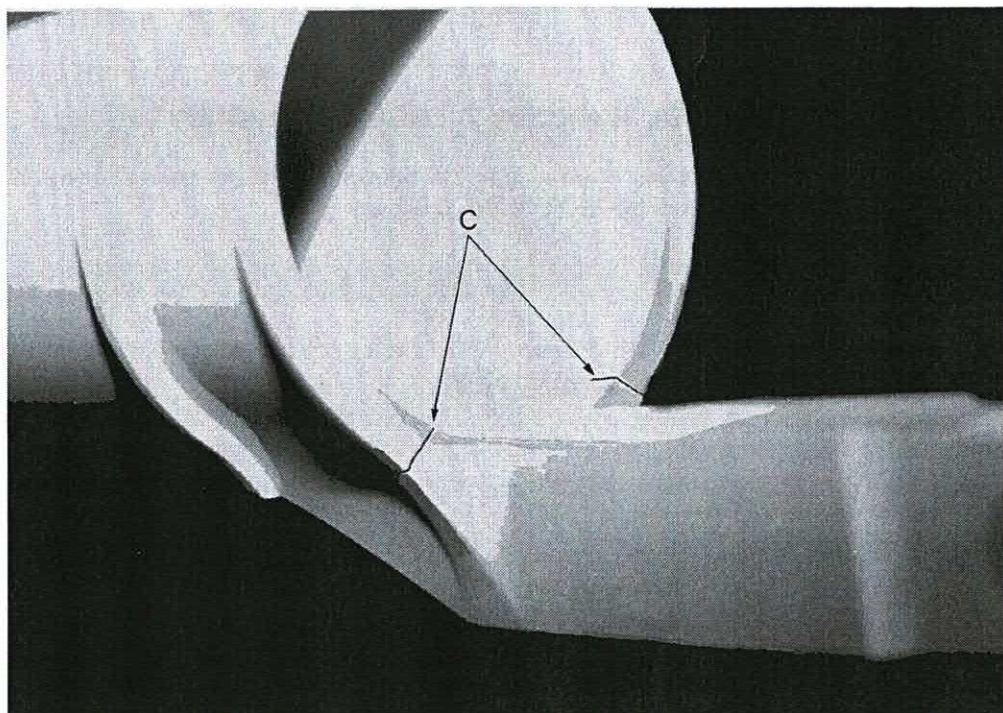
The first findings showed that the cracks had started in the connection area between the cylindrical casing and the fitting that attaches the coupling tube to the MGB (refer to Figure 1 (C)). These cracks run lengthwise on the cylindrical casing, on either side of the coupling tube attachment fitting. The cracks go through the cylindrical casing thickness. They are visible on the lower section of the coupling tube cylindrical body

- Inside the MGB compartment, visually check the area of the coupling tube cylindrical casing on either side of the fitting that attaches the coupling tube to the MGB:
. for cracks in the blending radius between the coupling tube cylindrical section and the fitting that attaches it to the MGB, see the cracked areas (C) shown on Figure 1.

- . remove and replace the coupling tube assembly as per AMM Tasks 63-11-00, 4-1 and 63-11-00, 4-2,
- . please inform the EUROCOPTER Customer Service Technical Support department: (STXV):
 - Fax: +33 (0)4 42 85 99 66.
