JOB NO : PEC 15/038	ACFT TYPE : BELL 429	SHEET NO: 1 of 2
DATE OPEN : 26.8.2015	ACFT S/N : 57060	
TIME : 1400	ACFT REGN : 9M-PEC	
RAISED BY : MUHAMMAD	A/F HOURS : 1073.3

DEFECT COLUMN	
<p>ASB 429-15-21: 429-001-523-101/103 AND 429-001-523-101/103 BELL CRANK ASSEMBLY SCHEDULED INSPECTION, INTRODUCTION OF,</p>

429-15-21

SUBJECT: 429-001-523-101/-103 AND 429-001-532-101/-103
BELLCRANK ASSEMBLY SCHEDULED
INSPECTION, INTRODUCTION OF.

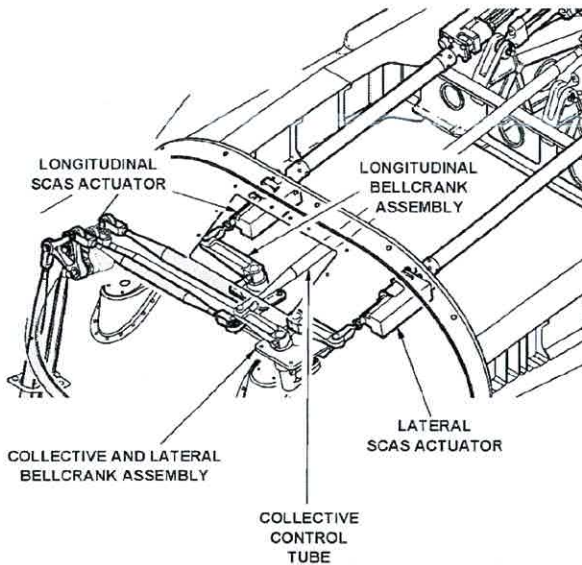
Figure 1 - Bellcrank Assemblies

1. Prepare the helicopter for maintenance.
2. Disconnect the forward ends of the collective control tube, longitudinal SCAS actuator and lateral SCAS actuator (Figure 1) (BHT-429-MM-1, Chapter 67).

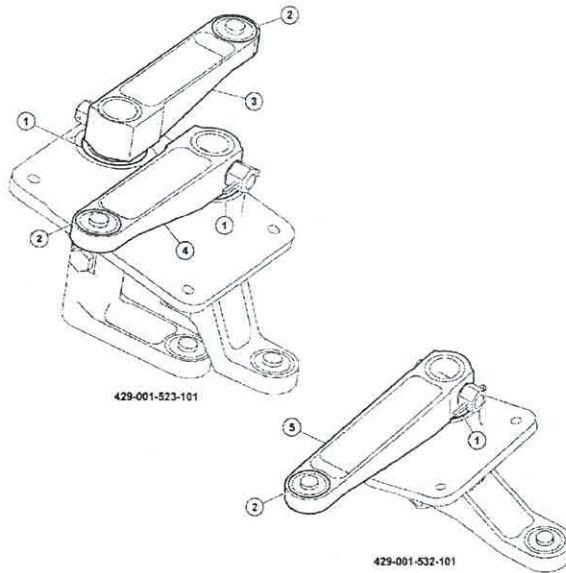
Figure 2 - Bellcrank Details

3. Slowly move the cyclic stick fore/aft and laterally, and the collective stick up/down from stop to stop. If any roughness is detected in the flight control system, remove and replace the six MS27646-4 pivot bearings (Item 1, Figure 2) in the collective/lateral 429-001-523-101/-103, and longitudinal bellcrank 429-001-532-101/-103 (BHT-429-MM-1, Chapter 67).
4. Should discrepant pivot bearings be found that require replacement, contact Product Support Engineering to report findings.

5. Check that the MS27643-4 bearings (Item 2) in the 429-001-525-101 collective (Item 3), 429-001-527-101 lateral (Item 4), and 429-001-530-101 longitudinal (Item 5) arm assemblies rotate freely.
6. Should discrepant arm bearings be found that require replacement, contact Product Support Engineering to report findings.
7. Connect the forward ends of the collective control tube, longitudinal SCAS actuator, and lateral SCAS actuator (Figure 1) (BHT-429-MM-1, Chapter 67).
8. Make an entry in the helicopter logbook and historical service records indicating compliance with this Alert Service Bulletin.

If binding is detected in any MS27643-4 arm end bearings, all three arm bearings must be replaced per the BHT-ALL-SPM. If tooling and facilities are not available, the arms may be sent through Bell Helicopter CPR for bearing replacement. Alternatively, arm assemblies may be purchased through spares.
