R44 SERVICE BULLETIN SB-108

DATE: 30 June 2021

SUBJECT: C029-3 Tail Rotor Blade Cracks

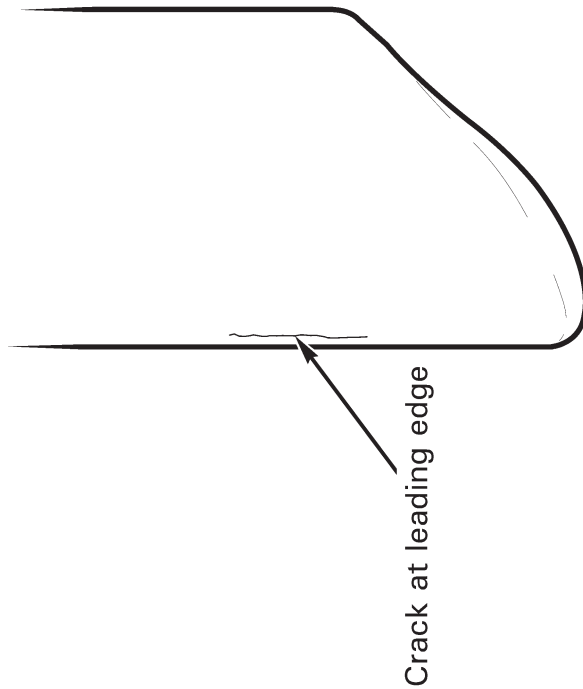
BACKGROUND: RHC has received reports of C029-3 tail rotor blades with a spanwise corrosion crack along the leading edge of the blade. All reports involve blades from a single manufacturing lot with a suspected heat treat anomaly. Affected blades must be removed from service. For continued operation until blades are replaced, additional pilot preflight inspection is required.

As part of each preflight inspection, perform detailed visual inspection of outboard 12 inches (30 cm) of blade leading edge. If any hairline crack similar to one shown in figure is found, aircraft is unairworthy. Replace blade prior to further flight.

Crack at leading edge

PART B: Replace each affected tail rotor blade per R44 Maintenance Manual (MM) § 9.300 and install tail rotor assembly per MM § 9.220. Enter new blade serial numbers in aircraft maintenance records.
