R22 SERVICE LETTER SL-93

R44 SERVICE LETTER SL-82

R66 SERVICE LETTER SL-40

SUBJECT: Tail Rotor Blade Condition and Care

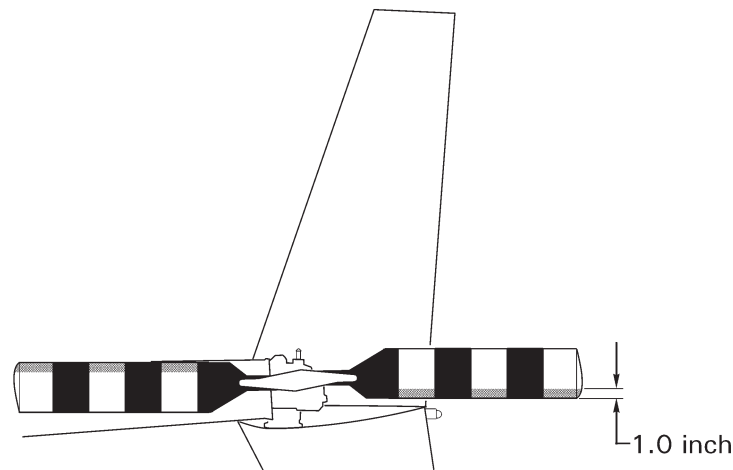
Preferred blade condition is with fully painted leading edge. Use two coats of Desoprime CA7501 epoxy primer (or equivalent). Scuff primer prior to applying second coat. Use Dupont Imron polyurethane enamel or equivalent paint. Refer to aircraft Maintenance Manual (MM) for specific paint codes. Blades with striped leading edges may be painted with solid black leading edge as shown below if desired for ease of application:

Paint offers the best protection against leading edge corrosion. If painting blades is impractical, at least a single coat of primer on leading edges provides some protection.
