TO: Holders of RR300 Series Operations and Maintenance Manual, Publication CSP 21009.

Reason: Revised inspection procedure.

Component: Compressor Front Support Assembly

COMPRESSOR FRONT SUPPORT ASSEMBLY INSPECTION/CHECK

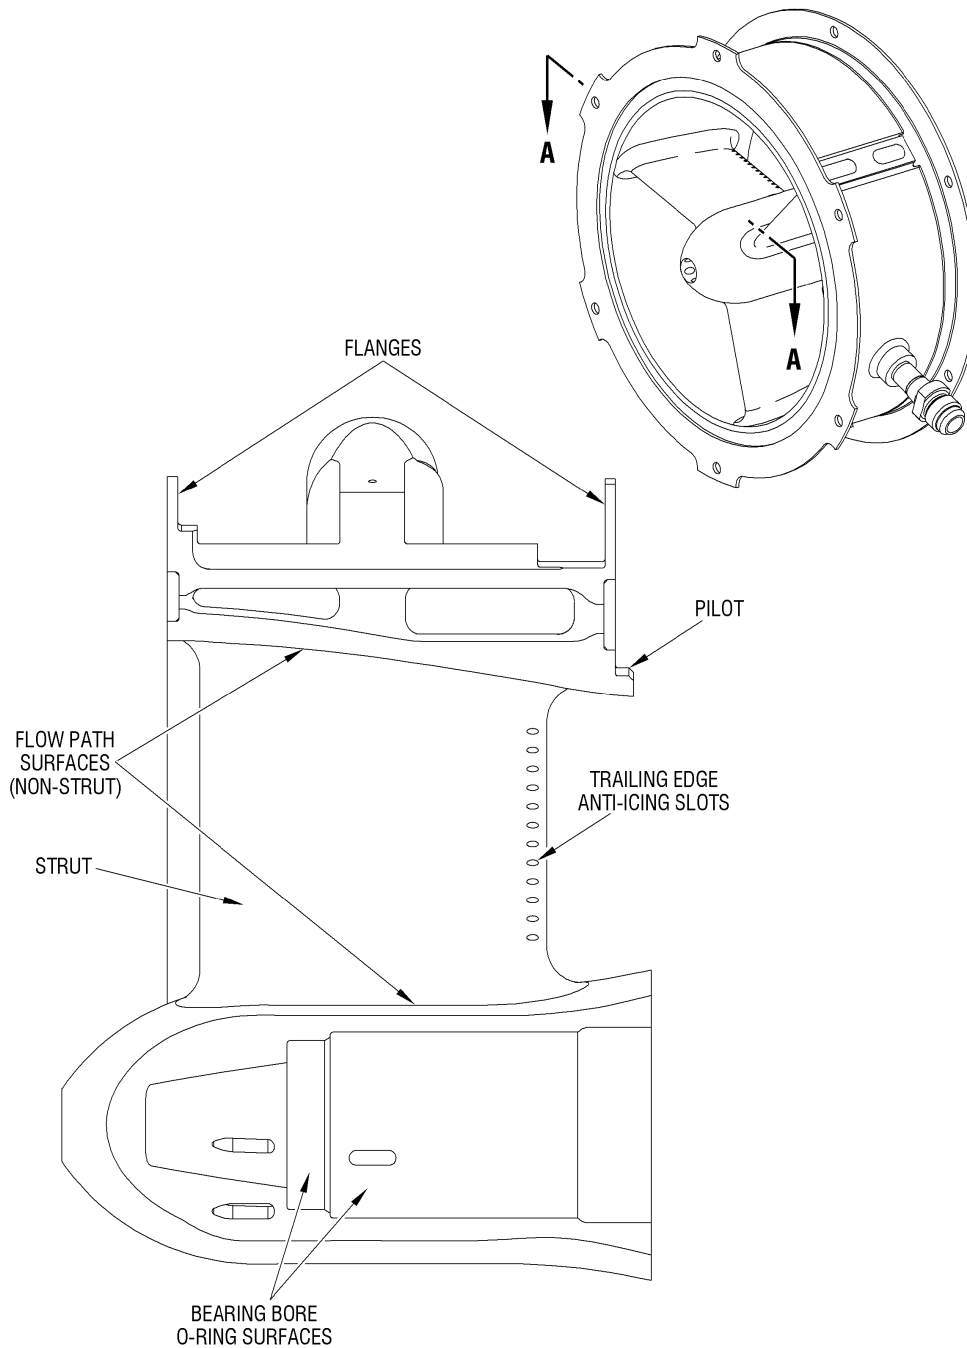
Compressor Front Support - Inspection/Check
FIG. 801/TASK 72-30-10-990-801

(1) Do the visual inspection of the compressor front support assembly (support).

(a) Do the visual inspection of the support when it is removed to the limits that follow:

ITEM	SERVICEABLE LIMITS	REPAIR LIMITS	ACTION NECESSARY
Cracks or linear indications	None permitted.	There is no limit to the quantity.	Replace the support.
Flow path area (non-strut)			
- Nicks or dents	Maximum diameter of 0.040 in. (1.02 mm) with a maximum depth of 0.020 in. (0.51 mm).	There is no limit to the quantity.	Replace the support.
- Scratches	Maximum length of 0.100 in. (2.54 mm) with a maximum depth of 0.020 in. (0.51 mm).	There is no limit to the quantity.	Replace the support.
- High metal	None permitted.	There is no limit to the quantity.	Remove the high metal by blending (Ref. TASK 70-33-03-300-801).

ITEM	SERVICEABLE LIMITS	REPAIR LIMITS	ACTION NECESSARY
- Nicks or dents	Maximum diameter of 0.040 in. (1.02 mm) with a maximum depth of 0.010 in. (0.25 mm).	There is no limit to the quantity.	Replace the support.

- Scratches	Maximum length of 0.100 in. (2.54 mm) with a maximum depth of 0.010 in. (0.25 mm).	There is no limit to the quantity.	Replace the support.
- High metal	None permitted.	There is no limit to the quantity.	Remove the high metal by blending (Ref. TASK 70-33-03-300-801).
Bearing bore (non-O-ring surfaces)

- Nicks or dents	Maximum diameter of 0.025 in. (0.64 mm) with a maximum depth of 0.010 in. (0.25 mm).	There is no limit to the quantity.	Replace the support.

- Scratches	Maximum length of 0.200 in. (5.08 mm) with a maximum depth of 0.010 in. (0.25 mm).	There is no limit to the quantity.	Replace the support.
- High metal	None permitted.	There is no limit to the quantity.	Remove the high metal by blending (Ref. TASK 70-33-03-300-801).

- Wear from No. 1 bearing pin	Maximum axial (fore and aft) width of 0.100 in. (2.54 mm).	There is no limit to the quantity.	Replace the support.
Bearing bore (O-ring surfaces)

- Nicks or dents	None permitted.	There is no limit to the quantity.	Replace the support.
- Scratches	None permitted.	There is no limit to the quantity.	Replace the support.

- High metal	None permitted.	There is no limit to the quantity.	Remove the high metal by blending. Keep the circumferential sequence of the surface texture. Do not make axial scratches (Ref. TASK 70-33-03-300-801).
Fore and aft flanges

- Nicks or dents	Maximum diameter of 0.040 in. (1.02 mm) with a maximum depth of 0.010 in. (0.25 mm).	There is no limit to the quantity.	Replace the support.

ITEM	SERVICEABLE LIMITS	REPAIR LIMITS	ACTION NECESSARY
- Scratches	Maximum length of 0.200 in. (5.08 mm) with a maximum depth of 0.010 in. (0.25 mm).	There is no limit to the quantity.	Replace the support.
- High metal	None permitted.	There is no limit to the quantity.	Remove the high metal by blending (Ref. TASK 70-33-03-300-801).
Pilot			
- High metal	None permitted.	There is no limit to the quantity.	Remove the high metal by blending (Ref. TASK 70-33-03-300-801).
Threaded fittings			
- Damaged threads	None permitted.	There is no limit to the quantity.	Replace the support.
- Axial scratches on seal surface	None permitted.	There is no limit to the quantity.	Replace the support.
Strut trailing edge anti-icing slot			
- Blockage	None permitted.	There is no limit to the quantity.	Replace the support.
