SERVICE BULLETIN
SB0222 March 6th, 2023 Revision 01

BATTERY 443CH1 P/N 416470
One-way valve inspection

This Service Bulletin (SB) 0222 is a notification from Saft concerning design improvement of the battery 443CH1 Saft P/N 416470 one-way valve Saft P/N 415690.

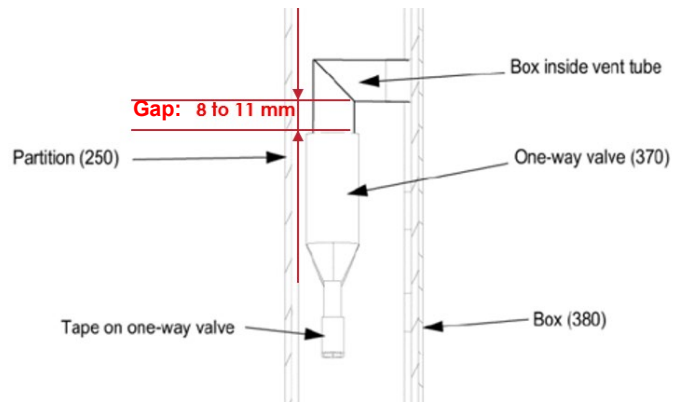
Figure 001 – Gap between the one-way valve (370) Saft P/N 415690 with the vent tube

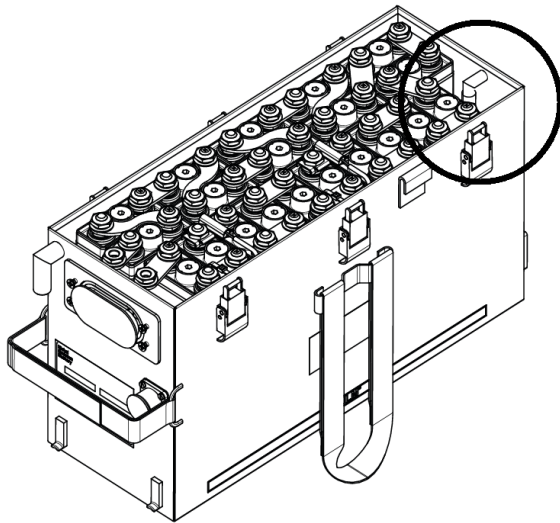
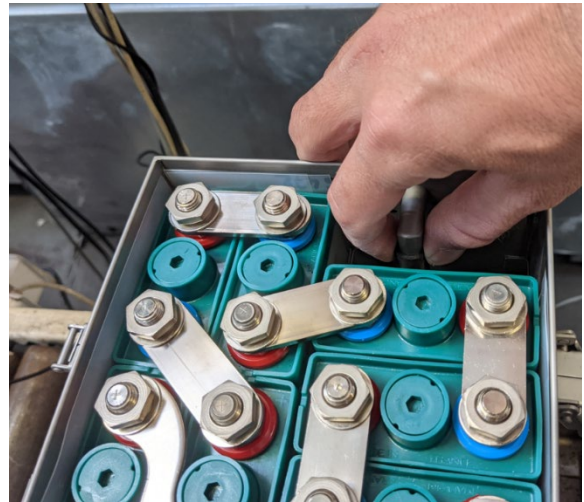
Figure 002 – Detailed view one-way valve (370) location and clearance for handling.

- Remove the one-way valve (370) by gently pulling on the one-way valve to remove it from the vent tube, refer to figure 002.
- Scrap the defective one-way valve (370).

- Install the new one-way valve (370) from inside the box (380) on the box vent tube, refer to figure 002.
- Make sure that the one-way valve (370) Saft P/N 416710 is installed fully and reaches a stop as indicated on the schematic in figure 003 (to 90° tube).
- Once replacement done add on the battery logbook in the column “comments” the following mention: “SB0222 applied”.

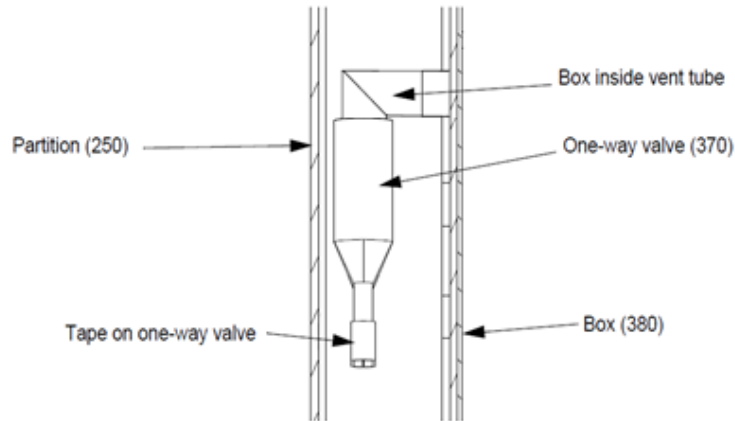
Figure 003 – One-way valve (370) Saft P/N 416710 installation

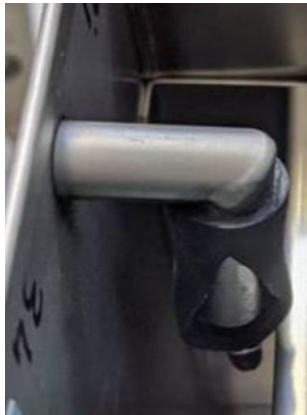
- Visual inspect the installed one-way valve (370) Saft P/N 415690 for any signs of cracks.
If crack on the one-way valve (370) Saft P/N 415690 is identified, example in figure 004, it shall be removed in accordance with point (3).
- Visual inspect the gap between the tube and the one-way valve (370) **Saft P/N 415690** as indicated in figure 001. The **gap must be between 8 to 11 mm**. The measurement is done visually or with an insulated tool.
If the gap is less than 8 mm, the one-way valve must be replaced in accordance with point (3)
If the gap is over 11 mm, adjust the one-way valve in the gap 8 to 11 mm to the tube.
- Else, if one-way valve (370) is not defective, install the complete cover point (5) or continue the maintenance tasks applicable.

4 – Example of cracked one-way valve (370)
