SERVICE BULLETIN

N° 139-722

DATE: August 22, 2022

ATA 62 – MAIN ROTOR HEAD ASSY UPGRADE

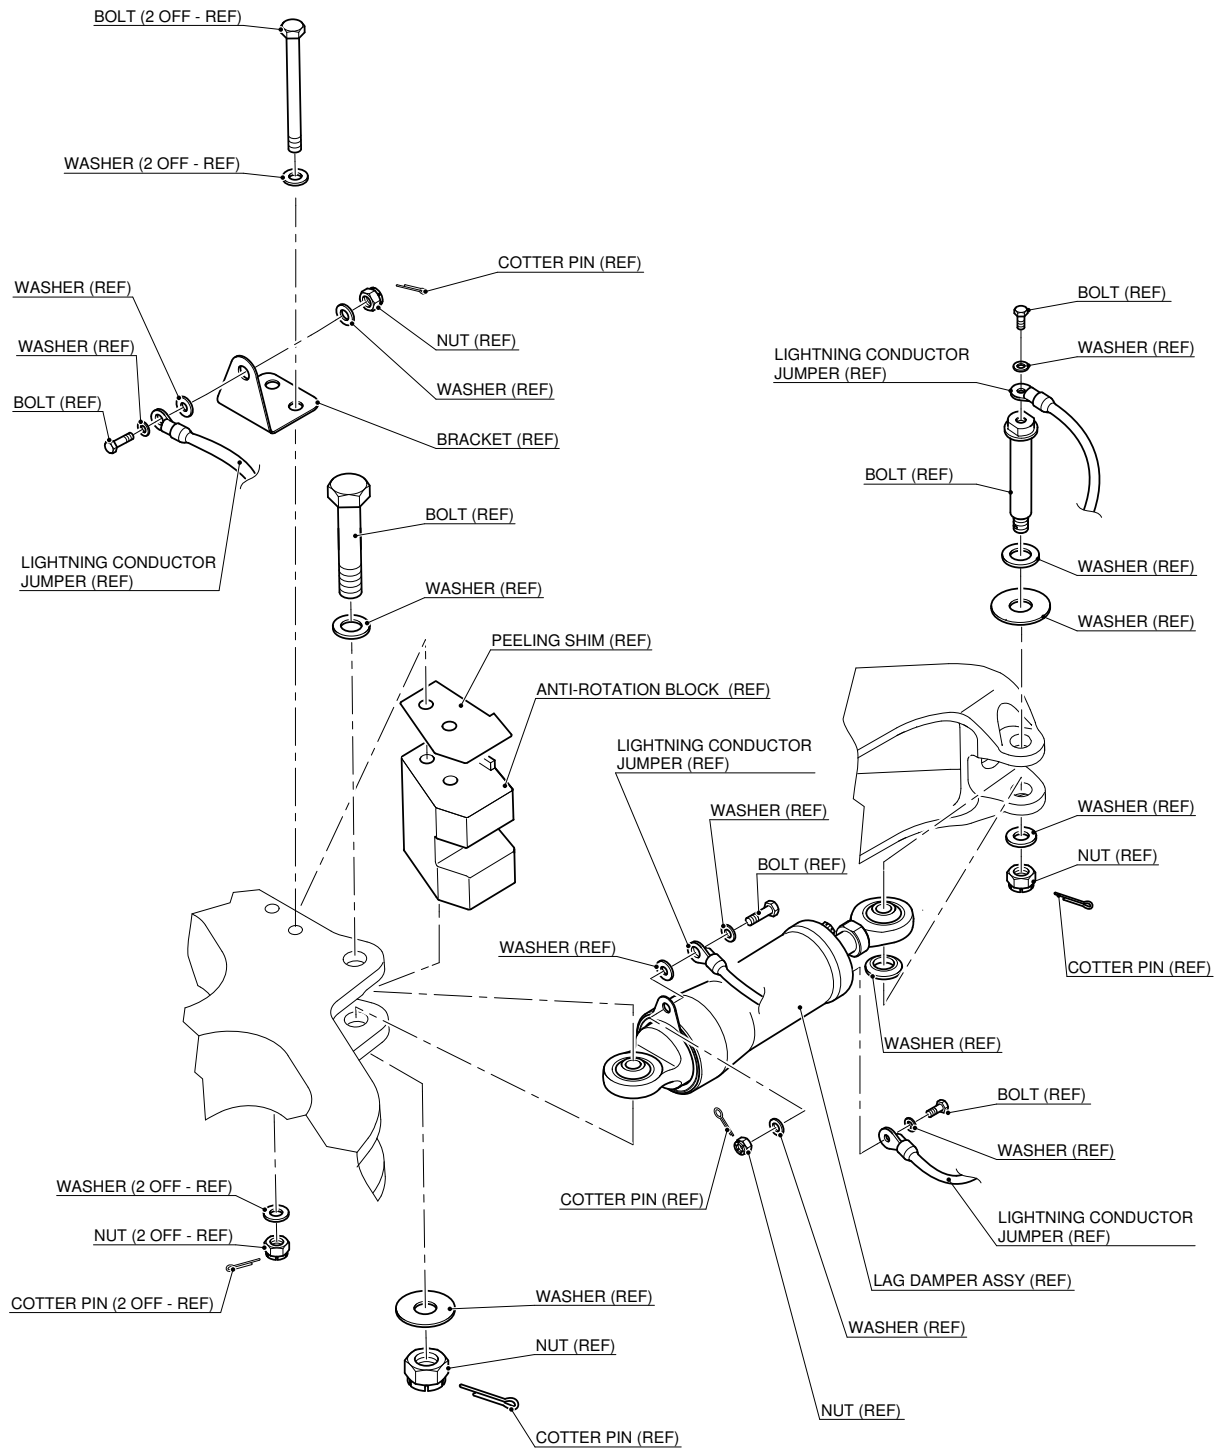
Figure 2

VIEW A
TYPICAL 5 PLACES

1. In accordance with applicable steps of AMP DM 39-A-62-22-00-00A-530A-B and with reference to Figures 1 thru 3, remove and discard the electrical bonding contacts P/N 3G6220A06631 or P/N 3G6220A06632.
2. In accordance with applicable steps of AMP DM 39-A-62-22-00-00A-530A-B and with reference to Figures 1 thru 3, remove and discard twenty flanged bushings P/N 3G6220A03251.
3. In accordance with applicable steps of AMP DM 39-A-62-22-00-00A-530A-B and with reference to Figures 1 thru 4, remove and discard the M.R. scissor attachment flange assy P/N 3G6220A00632.
4. In accordance with applicable steps of AMP DM 39-A-62-22-00-00A-710A-B and with reference to Figures 1 thru 4, install the M.R. scissor attachment flange assy P/N 3G6220A00633.

5. In accordance with applicable steps of AMP DM 39-A-62-22-00-00A-710A-B and with reference to Figures 1 thru 3, install twenty flanged bushings P/N 3G6220A03252.
6. In accordance with applicable steps of AMP DM 39-A-62-22-00-00A-710A-B and with reference to Figures 1 thru 3, install the electrical bonding contact P/N 3G6220A06633.
