SERVICE BULLETIN

N° **139-444**

REV. : C - June 28, 2018

ATA 78 - EXHAUST DUCTS AND REAR FIREWALL RETROMOD

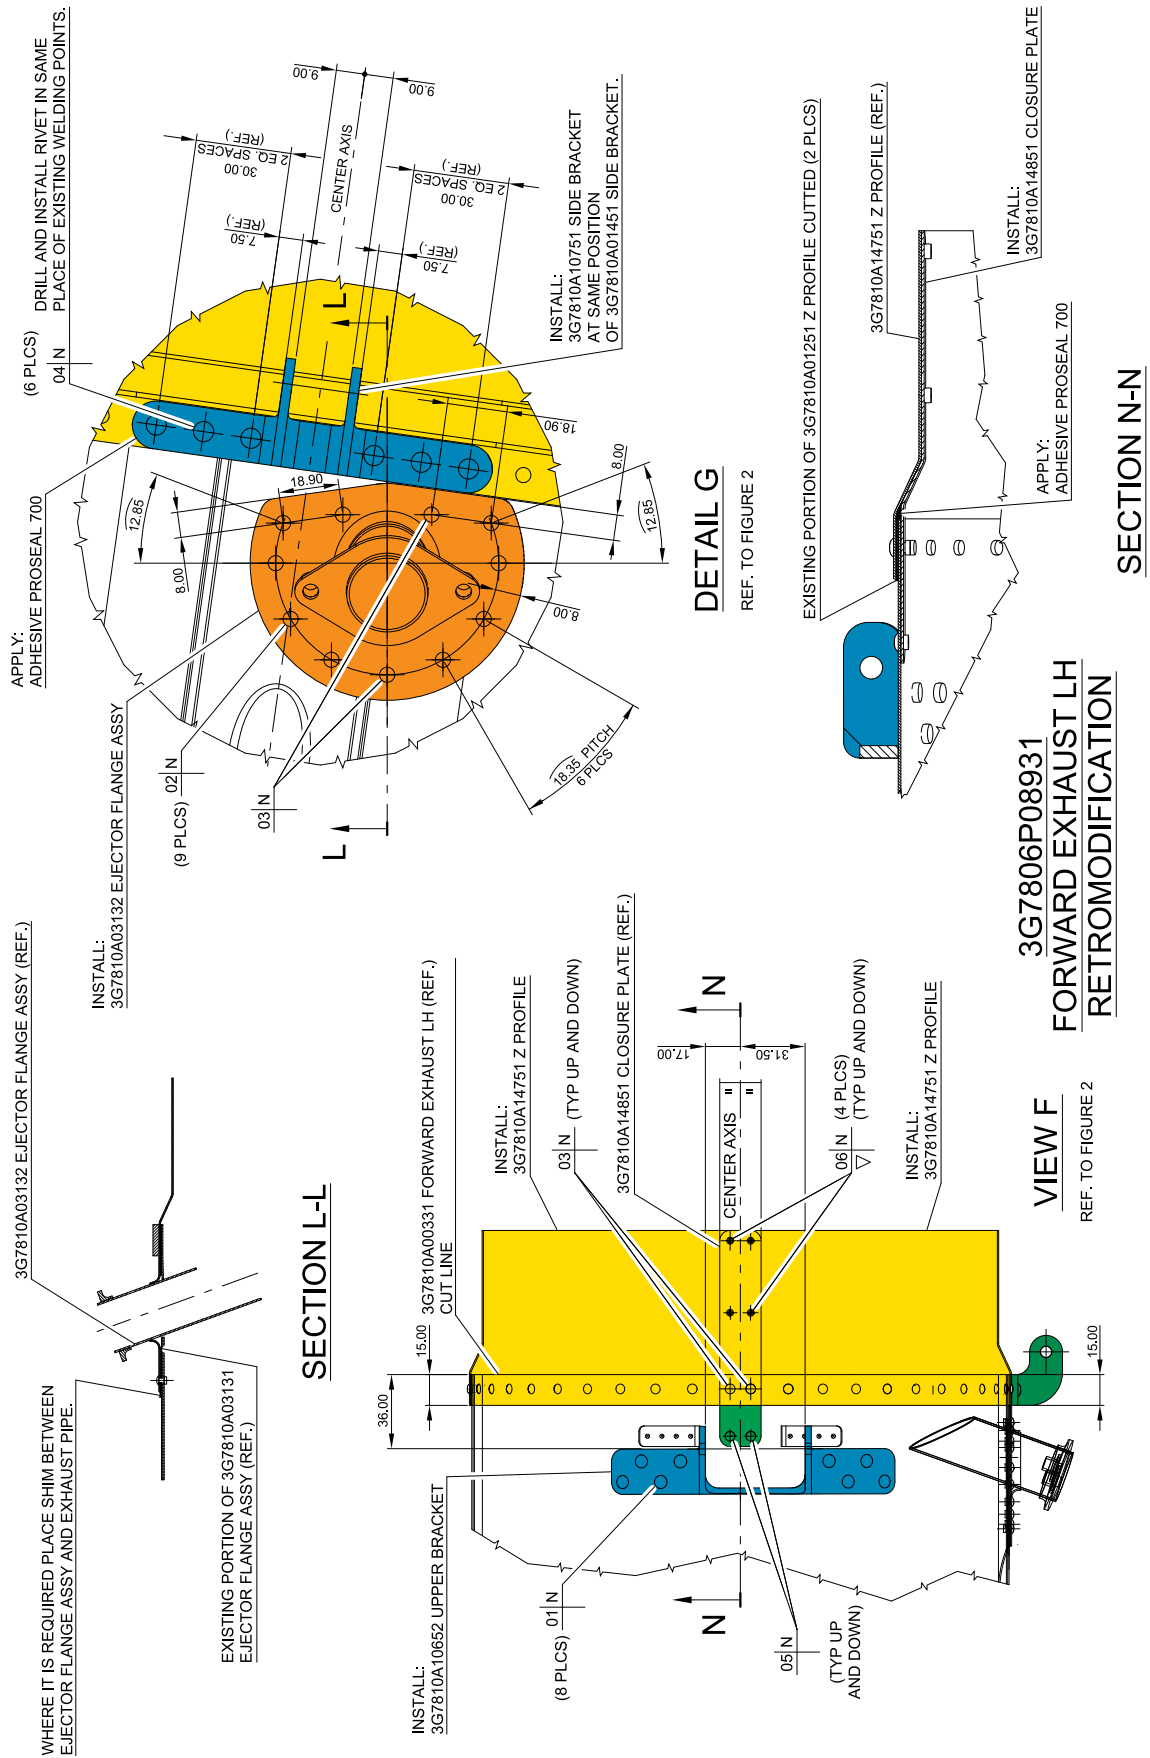
Perform following step 3.8 only if the remaining part of Z profile P/N 3G7810A01251 is damaged.

- 3.8 With reference to Figure 3 section N-N, remove the portion of Z profile damaged and replaced it with a shim with the same dimensions (material AMS5525 Stainless steel plate THK 0.64 mm).

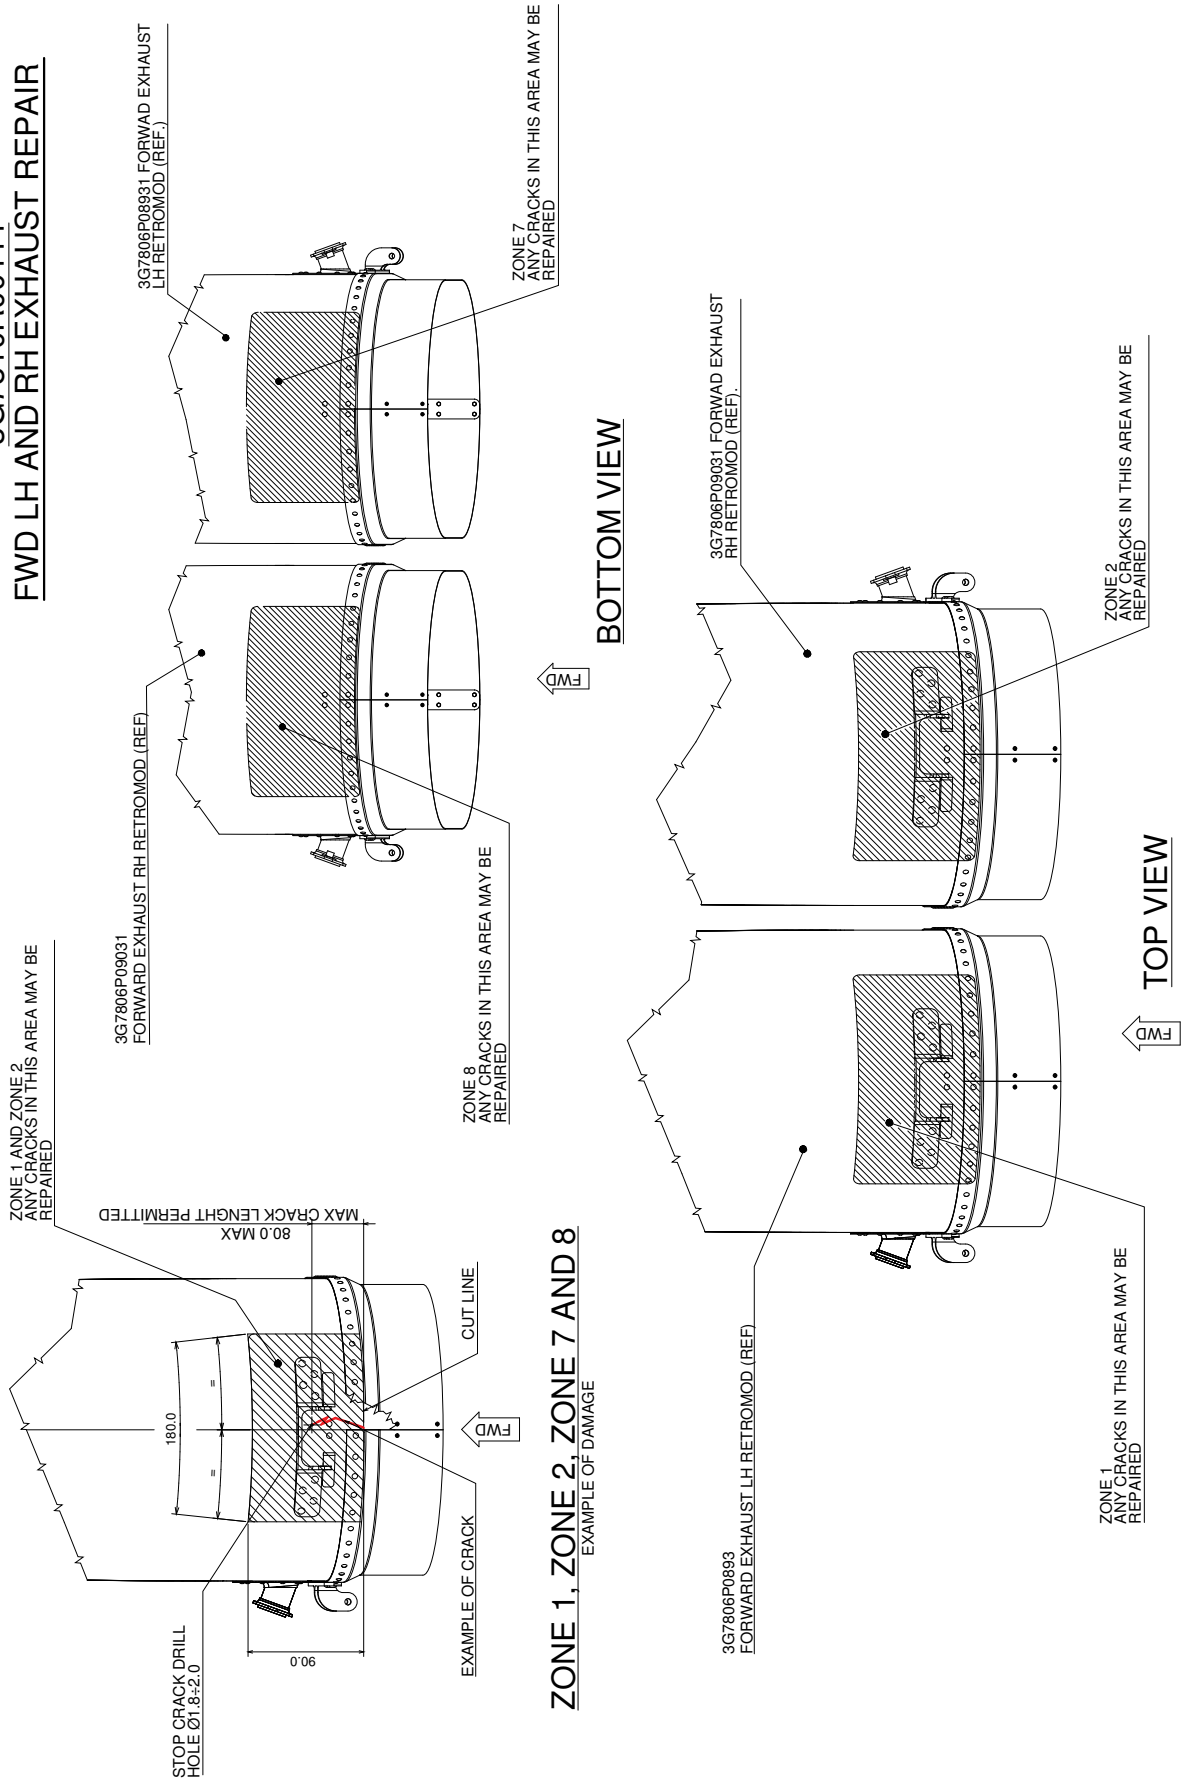
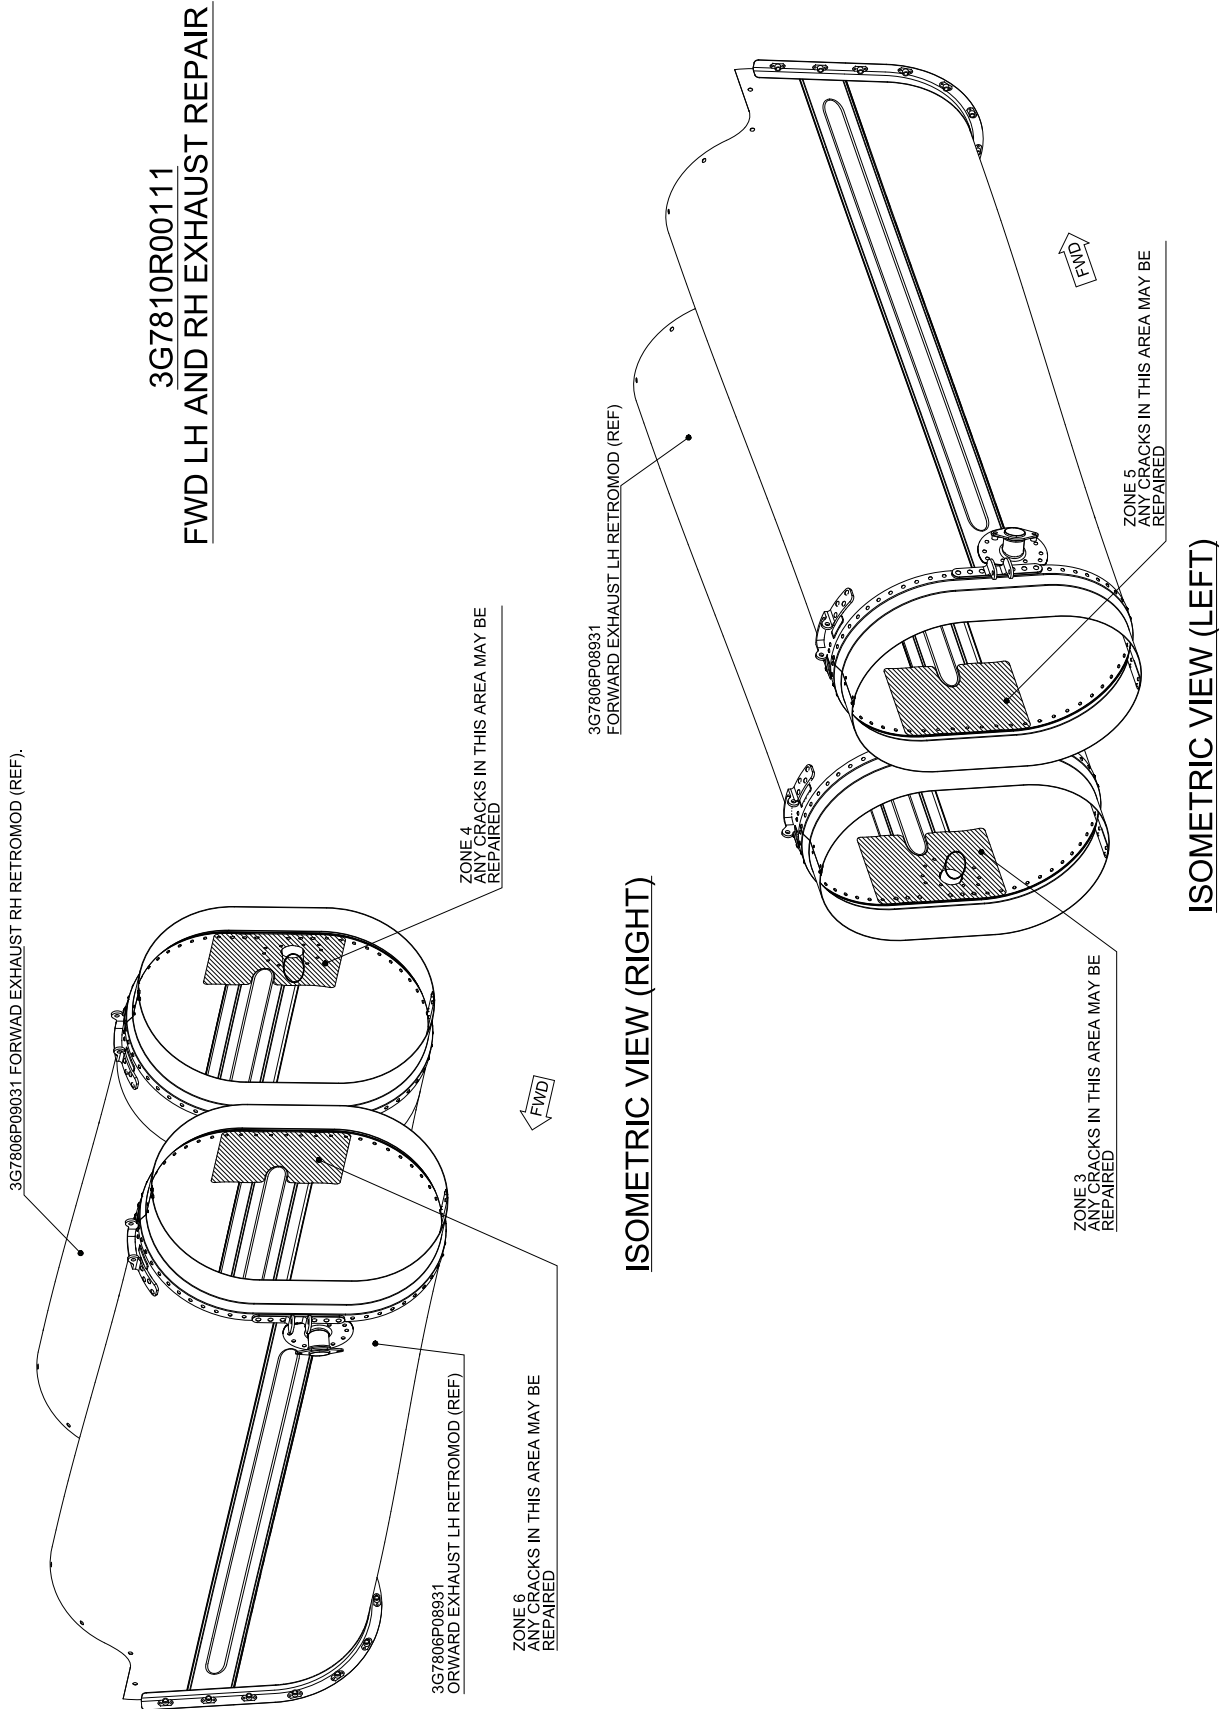
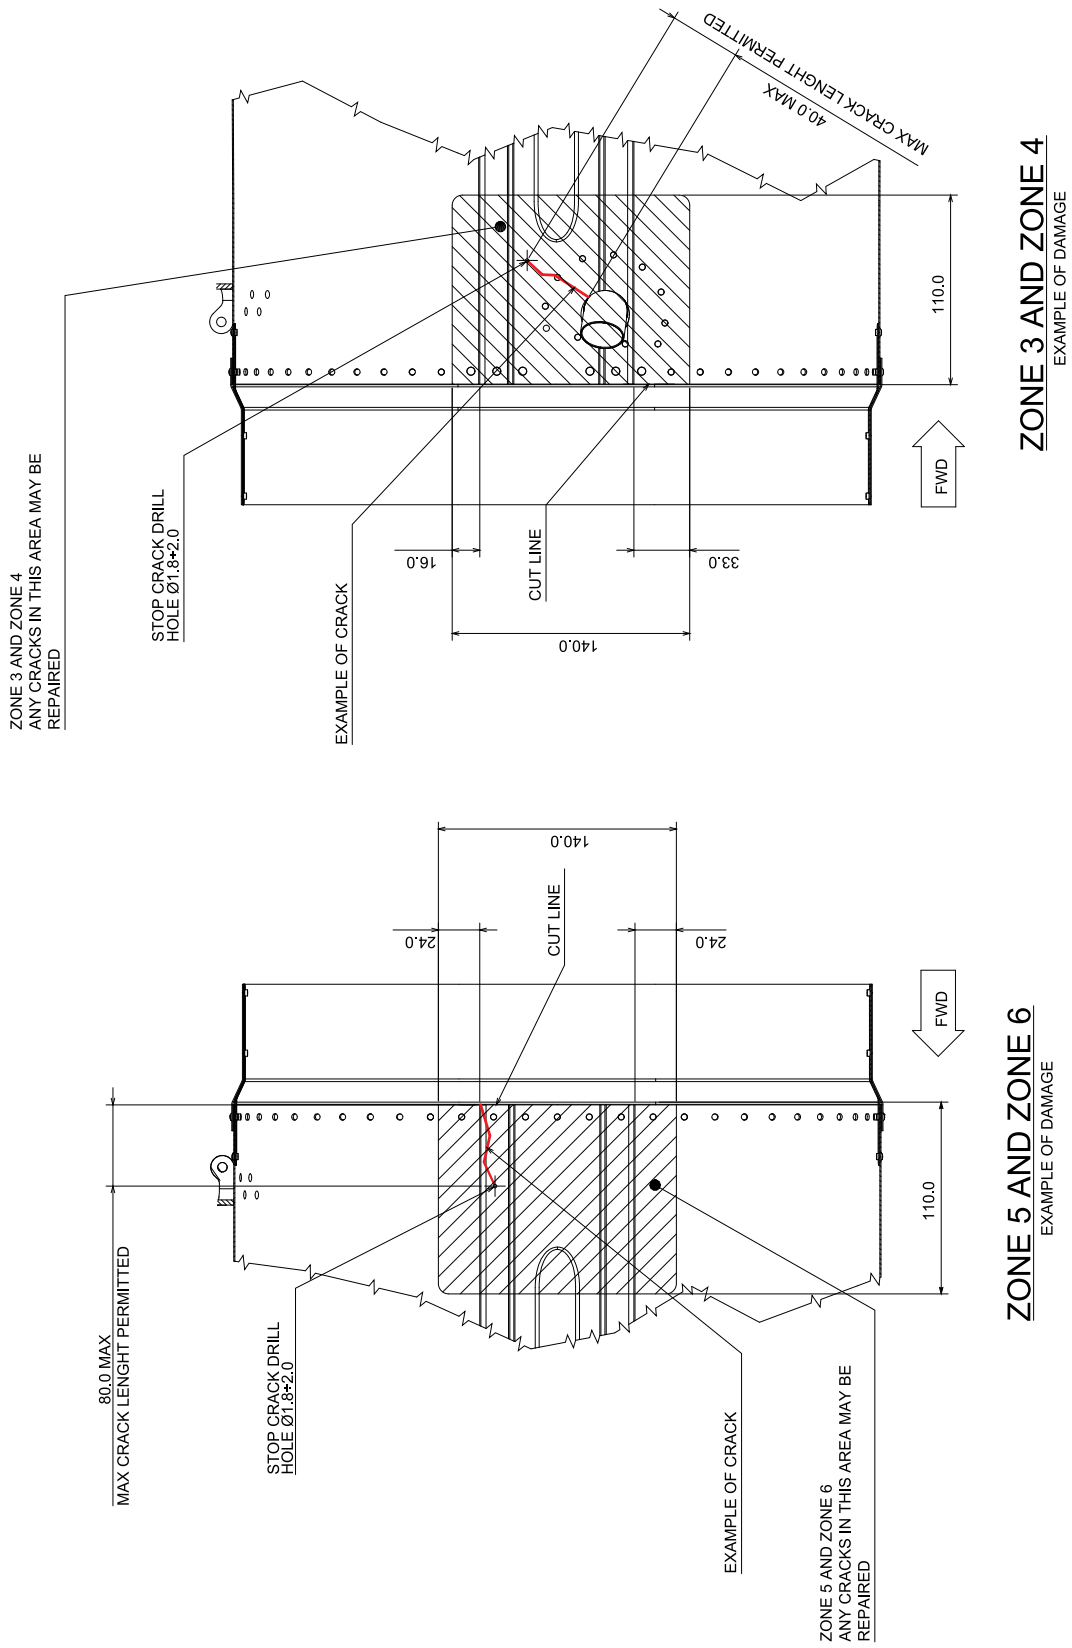
2. With reference to Figure 22 thru Figure 24, verify if cracks are in the areas and within the maximum dimension permitted.

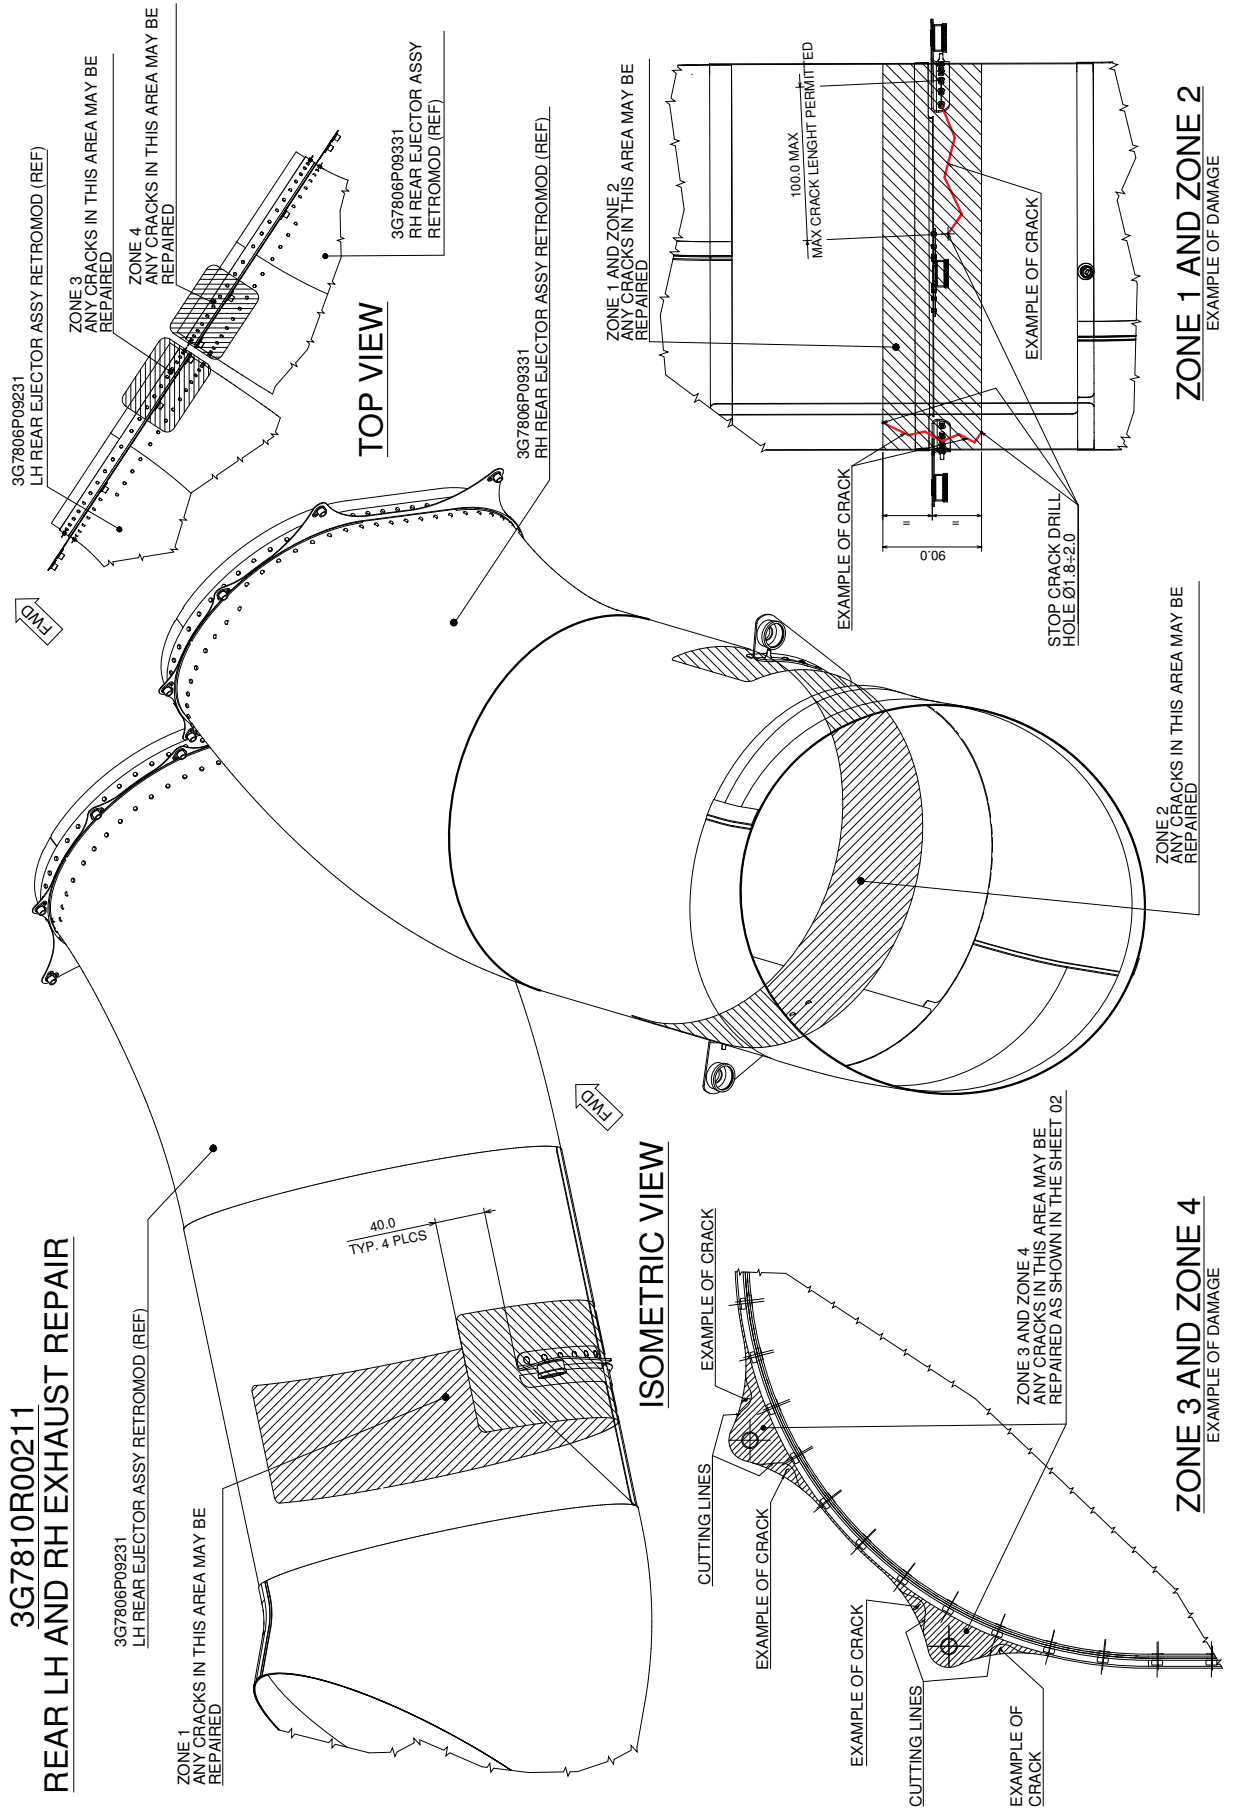
Figure 31

2. With reference to Figure 31, verify if cracks are in the areas and within the maximum dimension permitted.

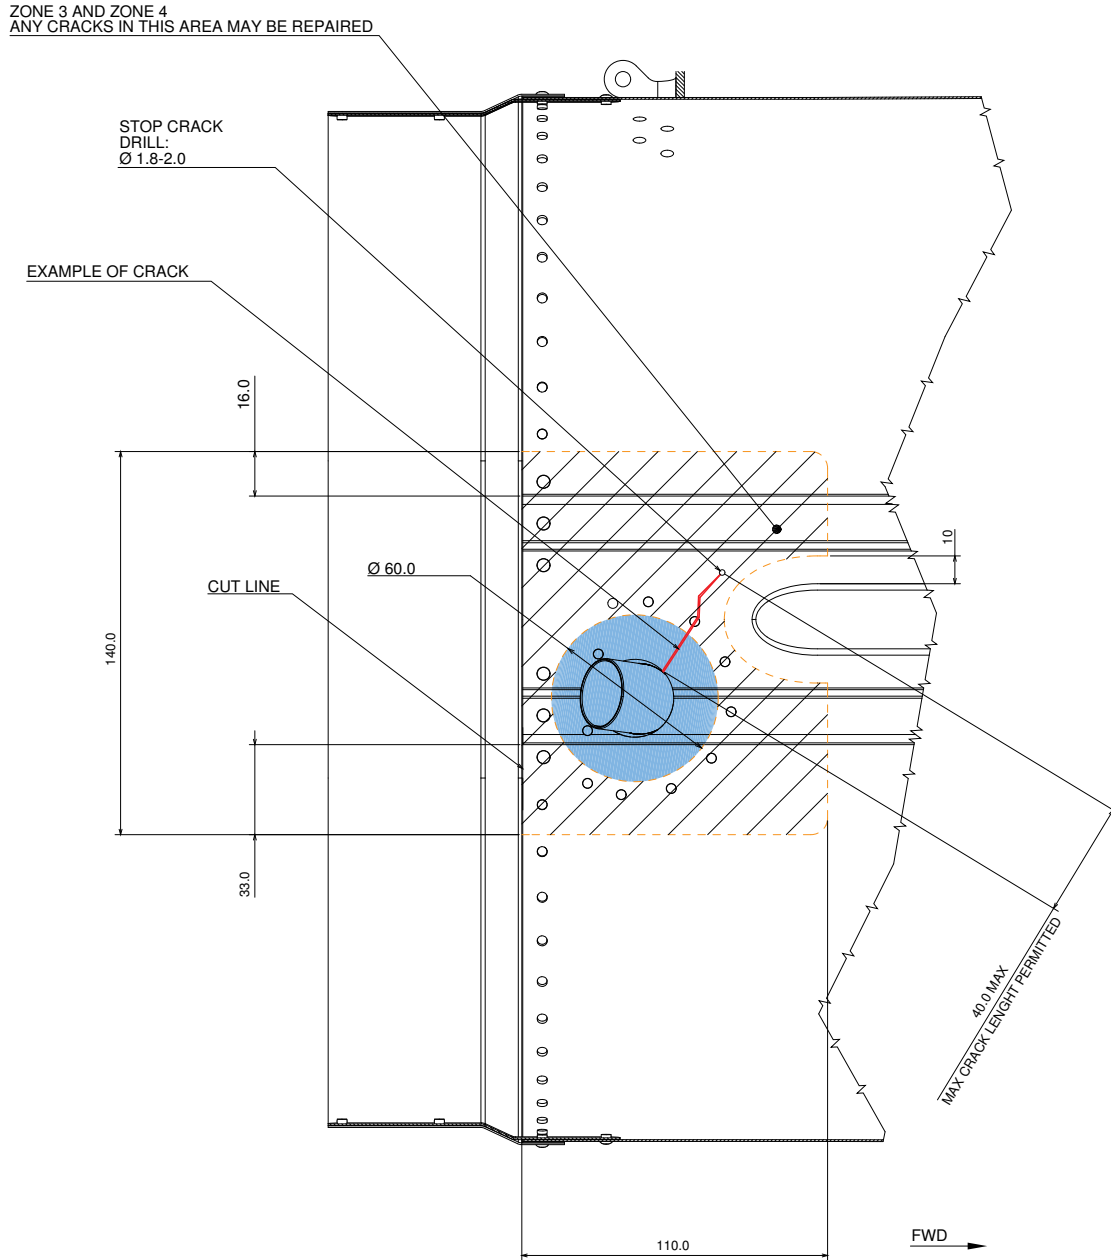
Figure 35

In the Zone 3 is acceptable to have multiple cracks or lack of material in the circular area highlighted in Figure 35.

In the Zone 4 is acceptable to have multiple cracks or lack of material in the circular area highlighted in Figure 35.

ZONE 3 AND ZONE 4
EXAMPLE OF DAMAGE

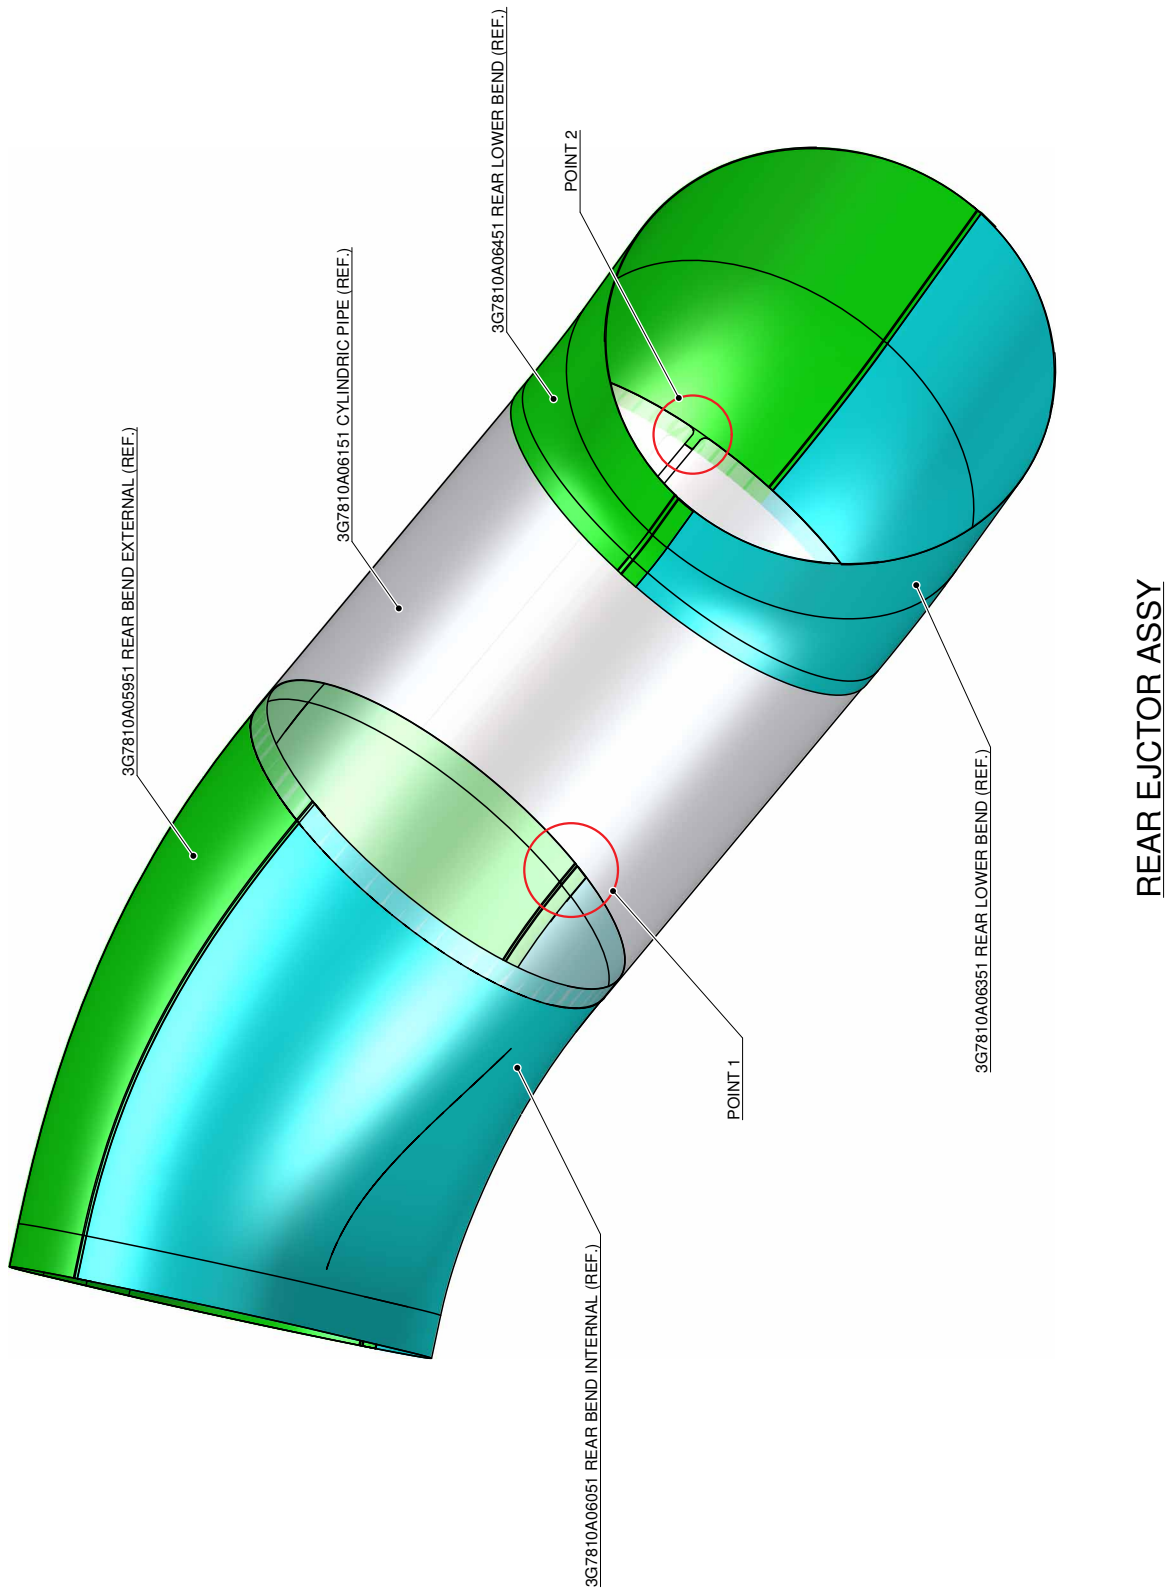
Figure 36

- g) With reference to Figure 36, if a slot is observed on the junctions (Point 1 and 2) between the cylindrical pipe and the others metal sheets of the rear exhaust P/N 3G7810A02131 or 3G7810A02231 or 3G7806P09231 or 3G7806P09331, it is possible to plug it by means of inert gas tungsten arc welding according to AWS D17 Class B (for complete duct sealing).

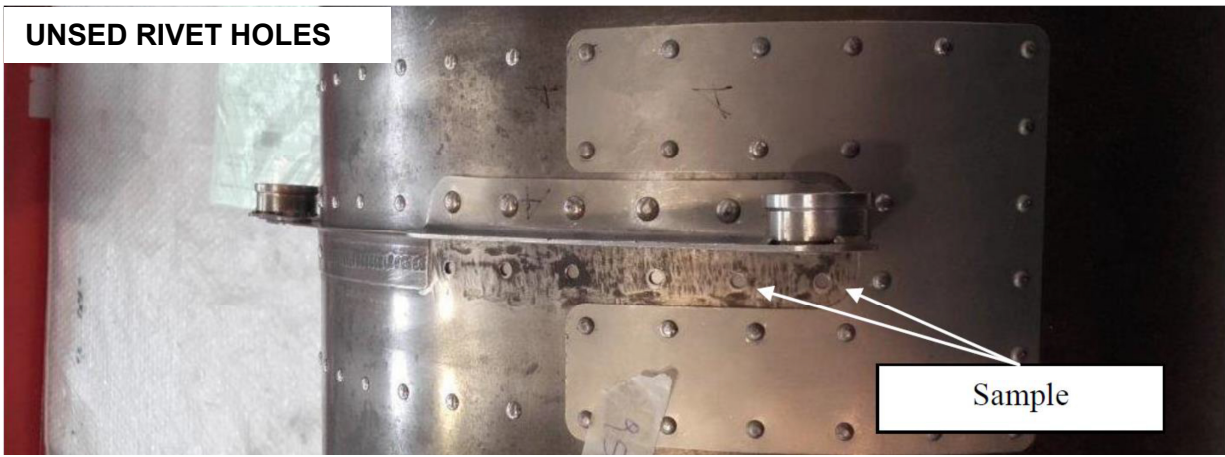
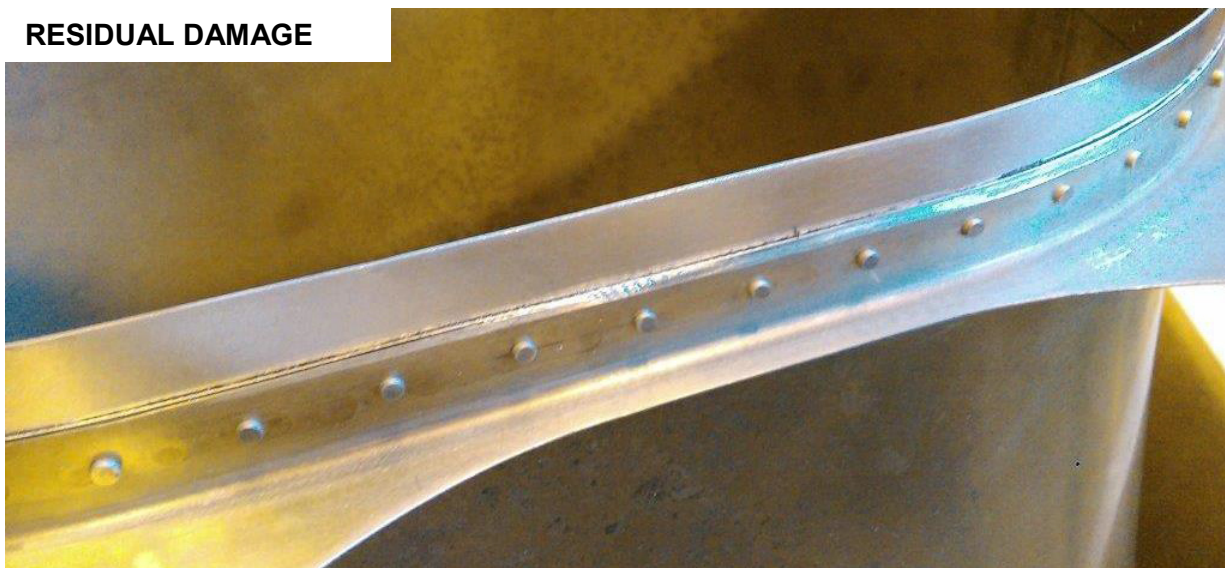
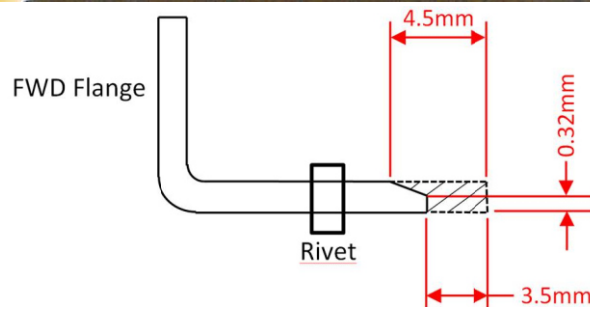
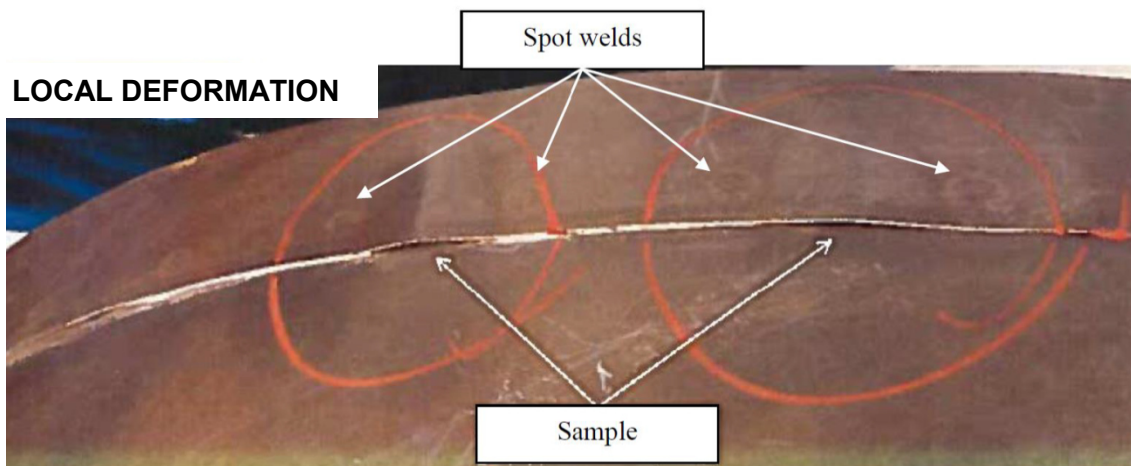
Figure 37

- 3.18 With reference to Figure 8, mark P/N 3G7806P09231 in a visible area on the reworked LH rear ejector assy, by means of an indelible pen.
4. With reference to Figure 37, if the rear exhaust aft attachment flange P/N 3G7810A06551 or P/N 3G7810A06552 has been subject to temporary repair procedure applied as part of dedicated in-service maintenance action, and if during the application of the retro-modification 3G7806P09231 the removal of such temporary repairs related hardware leaved unused rivet holes in the exhaust duct, perform the following procedure:

5. If the Rear Exhaust FWD Profile P/N 3G7810A06651 or P/N 3G7810A06751 has wear perform the following operation:
 - 5.1 With reference to Figure 37, verify the maximum extension and depth of residual damage. Any residual damage that affects the dashed area indicated in Figure 37, is considered acceptable; if the damage exceeds the dashed area, contact AW139 Customer Support Engineering (cse.aw139.aw@leonardocompany.com) to receive proper repair instruction.

6. With reference to Figure 37, verify the presence of a local deformation of the reinforcing ring on the end section of the Rear Exhaust.
 - 6.1 If such deformation is confined within two consecutive spot welds without affecting their adherence to the exhaust duct, and its height do not exceeds 1mm, then it is acceptable. If NOT, contact AW139 Customer Support Engineering (cse.aw139.aw@leonardocompany.com) to receive proper repair

- 4.1 Comply with Part XII of this SB to install Rear LH exhaust repair P/N 3G7810R00611.
 - 4.2 With reference to Figure 37, verify if the holes lies inside the reinforcing plates are at least 10mm from the plates edges.

- 4.3 If confirmed, the presence of the holes lies inside the reinforcing plates is acceptable; if NOT, contact AW139 Customer Support Engineering (cse.aw139.aw@leonardocompany.com) to receive proper repair instruction.
