**SERVICE BULLETIN**

<sub>N°</sub> 139-539

**DATE:** January 26, 2022

ATA 53 - TRDL BEARING SUPPORT PANEL REINFORCEMENT

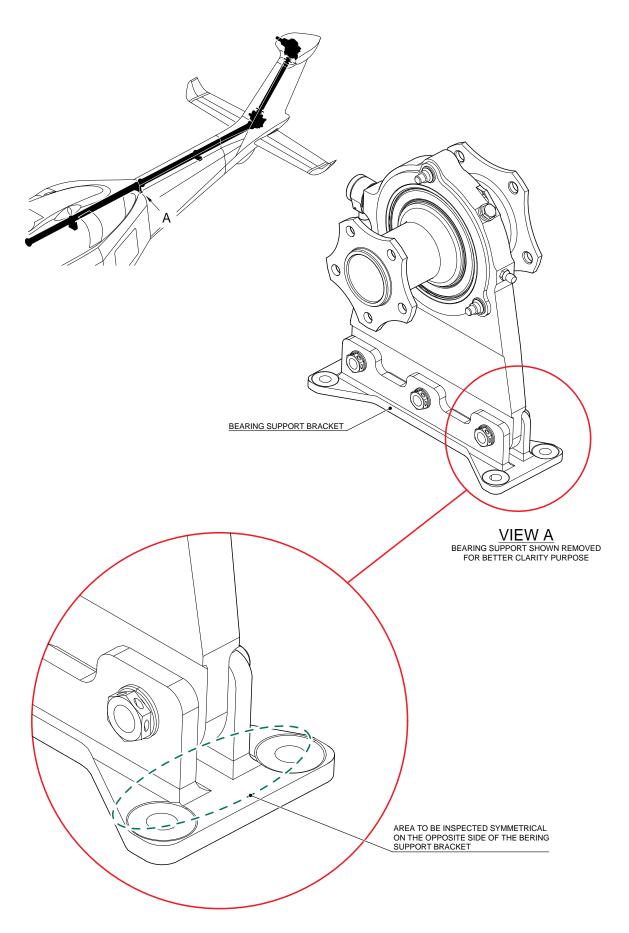
Figure 1

Do not remove paint from the bearing support bracket performing following step 4.1. Even in case of cracks in the paint, replacement of the bearing support bracket is required.

- 4.3.2 Return the defective bearing support bracket to LHD. Contact Product Support Engineering (<a href="mailto:engineering.support.lhd@leonardocompany.com">engineering.support.lhd@leonardocompany.com</a>) for the appropriate instruction to return defective components.

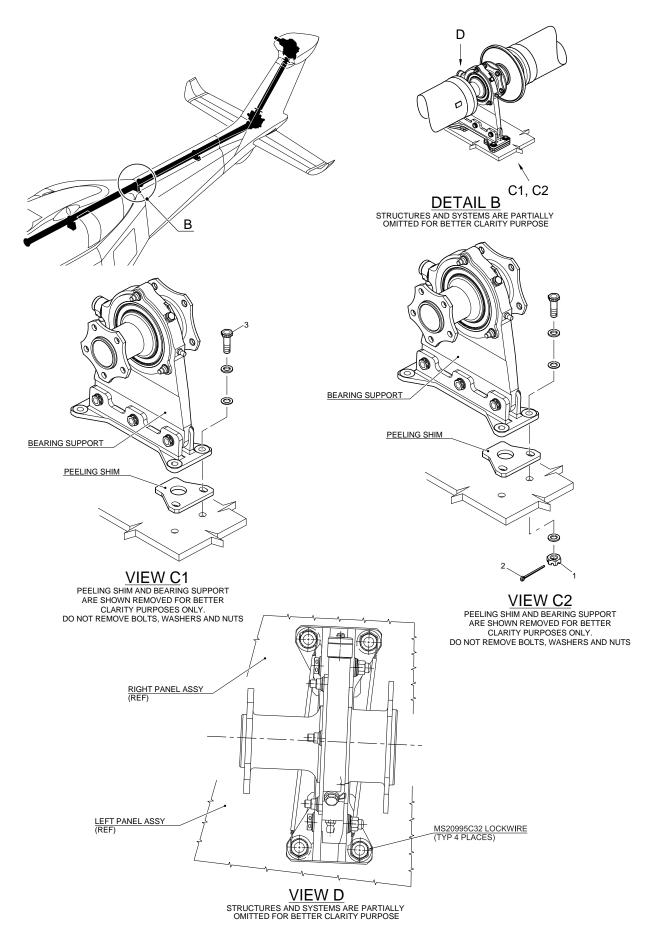
- 5. With reference to Figure 2 View D and to Figures D1 thru D5, D22 and D23 in Annex D, perform the visual inspection for cracks and signs of corrosion of the left and right tail boom panels, on both the upper and the lower side (under roof) of the panel. If there are cracks or signs of corrosion, proceed to step 4 of Part II, to better define the damage limits.

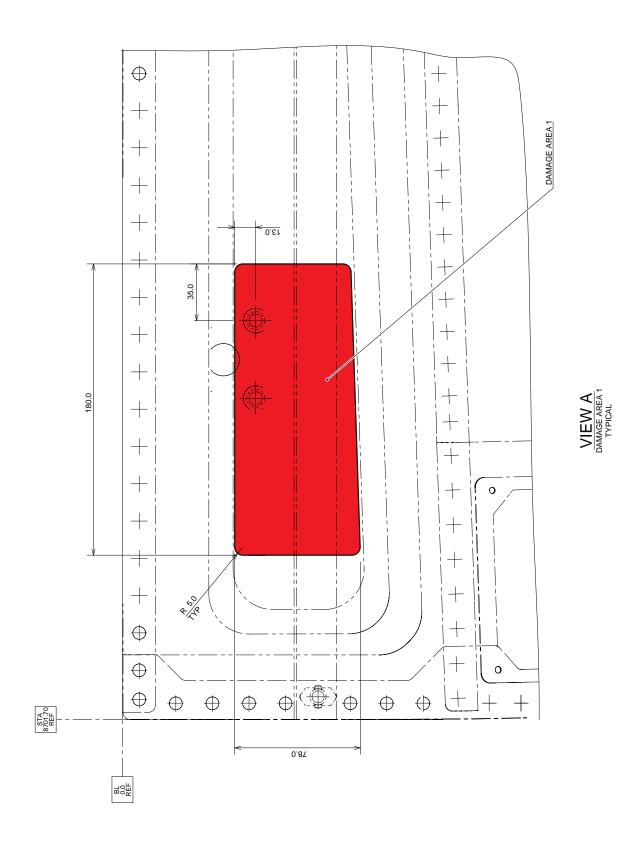
Figure D2

For the identification of the applicable damages of this procedure refer to Figure D2.

- For the damage area 1 (see Figure D2), perform tail boom assy repair 3G5350R00211 described in paragraph 4 of Annex D;
    - For the damage area 2 (see Figure D3), perform tail boom assy repair SK139-1322 described in paragraph 5 of Annex D;

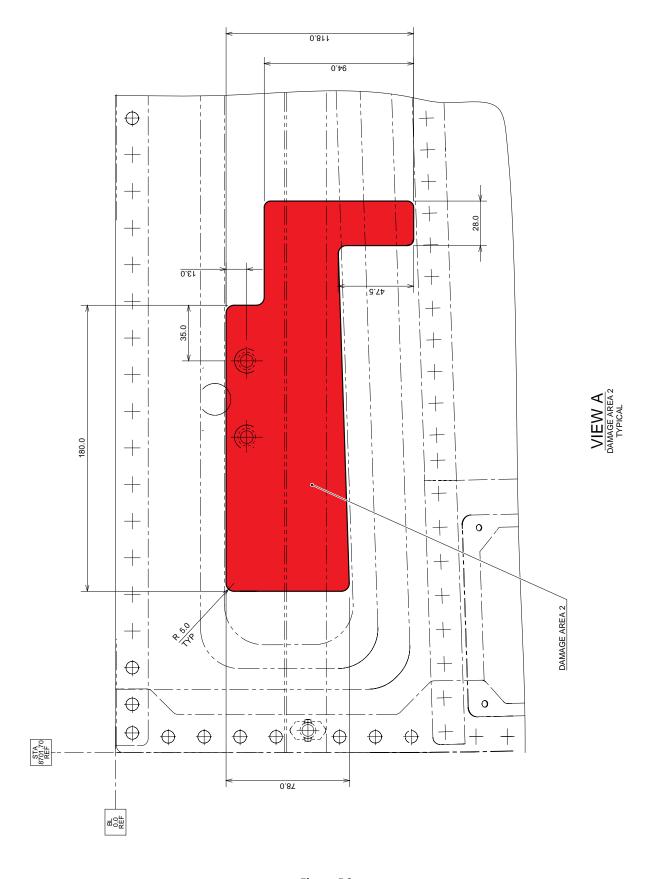
Figure D3

For the identification of the applicable damages of this procedure refer to Figure D3.

For helicopters equipped with the tail boom assy repair SK139-1322, it is allowed to trim the contour of the doubler P/N 3G5350P00355 to fit with the existing doubler.

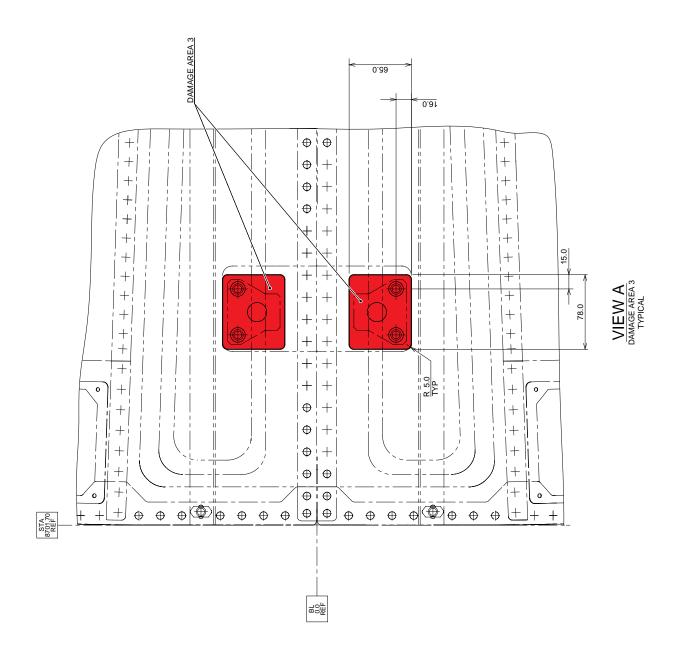
Figure D4

For the identification of the applicable damages of this procedure refer to Figure D4.

- For the damage area 3 (see Figure D4), perform tail boom assy repair RS139-5351-0348 described in paragraph 6 of Annex D;
    - For the damage area 4 (see Figure D5), perform tail boom assy repair RS139-5351-0249 described in paragraph 7 of Annex D;

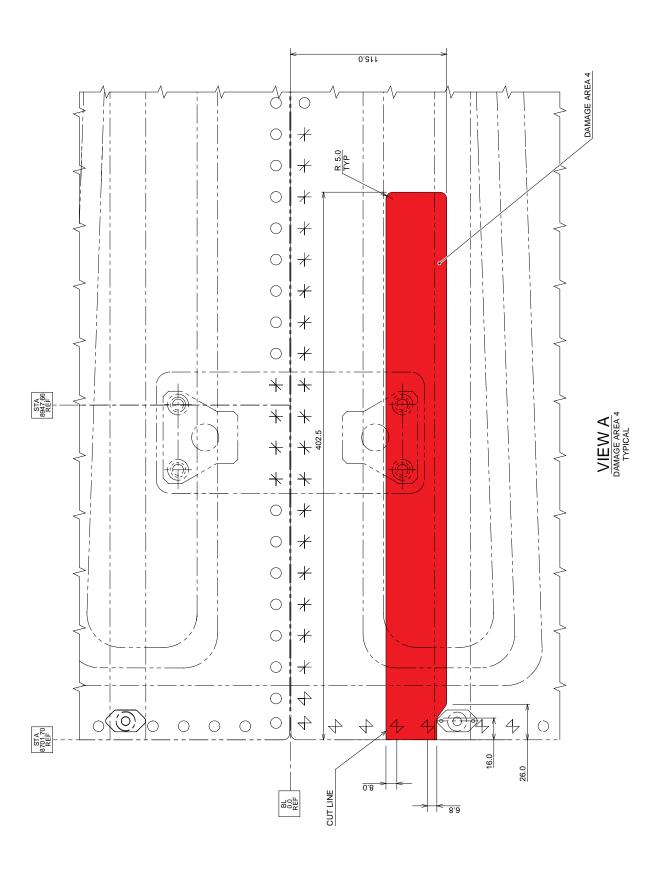
Figure D5

For the identification of the applicable damages of this procedure refer to Figure D5.

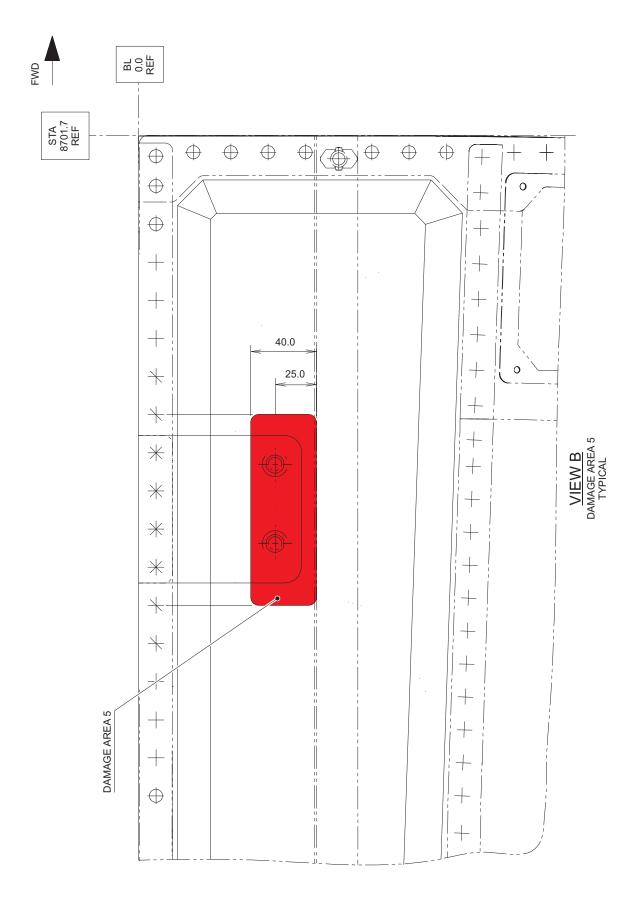
Figure D22

For the identification of the applicable damage of this procedure refer to Figure D22.

- For the damage area 5 (see Figure D22), perform tail boom assy repair SK139-1510, described in paragraph 9 of Annex D;
    - For the damage area 6 (see Figure D23), perform tail boom assy repair RS139-5351-0714, described in paragraph 8 of Annex D.

- 9.1 Perform tail boom assy repair SK139-1510, according to Annex E.
- 9.2 Continue to step 7, 8, 9, or 10 of Part III of this Service Bulletin to complete retromod P/N 3G5350P00311 installation, and perform following applicable steps as required.

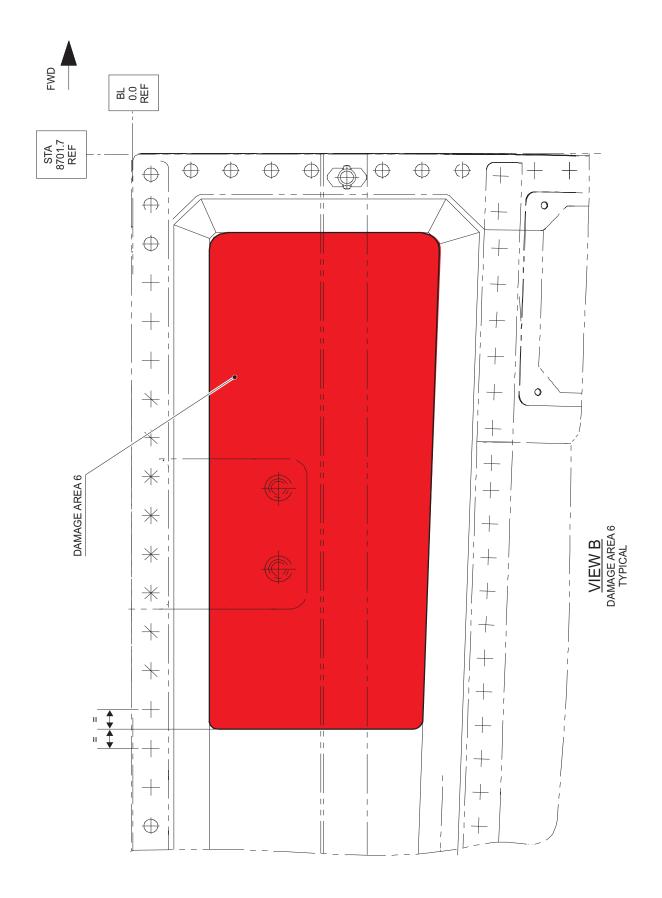
Figure D23

For the identification of the applicable damages of this procedure refer to Figure D23.
