SERVICE BULLETIN

N° **139-629**

ATA 95 – FORWARD FLOATS COVERS UPGRADE

SERVICE BULLETIN SB2019-04 C DART AW139 FWD FLOAT LEFT AND RIGHT ASSEMBLIES UPGRADE

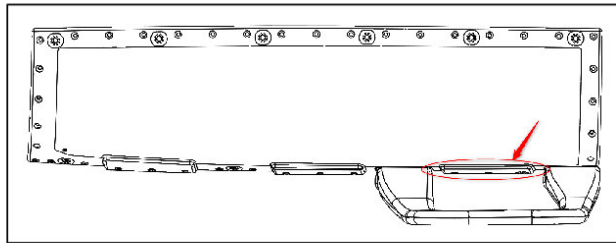
1. Inspect the cover from underside of the aircraft looking outboard at the FWD Pod Assembly in the indicated area in Figure 1.

Figure 1: LH Pod Assembly Cover Cutout Location (RH Opposite)

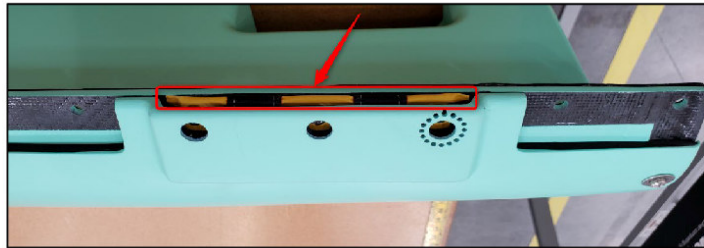
Figure 2: RH Cover with Cutout (LH Opposite)

2. If the cover looks like Figure 2, with the correct cutout, no further action is required.

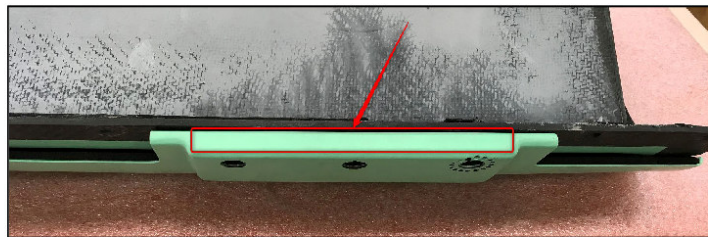
Upon inspection, it was discovered that some LH and RH forward covers (P/N 650.0803 and 650.0804) were manufactured missing a cutout feature on their return flanges. The forward covers were designed to have the cutout to facilitate deployment from the pod during an emergency float activation.

Figure 3: RH Cover Missing Cutout (LH Opposite)

3. If the cover looks like Figure 3, missing the indicated cutout, proceed to Section 2.2.

At the next scheduled service interval, remove the affected forward pod assemblies and return them to DART (or an approved service center) for rework.

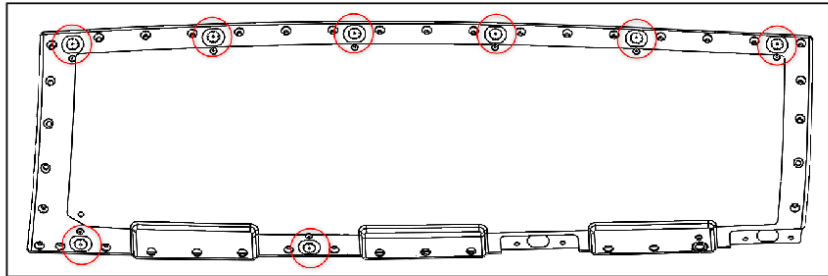
Figure 4: Screw Locations on Pod Assembly Cover (LH shown, RH opposite)

1. Remove the cover from the forward pod assembly by unscrewing the eight screws (P/N 601.2279) on the front of the cover as indicated in Figure 4.

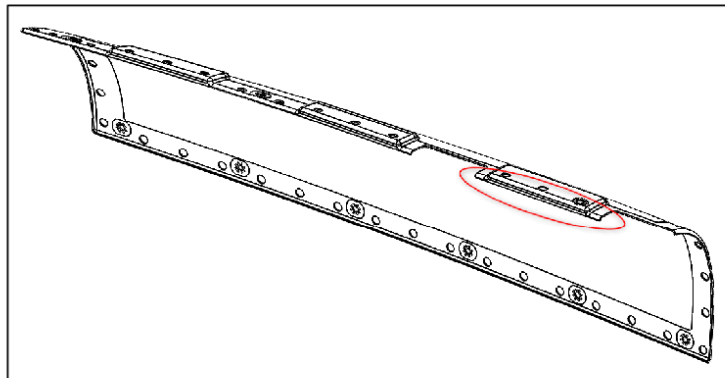
Figure 5: Cutout Location (LH shown, RH opposite)

1. On the cover, identify the location where the cutout needs to be added (Figure 5).

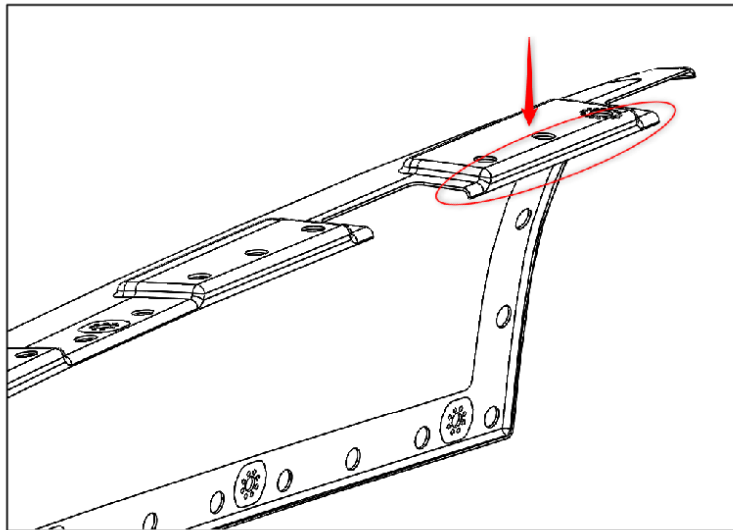
Figure 7: Marking Template Placement on Cover's Edge (LH shown, RH opposite)

2. Place the provided marking template (P/N 607.2710) on the edge of the cover's flange as shown in Figure 7 and Figure 8.

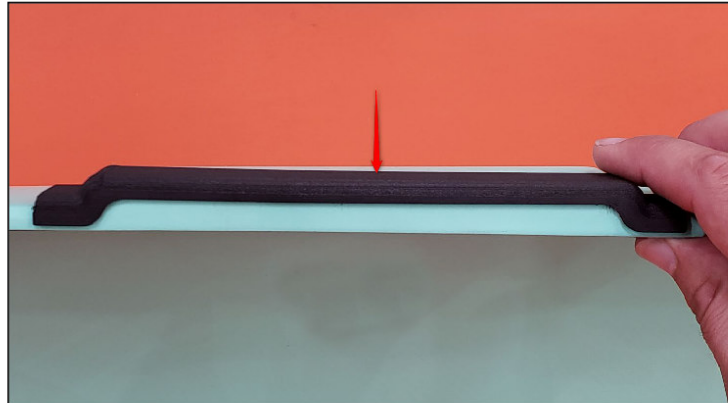
Figure 8: Marking Template on the Edge of the Cover

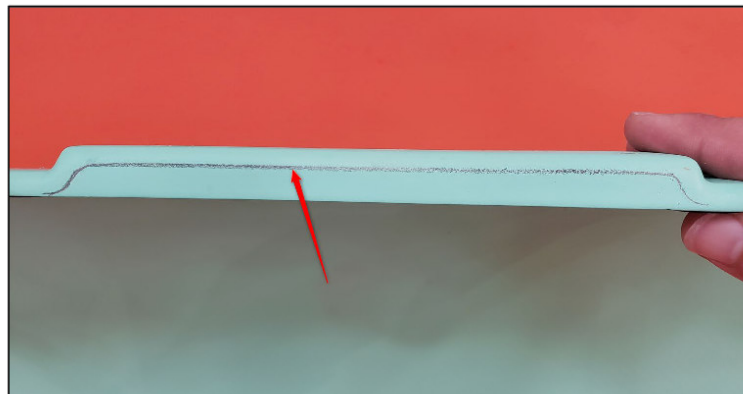
Figure 9: Marked Cover

3. Mark the cover with a pencil or marker as shown in Figure 9.

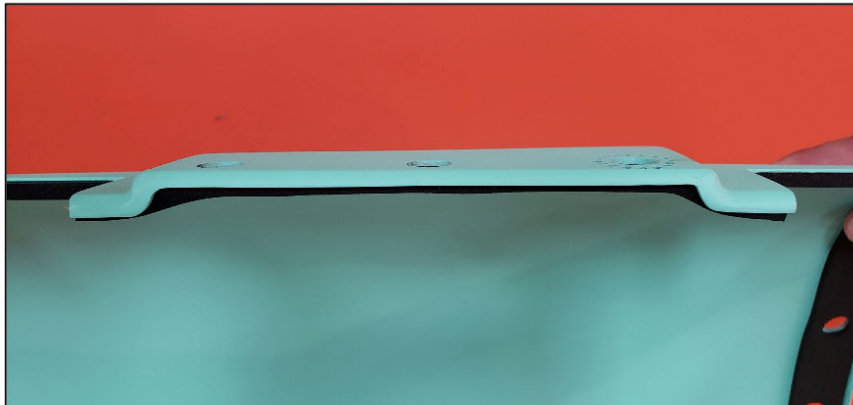
Figure 10: Final Cutout on Cover (LH shown, RH opposite)

4. Use a Dremel or rotary file on high speed to cut the cover up to the marking, as shown in Figure 10.
5. Use a file to deburr. Use preferred MIL spec primer to coat any exposed surfaces.

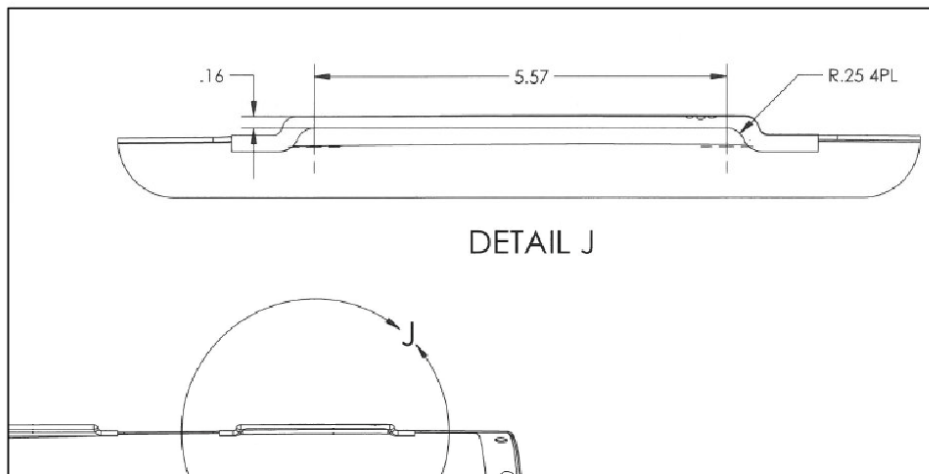
Figure 11: Reference Dimensions (LH shown, RH opposite)

6. Inspect the cutout using the marking template and reference dimensions given in Figure 11.
