SERVICE BULLETIN

N° 139-636

DATE: May 11, 2021

ATA 78 - REAR FIREWALL MODULE ASSY RETROMOD INSTALLATION

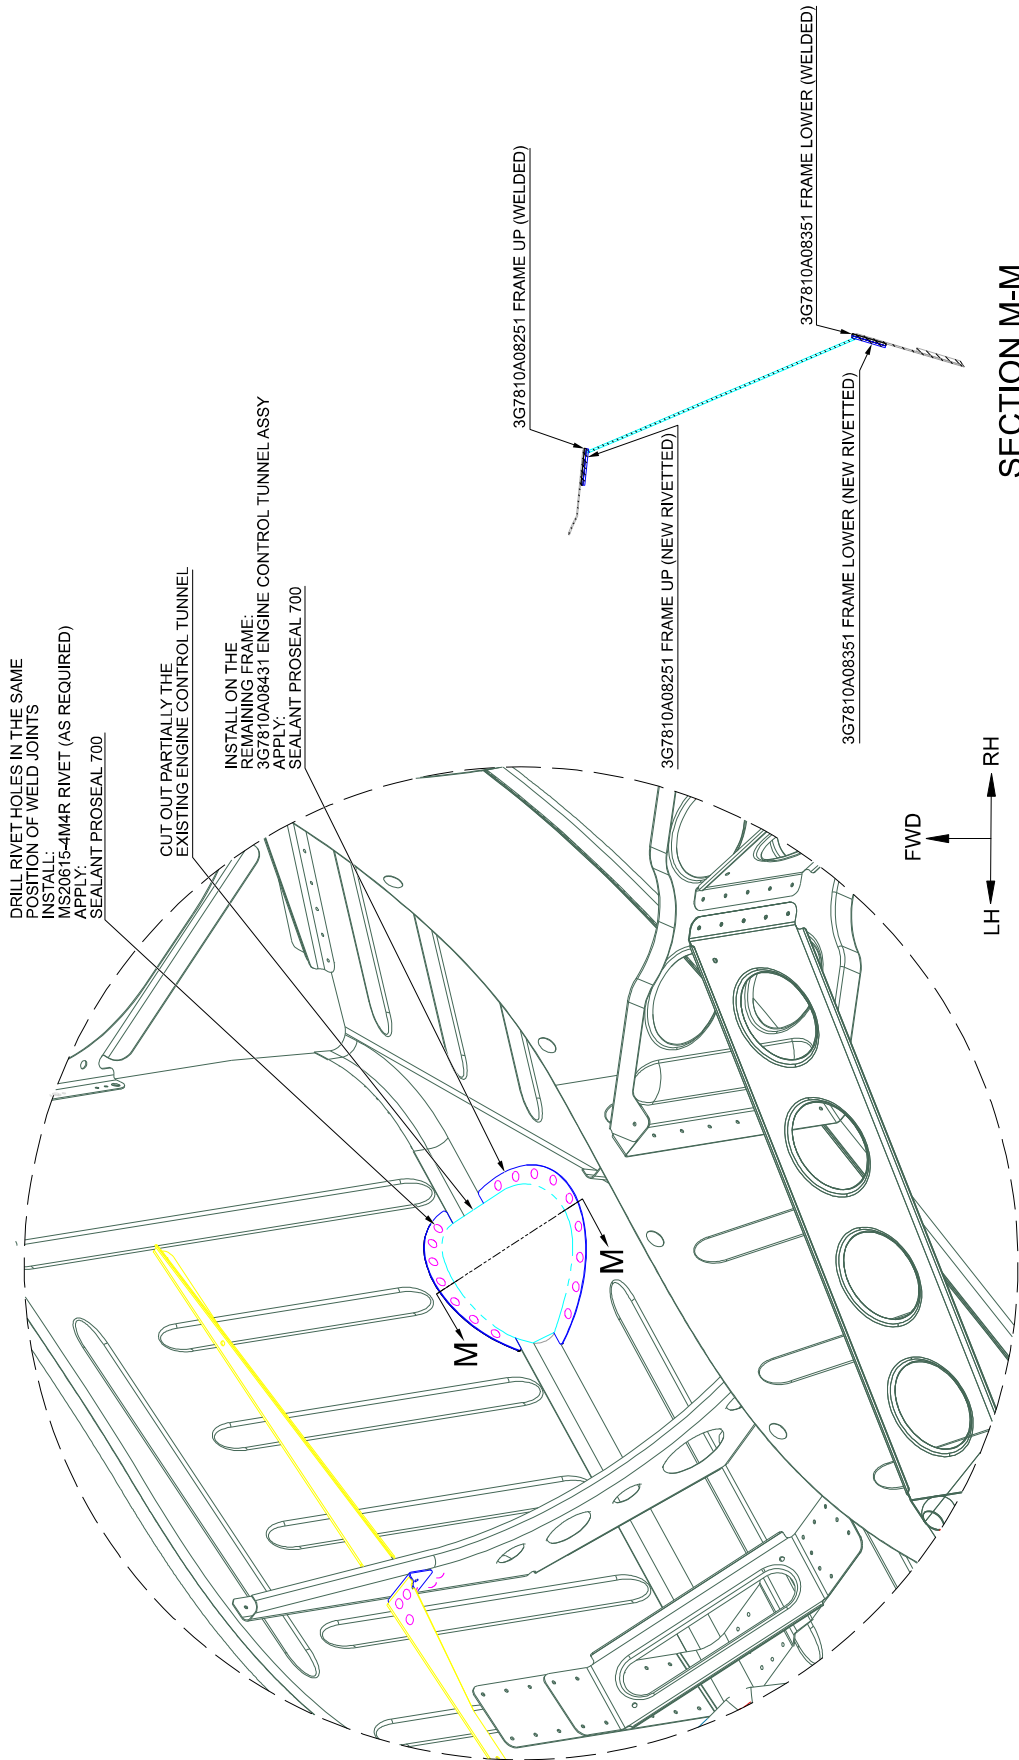
If repair structures are present in the zone indicated in Figure 3 Detail H, they cover at least $\frac{3}{4}$ of the entire engine control tunnel assy frame and no cracks are present, it is allowed not to install the new engine control tunnel assy P/N 3G7810A08431. If repair structure cover less than $\frac{3}{4}$ of the entire engine control tunnel assy frame, contact the Product Support Engineering (engineering.support.lhd@leonardocompany.com) to receive instructions.

- 3.9 With reference to Figure 3 Detail H, perform the indicated cutout on the existing engine control tunnel assy P/N 3G7810A08431.
- 3.10 With reference to Figure 3 Detail H, temporarily locate a new engine control tunnel assy P/N 3G7810A08431 on the remaining frames of the existing one.

- 3.11 With reference to Figure 3 Detail H, countermark and drill the rivets holes in the same position of weld joints.
- 3.12 With reference to Figure 3 Detail H and Section M-M, install the new engine control tunnel assy P/N 3G7810A08431 by means the of required rivets P/N MS20615-4M4R.

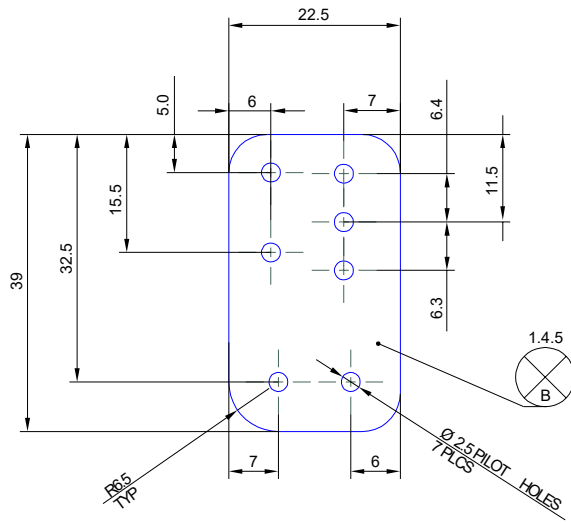
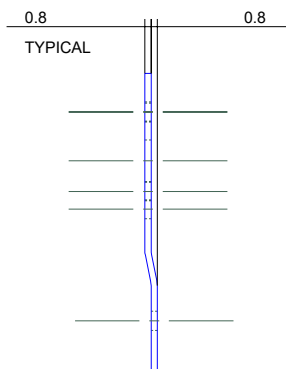
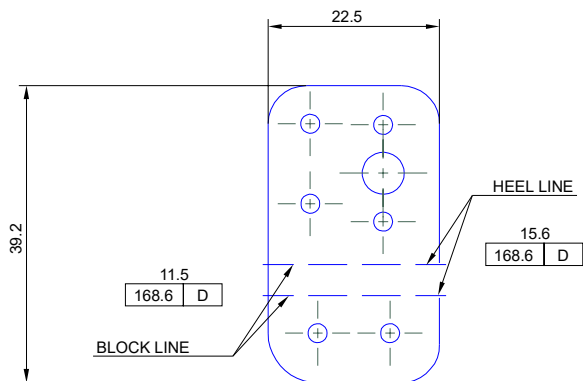
Figure 4

If P/N 3G7810A19831 doesn't fit with the structure due to the presence of a repair, it is possible to fabricate the plate from raw materials in order to make it fits with the repaired structure (refer to Figure 4). Dimensions in the figure are for reference, it is possible to adjust these dimensions to be compliant with standard practices contained in DM CSRPA-51-71-00-00A-028A-D.

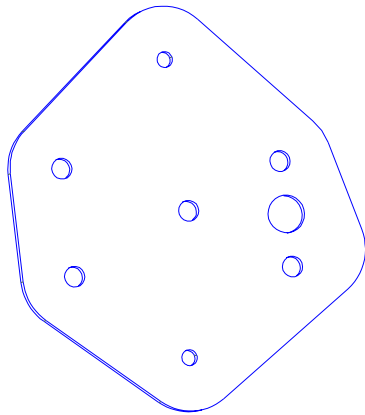
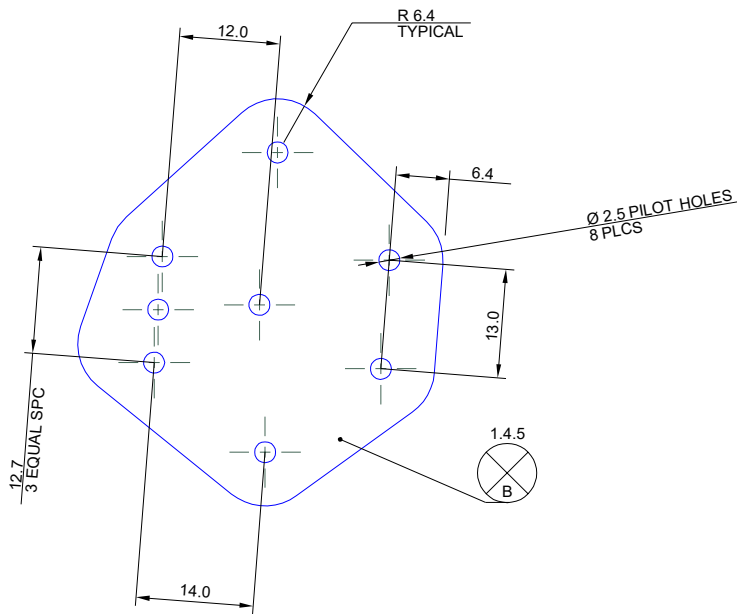
Figure 5

If P/N 3G7810A19931 doesn't fit with the structure due to the presence of a repair, it is possible to fabricate the plate from raw materials in order to make it fits with the repaired structure (refer to Figure 5). Dimensions in the figure are for reference, it is possible to adjust these dimensions to be compliant with standard practices contained in DM CSRPA-51-71-00-00A-028A-D.
