SERVICE BULLETIN

N° 139-641

ATA 25 - COLLECTIVE EMERGENCY LIFE-RAFT NEW HANDLE COVER

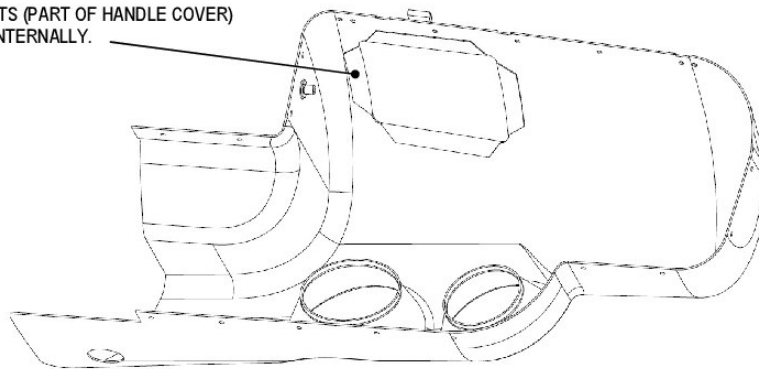
Figure 3 – New Handle Cover applied on fairing (internal side view)

TEXTILE WINGLETS (PART OF HANDLE COVER)
TO BE BONDED INTERNALLY.

- (4) Place the new handle Cover P/N 307463B to the fairing and joint gradually, ref. to figure 2. Fold back the four textile winglets of the Handle Cover to bond them to the internal side of the fairing, ref. to figure 3.

- (5) Let adhesive to cure for at least 24 Hours prior to try opening the Handle Cover.
- (6) Modify the part number of Double Head Light Fairing (Part is identified internally, ref. to figure 3). Use a permanent marker (ref. to paragraph 2.A) to cross the current part number 202811A (for right instl) or 202812A (for left instl) and add new part number 202811B (for right instl) or 202812B (for left instl).
 - (a) If present, change also the part number of Double Head Light Fairing Assy. Use a permanent marker (ref. to paragraph 2.A) to cross the current part number 202688A (for right instl) or 202689A (for left instl); then, add new part number 202688B (for right instl) or 202689B (for left instl).

- (1) Record compliance with this Service Bulletin in the component Log Card.
- (2) Record compliance with this Service Bulletin to the internal side of the Double Head Light Fairing Assy P/N 202688A or P/N 202689A (ref. to Figure 3). Use a permanent marker (ref. to paragraph 2.A) to mark the bulletin reference number (SB-139-25-004) close to the identification data modified as per step (6) of paragraph 3.A.
