SERVICE BULLETIN**N° 139-642****DATE:** July 16, 2020**REV. :** A - September 27, 2021

TITLE**ATA 64 – TAIL ROTOR HEAD INSPECTION AND MODIFICATION****REVISION LOG**

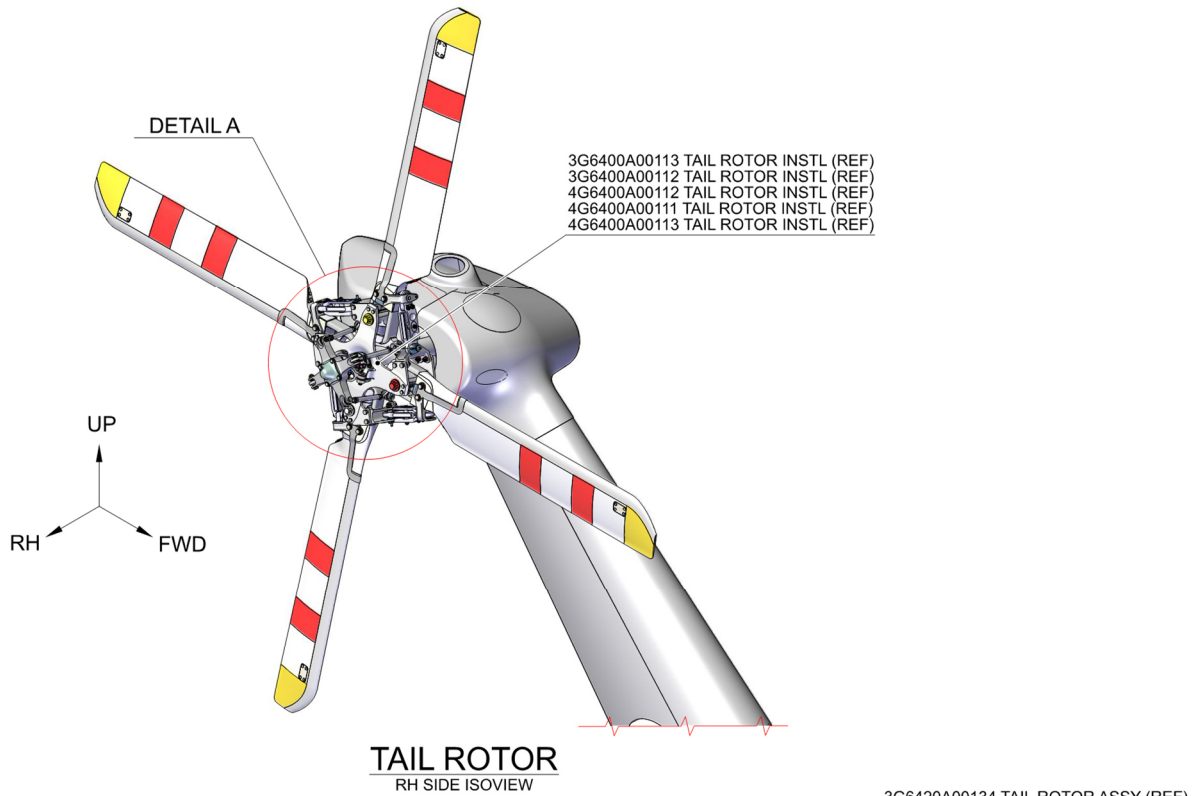
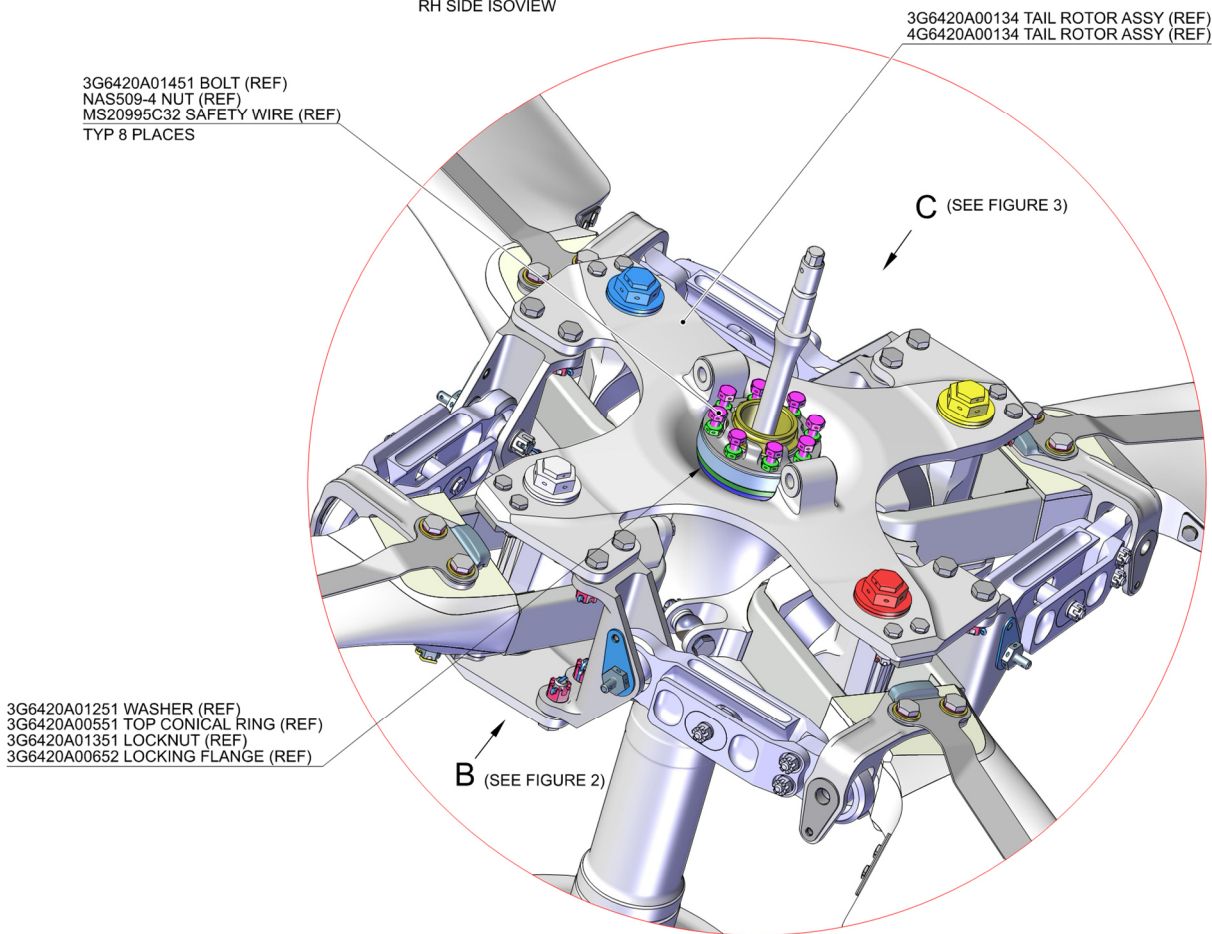
2. With reference to Figure 1, gain access to the T/R head installation.
3. With reference to Figure 1 Detail A, examine the presence and the condition of the safety wire (C014) P/N MS20995C32 on the n°8 nuts P/N NAS509-4 and n°8 bolts P/N 3G6420A01451. In case of findings go to step 8.

4. With reference to Figure 1 Detail A, examine the presence and the condition of the washer P/N 3G6420A01251. In case of findings go to step 8.
5. With reference to Figure 2 View B, make sure that there is an equal gap between the ends of the bottom conical half rings P/N 3G6420A00451. In case of findings go to step 8.

- 2.2 With reference to Figures 1 and 2, examine the components of the T/R head as described in the following procedure:
 - 2.2.1 With reference to Figure 1 Detail A, examine the presence and the condition of the safety wire (C014) P/N MS20995C32 on the n°8 nuts P/N NAS509-4 and n°8 bolts P/N 3G6420A01451. In case of findings go to step 3.

- 2.2.2 With reference to Figure 1 Detail A, examine the presence and the condition of the washer P/N 3G6420A01251. In case of findings go to step 3.
 - 2.2.3 With reference to Figure 2 View B, make sure that there is an equal gap between the ends of the bottom conical half rings P/N 3G6420A00451. In case of findings go to step 3.

DETAIL A
TAIL ROTOR CONTROL INSTL OMITTED FOR BETTER CLARITY PURPOSE

8. In accordance with the applicable steps of AMP DM 39-A-64-21-01-00A-31BA-B perform the SDI of the tail rotor head.

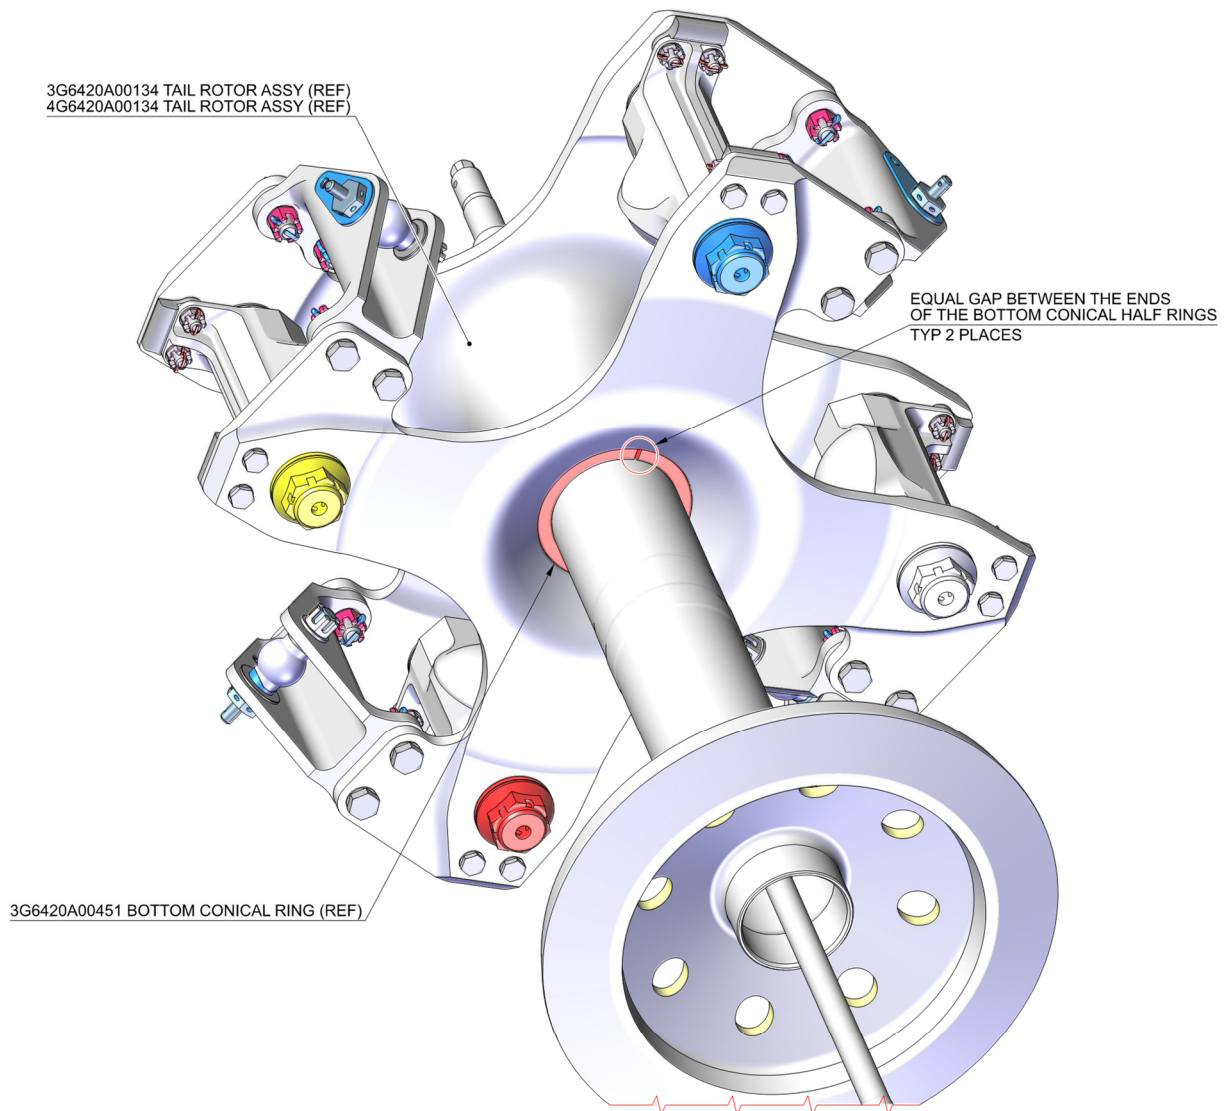
Figure 2

VIEW B

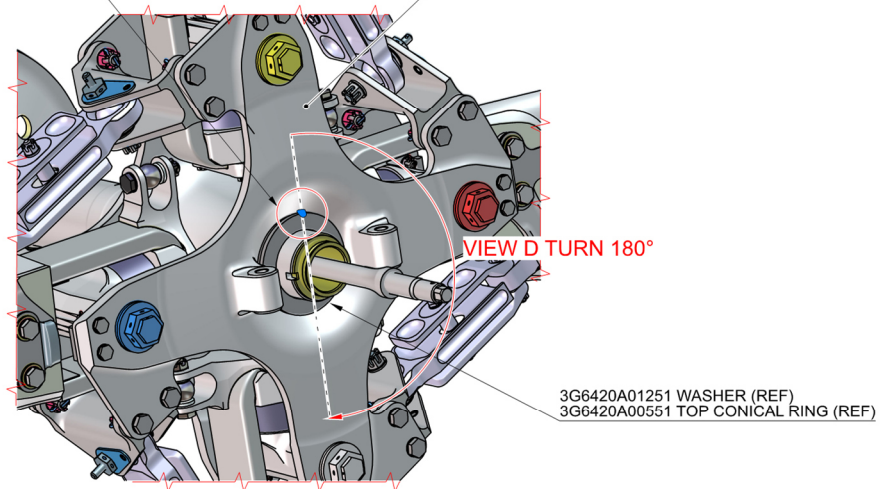
VIEW C

7. With reference to Figure 3 View C and View D, examine the condition of slippage marks and verify misalignment of the components monitored with slippage marks. In case of findings go to step 8.

2. With reference to Figure 1 Tail Rotor, gain access to the T/R head installation and perform the inspection as follows:
 - 2.1 With reference to Figure 3 View C and View D, examine the condition of slippage marks and verify misalignment of the components monitored with slippage marks. In case of findings go to step 3.

CLEAN AND APPLY:
N°1 SLIPPAGE MARK
(APPLICABLE COLOUR: YELLOW, GREEN OR BLUE)

- 9.2 With reference to Figure 3 View C, apply n°1 slippage mark with a colour between the hub, the top conical ring P/N 3G6420A00551 and the washer P/N 3G6420A01251 in the indicated position using the applicable paint colour: yellow, green or blue.
- 9.3 With reference to Figure 3 View D, turn the tail rotor blade of 180° and apply n°1 slippage mark with a colour between the hub, the top conical ring P/N 3G6420A00551 and the washer P/N 3G6420A01251 in the indicated position using the applicable paint colour: yellow, green or blue.
10. Return the helicopter to flight configuration and record for compliance with Part I of this Service Bulletin on the helicopter logbook.
11. Send the attached compliance form to the following mail box:

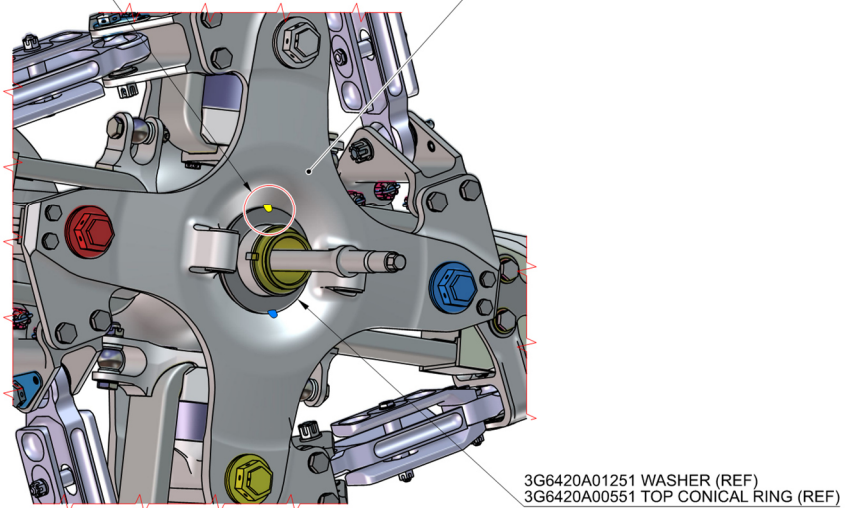
VIEW D
ROTATED 180°

CLEAN AND APPLY:
N°1 SLIPPAGE MARK
(APPLICABLE COLOUR: YELLOW, GREEN OR BLUE)
