SERVICE BULLETIN

N° 139-649

ATA 67 – TAIL ROTOR ACTUATOR UPGRADE

**SERVICE BULLETIN SB_27-0040 TAIL ROTOR ACTUATOR
P/N 3G6730V00731 UPGRADE TO P/N 3G6730V00732**

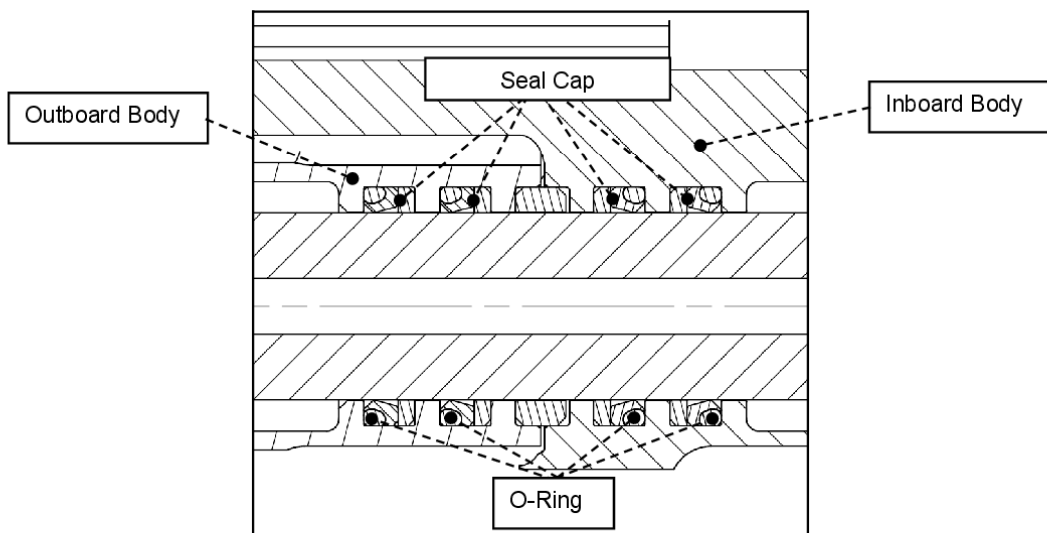
Figure 1: Dynamic Seals Orientation in the Inboard and Outboard Body (Central Glands)

CAUTION: THE SEAL ORIENTATION IS A KEY CHARACTERISTIC. 100% INSPECTION REQUIRED.

1. Refer to Figure 1. Install the O-Ring (P/N 081341), the Seal Cap and Back-Up Ring (P/N 085366) in the interface bores of the inboard (P/N 71827-81 or 70715-81) and outboard bodies (P/N 70711-81 or 71831-81).
